**BLACK CREEK CULVERT**

Site Number 030048

**CONCESSION 12 ROAD, TOWNSEND**

**Ontario Structure Inspection Manual - Inspection Form**

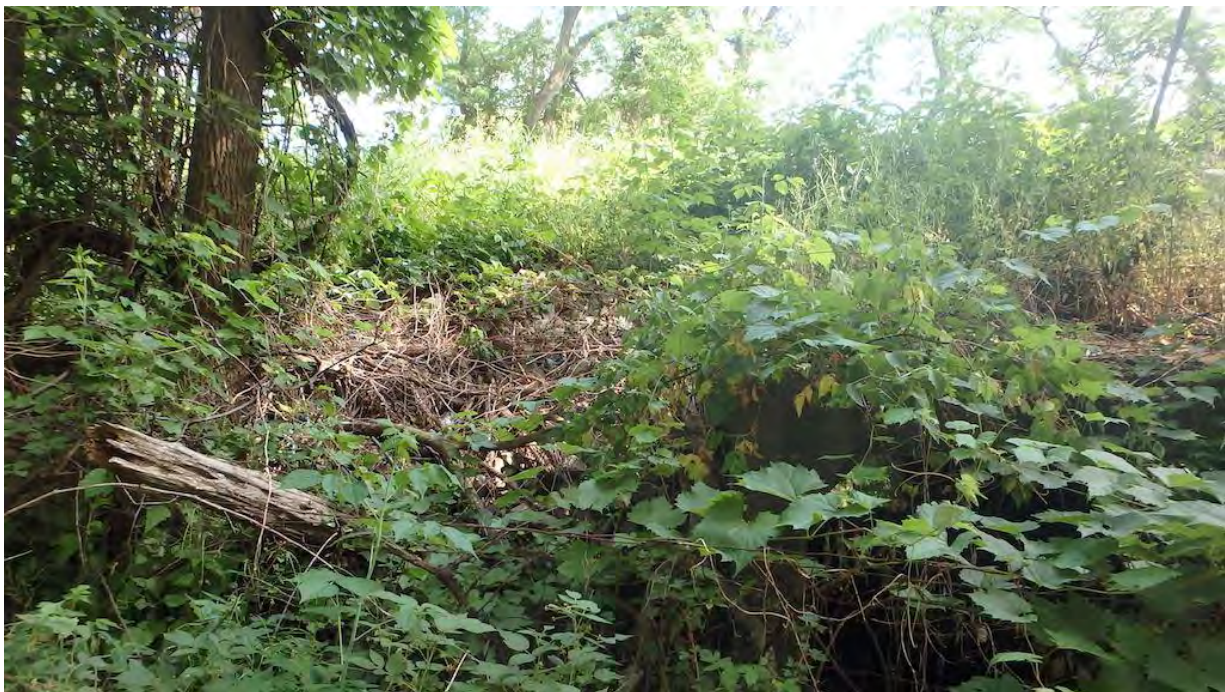
Figure 8 Minor Erosion at Northwest Quadrant

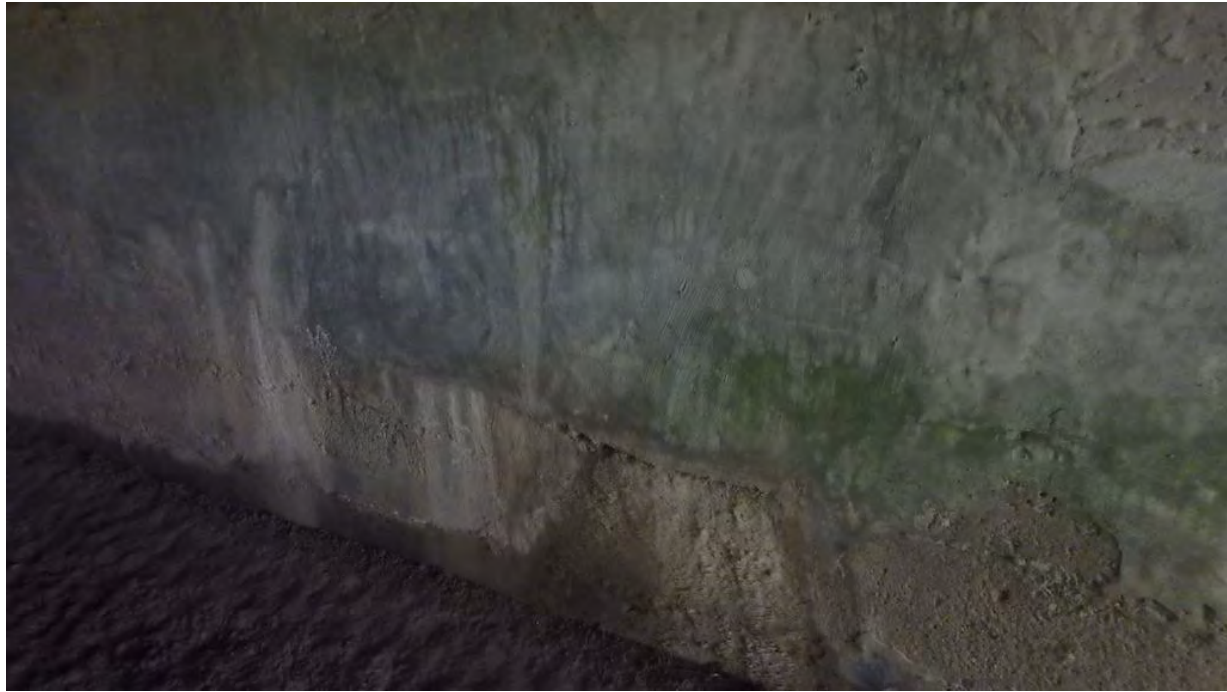
Figure 9 Typical Scaling and Leakage on Culvert Walls

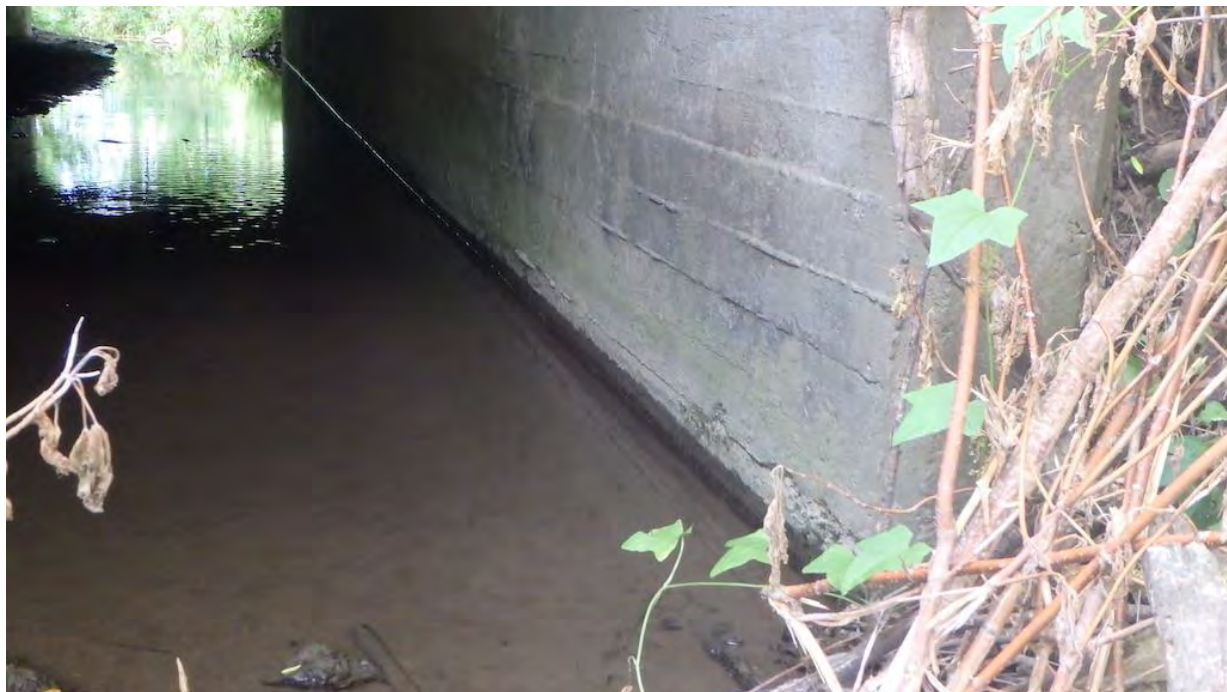
Figure 10 Typical Scaling and Spalling on Culvert Walls
