**LOT 20 CONCESSION 12 ROAD**

Site Number 030050

**Ontario Structure Inspection Manual - Inspection Form**

Field Inspection Information:	
Date of Inspection:	July 7, 2016
Type of Inspection:	<input checked="" type="checkbox"/> OSIM <input type="checkbox"/> Enhanced OSIM
Inspector:	Ben Buchwald M.Eng., EIT, G. Douglas Vallee Ltd.
Others in Party:	N/A
Access Equipment Used:	Hammer, Binoculars, Measuring Tape, Camera, etc.
Weather:	Sunny
Temperature:	24 °C

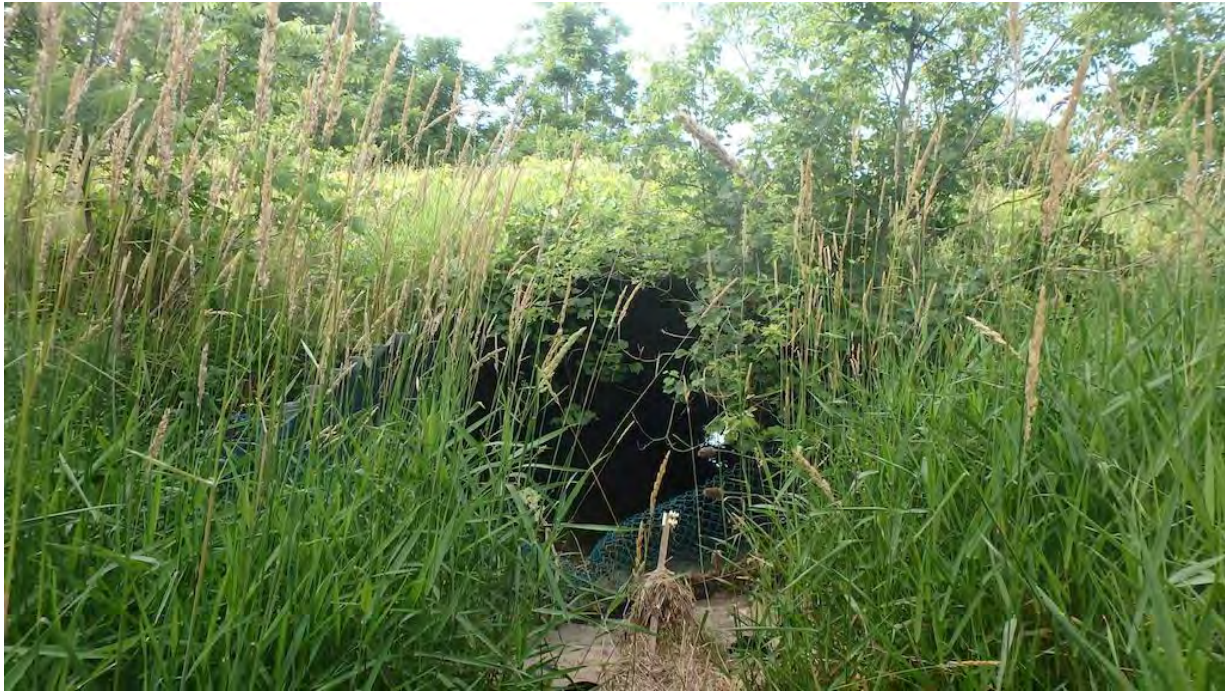
Figure 3 North Profile, Inlet

Element Group:	1200 Culverts					Length:	
Element Name:	1201 Inlet Components					Width:	
Location:	North End					Height:	
Material:	5	Corrugated Steel				Count:	1
Element Type:						Total Quantity:	1 Each
Environment:	Severe					Limited Inspection:	
Protection System:	Hot dip galvanizing					Perform. Deficiencies	
Condition Data:	Units	Exc.	Good	Fair	Poor		
	Each	0	0	0.5	0.5		
Comments: Some rock protection at northeast corner required. Has been undermined 0.5m and is sagging. Contains wood debris and garbage.							
Recommended Work:				Rehab <input checked="" type="checkbox"/>		Replace <input type="checkbox"/>	
Timing:				Urgent <input type="checkbox"/>		< 1yr <input type="checkbox"/>	
				1 - 5 yr <input checked="" type="checkbox"/>		6 - 10 yr <input type="checkbox"/>	
				Maintenance Needs:			
				Urgent <input type="checkbox"/>			
				1 year <input type="checkbox"/>			
				2 year <input type="checkbox"/>

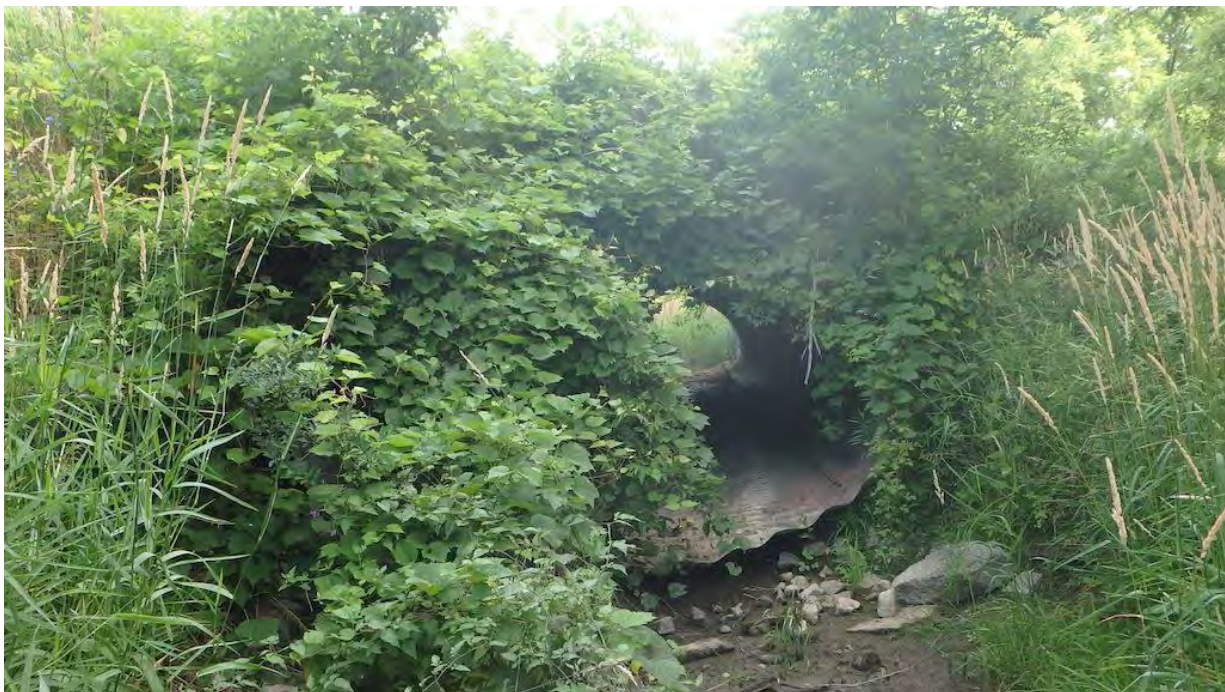
Figure 4 South Profile, Outlet

Element Group:	1200 Culverts	Length:				
Element Name:	1202 Outlet Components	Width:				
Location:	South End	Height:				
Material:	5 Corrugated Steel	Count:	1			
Element Type:		Total Quantity:	1 Each			
Environment:	Severe	Limited Inspection:				
Protection System:	Hot dip galvanizing	Perform. Deficiencies				
Condition Data:	Units	Exc.	Good	Fair	Poor	
	Each	0	0	0.5	0.5	
Comments: Has been undermined by 0.5m. Needs to be shored up.						
Recommended Work:      Rehab <input checked="" type="checkbox"/> Replace <input type="checkbox"/>				Maintenance Needs:		
Timing:      Urgent <input type="checkbox"/> < 1yr <input type="checkbox"/> 1 - 5 yr <input checked="" type="checkbox"/> 6 - 10 yr <input type="checkbox"/>				<input type="checkbox"/> Urgent <input type="checkbox"/> 1 year <input type="checkbox"/> 2 year

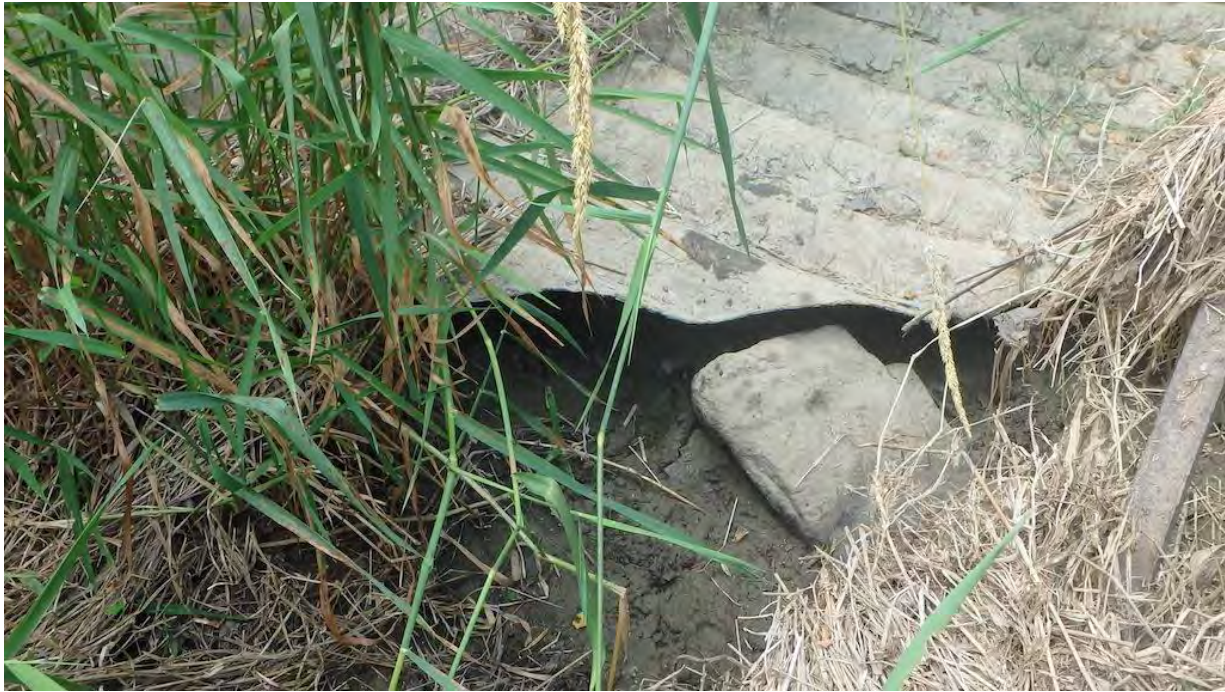
Figure 9 Undermining at Inlet

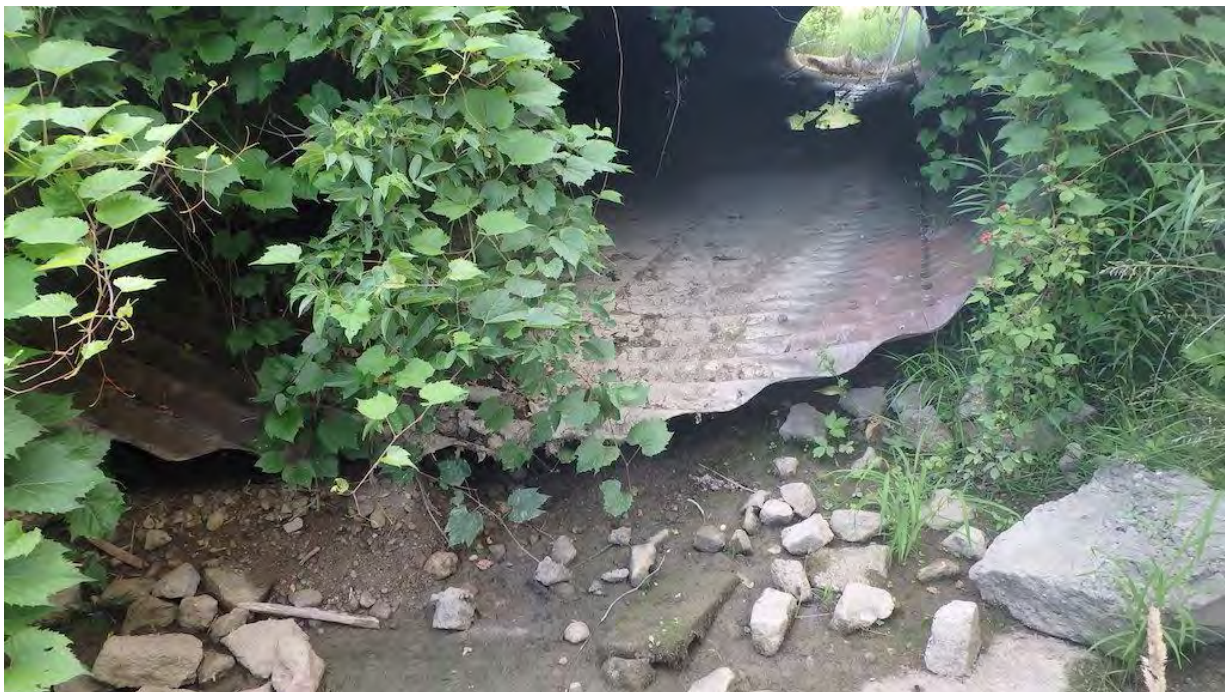
Figure 10 Undermining at Outlet

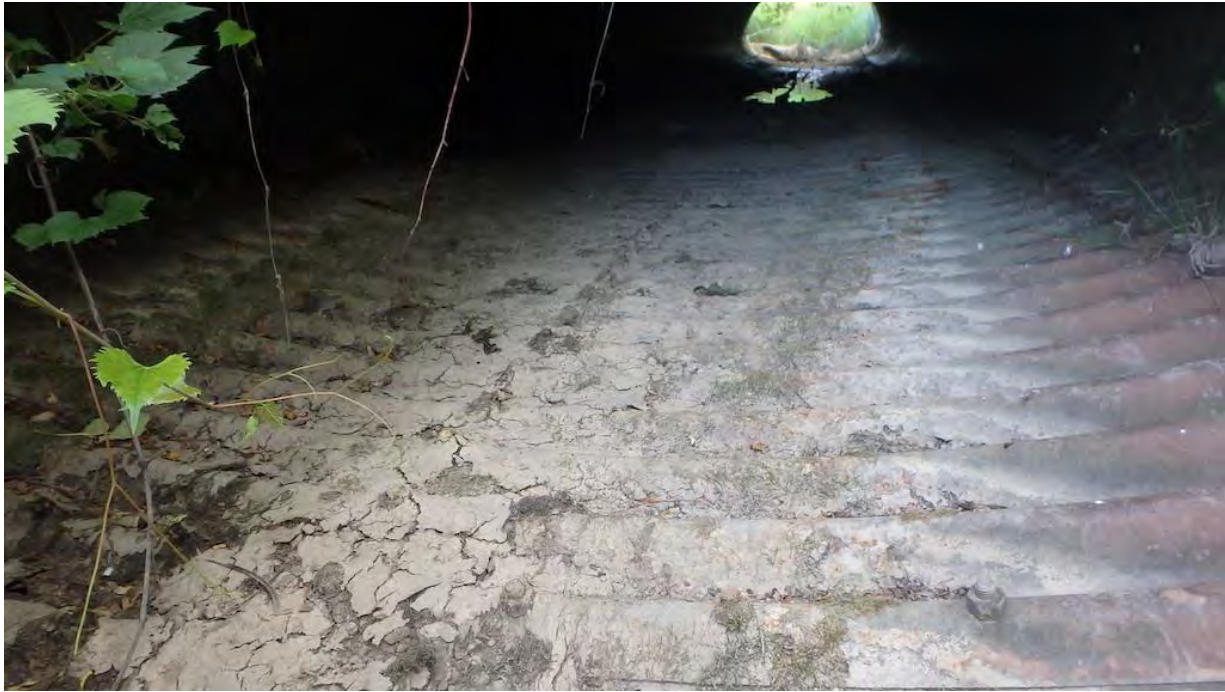
Figure 11 Typical Corrosion on Culvert Bottom
