LOT 17 CONCESSION 7 ROAD

Site Number 030055

CONCESSION 7 ROAD, TOWNSEND

Ontario Structure Inspection Manual - Inspection Form

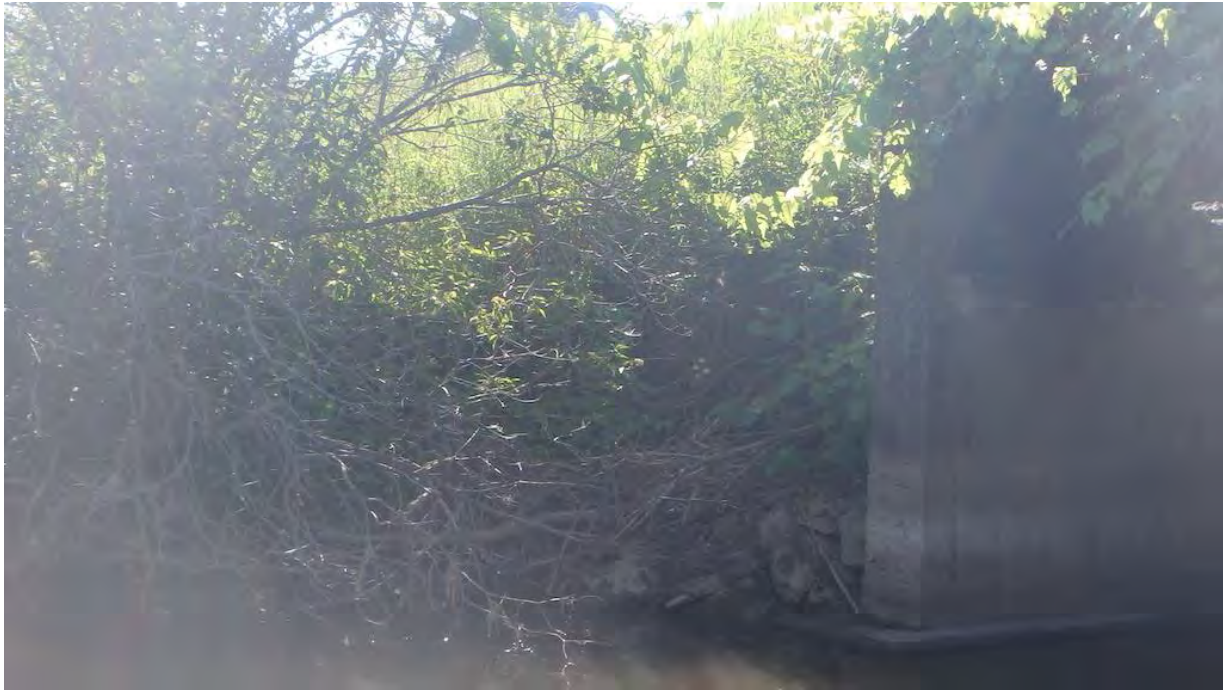
Figure 9 Minor Erosion at Northeast Quadrant
