**McMICHAEL ROAD CULVERT**

Site Number 030056

**McMICHAEL ROAD, TOWNSEND**

**Ontario Structure Inspection Manual - Inspection Form**

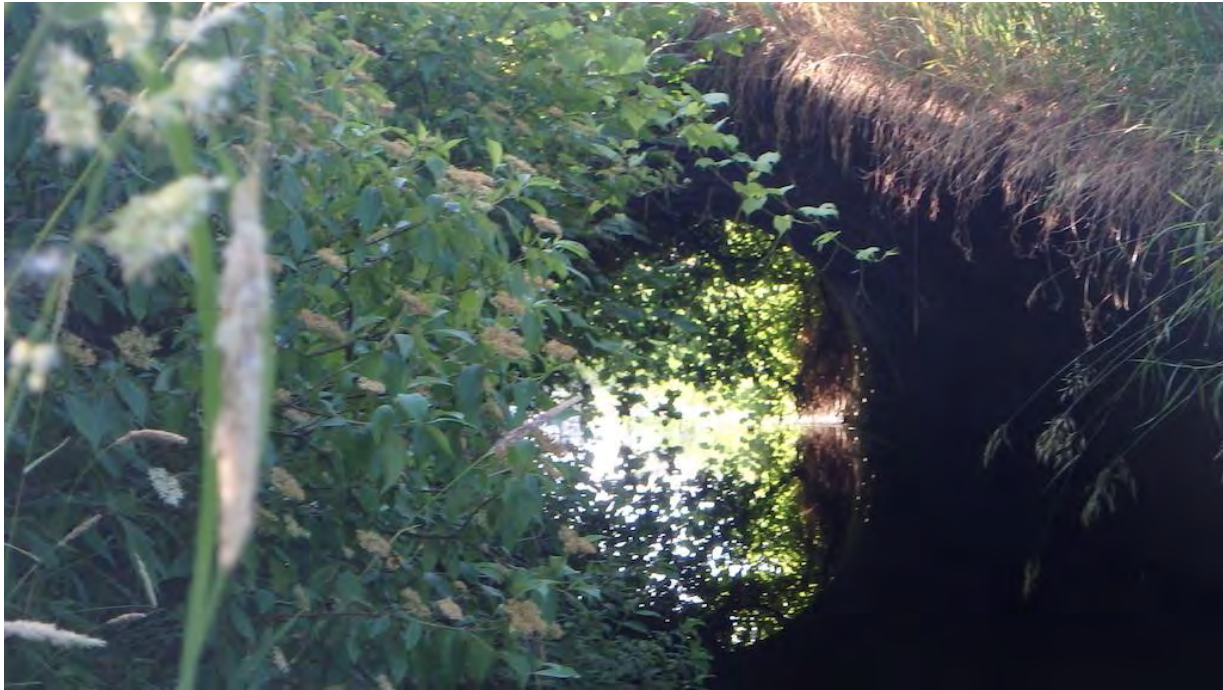
Figure 7      Barrel

Element Group:		1200 Culverts				Length:		29
Element Name:		1203 Barrels				Width:		6
Location:		Inside				Height:		
Material:						Count:		1
Element Type:						Total Quantity:		174 sq.m
Environment:		Moderate				Limited Inspection:		
Protection System:		Unknown				Perform. Deficiencies		
Condition	Units	Exc.	Good	Fair	Poor			
Data:	sq.m	0	172	2	0			
Comments: Includes: Inlet - Outlet (beveled - skewed) Stream - Straight. Limited inspection due to water level - visual inspection from ends. Under/side mining at inlet. Minor corrosion at barrel bottom edges. Minor erosion at inlet and outlet.								
Recommended Work: Rehab <input type="checkbox"/> Replace <input type="checkbox"/>				Maintenance Needs: Erosion Control at Bridge.				
Timing: Urgent <input type="checkbox"/> < 1yr <input type="checkbox"/> 1 - 5 yr <input type="checkbox"/> 6 - 10 yr <input type="checkbox"/>				<input type="checkbox"/> Urgent <input checked="" type="checkbox"/> 1 year <input type="checkbox"/> 2 year
