Lot 18-19 Concession 12 Townsend Culvert

Site Number 030071

VILLA NOVA ROAD, TOWNSEND

Ontario Structure Inspection Manual - Inspection Form

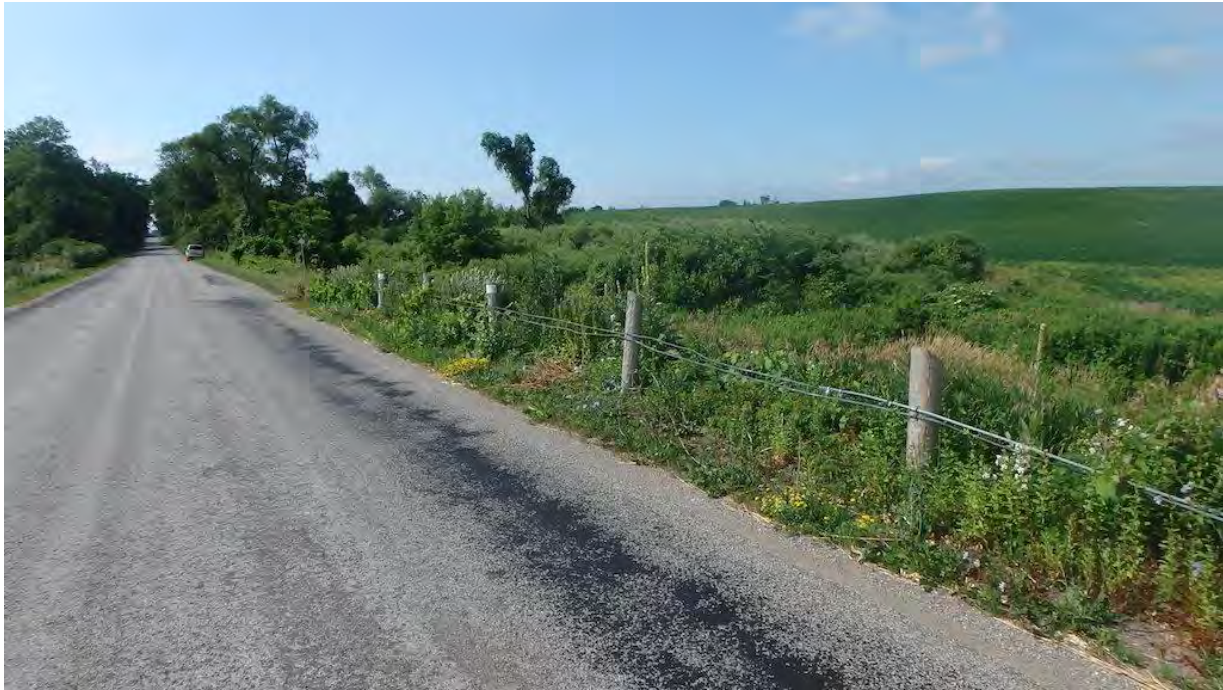
Element Group:		400 Barriers				Length:	30
Element Name:		403 Posts				Width:	
Location:		East and West				Height:	
Material:						Count:	2
Element Type:						Total Quantity:	60 Each
Environment:						Limited Inspection:	
Protection System:		Unknown				Perform. Deficiencies	
Condition	Units	Exc.	Good	Fair	Poor		
Data:	Each	0	0	30	30		
Comments: Replace with standard 3 cable system. No hazard signs at quadrants. Cables loose. Posts are old. Some posts unstable. Some cables are detached. Barriers do not extend past culvert ends.							
Recommended Work: Rehab <input type="checkbox"/> Replace <input checked="" type="checkbox"/>				Maintenance Needs:			
Timing: Urgent <input type="checkbox"/> < 1yr <input type="checkbox"/> 1 - 5 yr <input checked="" type="checkbox"/> 6 - 10 yr <input type="checkbox"/>				<input type="checkbox"/> Urgent <input type="checkbox"/> 1 year <input type="checkbox"/> 2 year

Figure 9 Typical Barrier

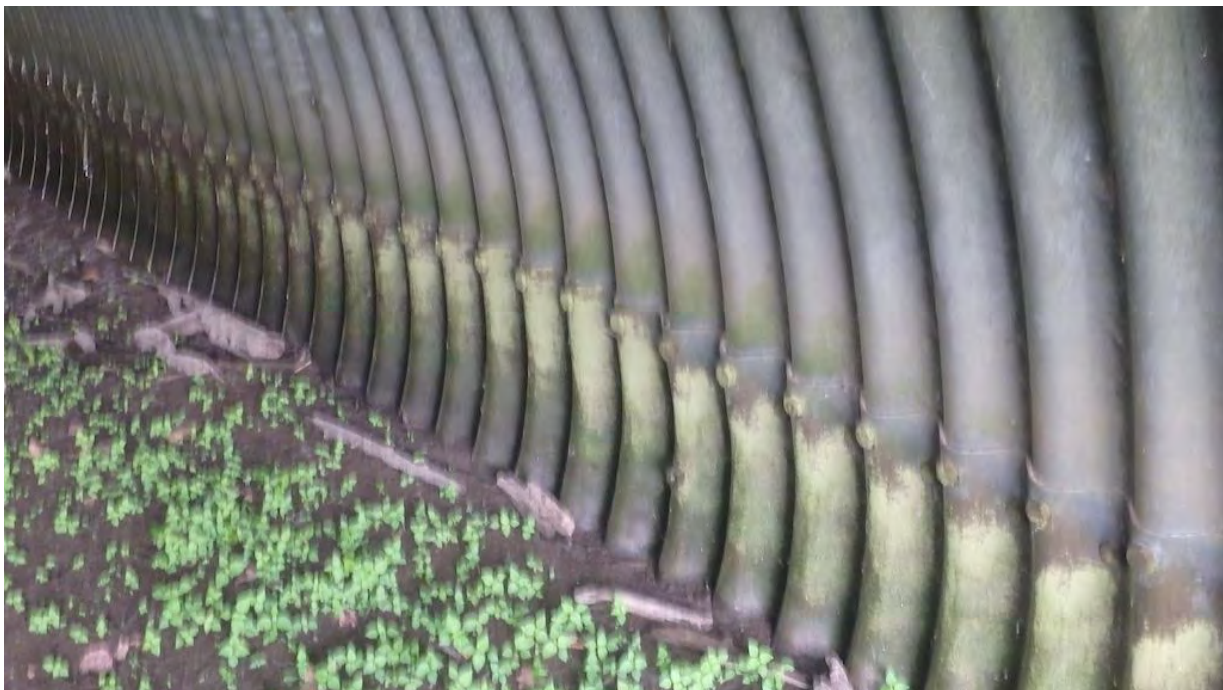
Element Group:		1200 Culverts				Length:	34
Element Name:		1203 Barrels				Width:	10
Location:		Interior				Height:	
Material:		5 Corrugated Steel				Count:	1
Element Type:						Total Quantity:	340 sq.m
Environment:		Moderate				Limited Inspection:	
Protection System:		Unknown				Perform. Deficiencies	
Condition	Units	Exc.	Good	Fair	Poor		
Data:	sq.m	0	306	34	0		
Comments: Steel wingwalls of culvert are pushed in by fill and are severely deflecting inward. Regrade slopes. Requires reinforcing/slope regrading. New culvert ends required, and regrading.							
Recommended Work: Rehab <input checked="" type="checkbox"/> Replace <input type="checkbox"/>				Maintenance Needs:			
Timing: Urgent <input type="checkbox"/> < 1yr <input type="checkbox"/> 1 - 5 yr <input checked="" type="checkbox"/> 6 - 10 yr <input type="checkbox"/>				<input type="checkbox"/> Urgent <input type="checkbox"/> 1 year <input type="checkbox"/> 2 year

Figure 10 Typical Surface Corrosion in Barrel

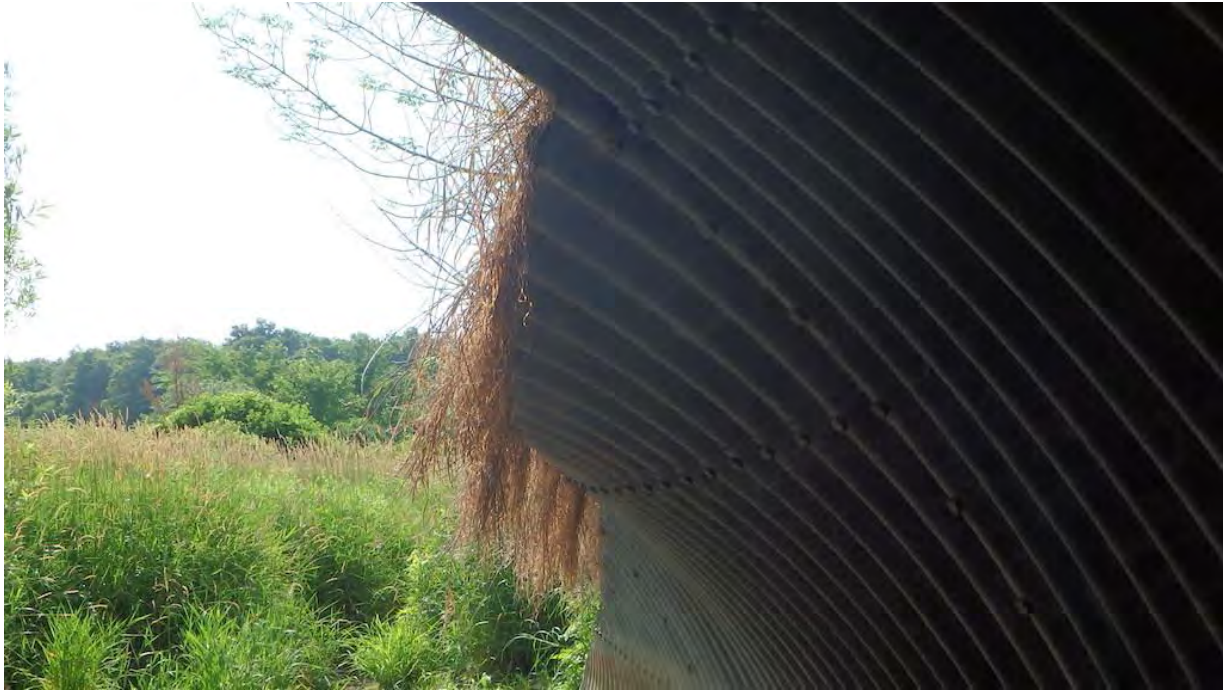
Figure 11 Deflected Culvert Ends at all Quadrants

Overall Structure Notes:	
Recommended Work on Structure:	<input type="checkbox"/> None <input checked="" type="checkbox"/> Minor Rehab. <input type="checkbox"/> Replace <input type="checkbox"/> Maintenance <input type="checkbox"/> Major Rehab.
Timing of Recommended Work:	<input checked="" type="checkbox"/> 1 to 5 years <input type="checkbox"/> 6 to 10 years
Overall Comments:	New culvert ends required.
Date of next Inspection:	July 1, 2018
