**CONCESSION 13 CULVERT**

Site Number 030201

**CONCESSION 13 ROAD, TOWNSEND**

**Ontario Structure Inspection Manual - Inspection Form**

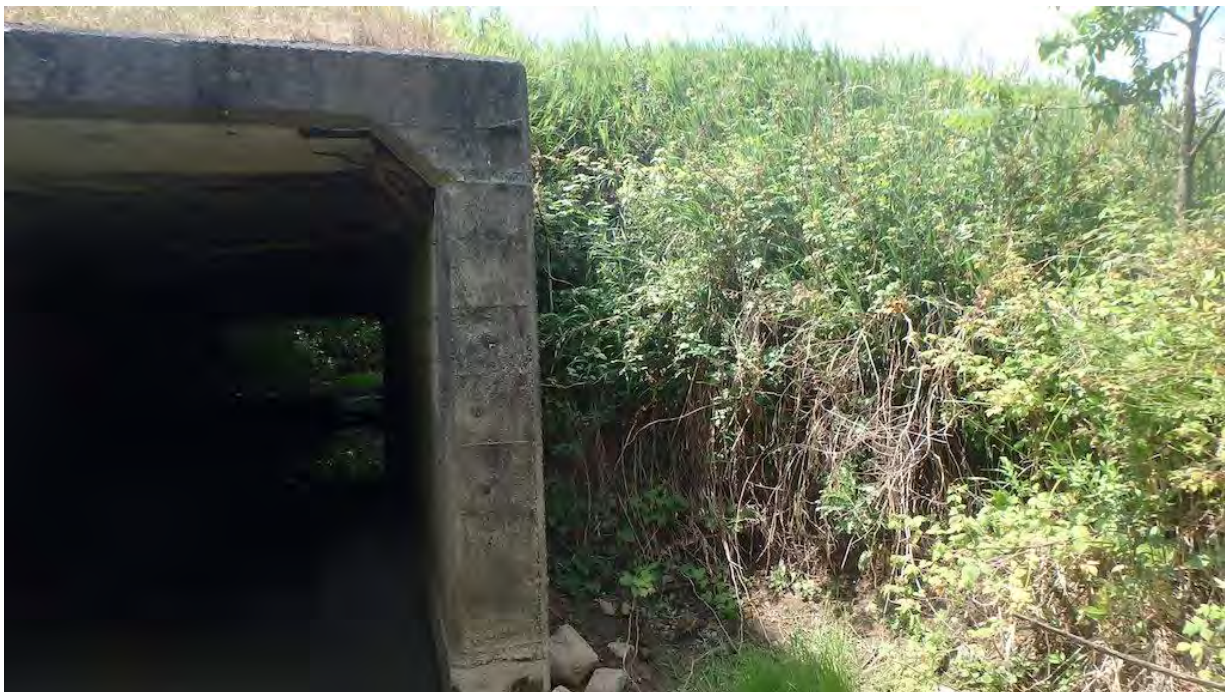
Figure 10 Erosion at Northwest Quadrant

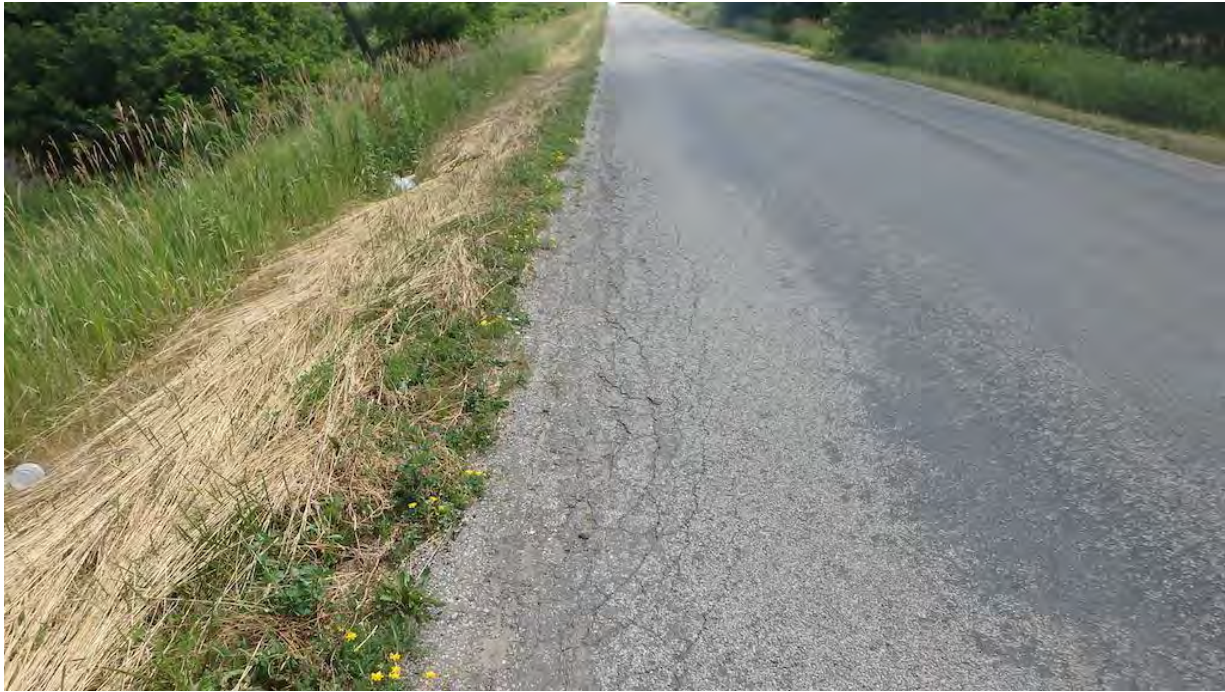
Figure 11      Cracking and Rutting at Edges of Wearing Surface
