**WATERFORD CAUSEWAY BRIDGE**

Site Number 120000

**ST. JAMES STREET, WATERFORD**

**Ontario Structure Inspection Manual - Inspection Form**

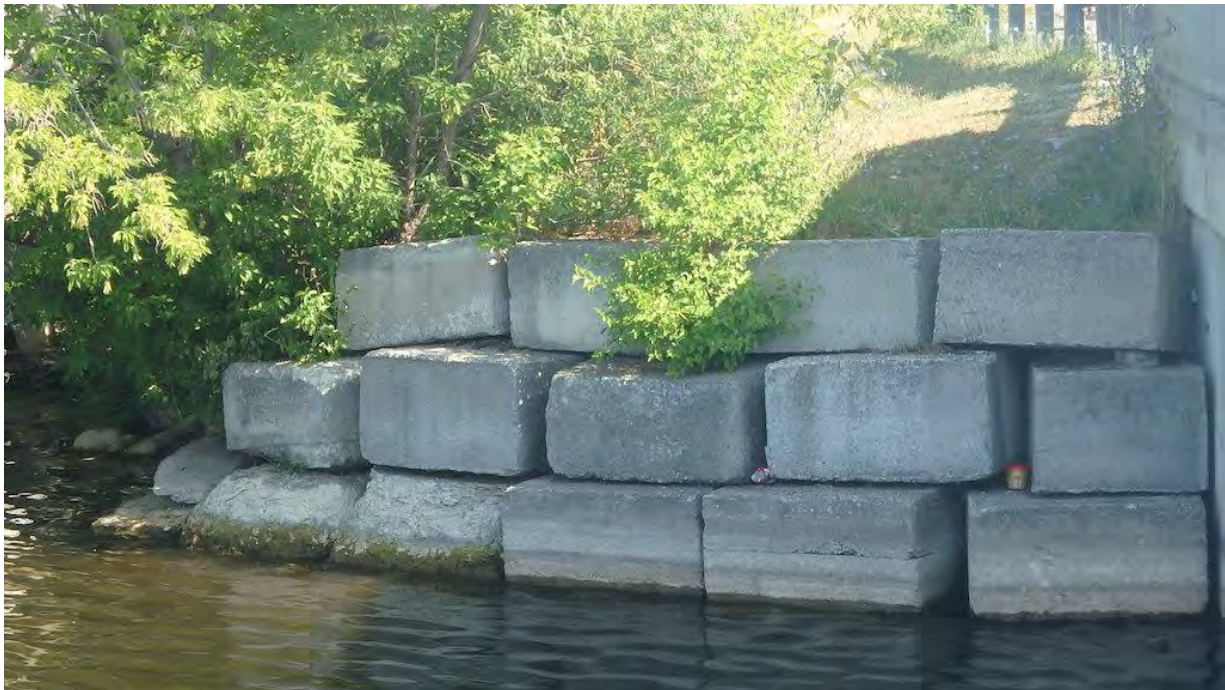
Figure 10      Separation of Retaining Wall

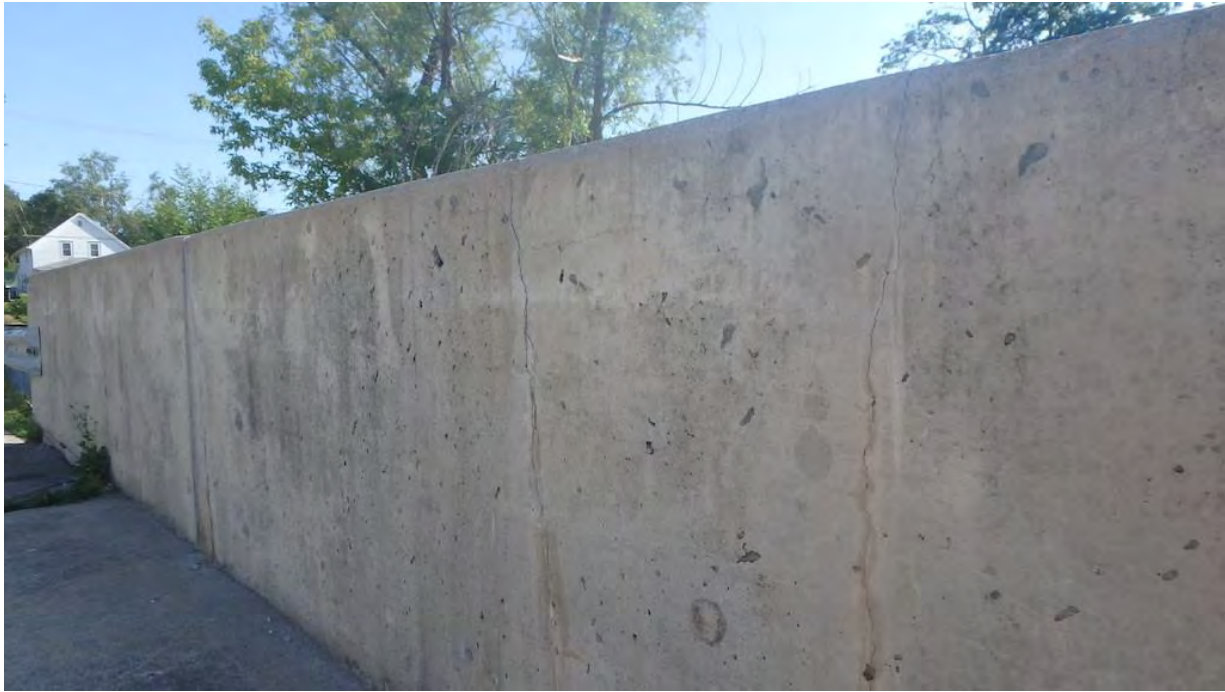
Element Group:		400 Barriers				Length:	50
Element Name:		401 Barrier/Parapet Walls				Width:	
Location:						Height:	
Material:		4 Cast-in-place Concrete				Count:	2
Element Type:						Total Quantity:	100 m
Environment:						Limited Inspection:	
Protection System:		Unknown				Perform. Deficiencies	
Condition	Units	Exc.	Good	Fair	Poor		
Data:	m	0	0	100	0		
Comments: Vertical cracks in parapet wall, approximately every 1 to 2 meters. Retaining wall at Southeast settling and falling away from wingwall. Corner block at Northeast retaining wall settled.							
Recommended Work:    Rehab <input type="checkbox"/> Replace <input type="checkbox"/>					Maintenance Needs:		
Timing:    Urgent <input type="checkbox"/> < 1yr <input type="checkbox"/> 1 - 5 yr <input type="checkbox"/> 6 - 10 yr <input type="checkbox"/>					<input type="checkbox"/> Urgent <input type="checkbox"/> 1 year <input type="checkbox"/> 2 year

Figure 11 Typical Vertical Cracks in Barrier Walls

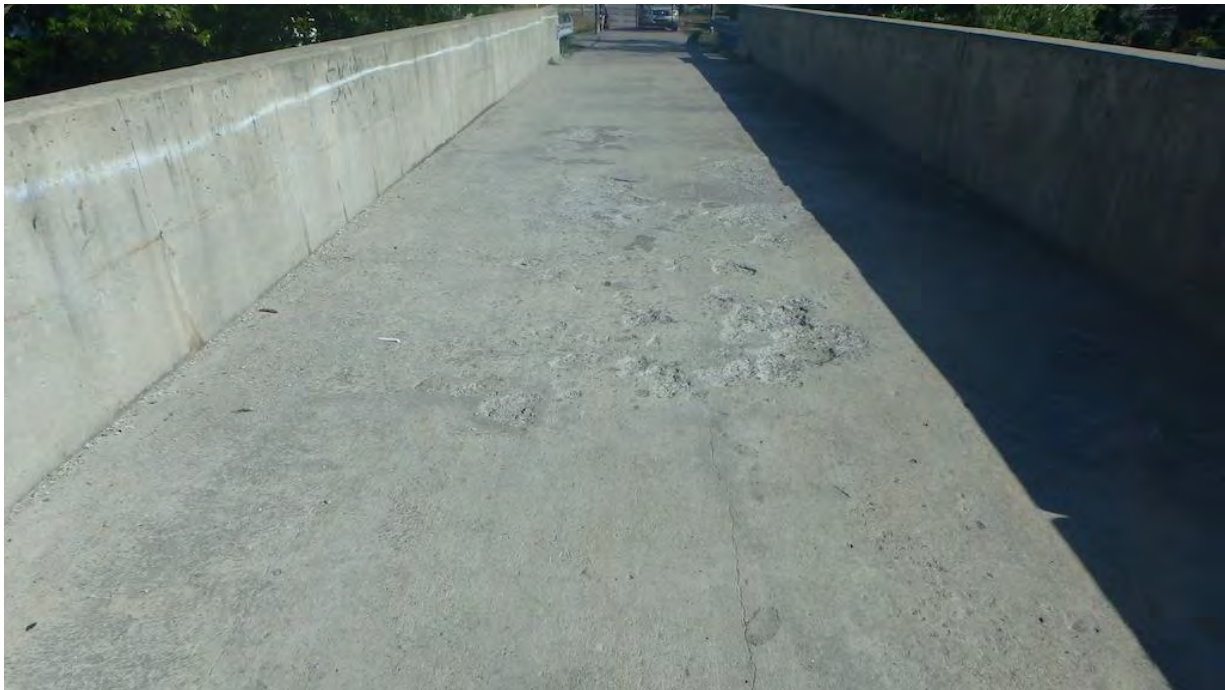
Element Group:		100 Decks				Length:	
Element Name:		102 Deck Top				Width:	
Location:						Height:	
Material:						Count:	1
Element Type:						Total Quantity:	1 Each
Environment:						Limited Inspection:	
Protection System:		Unknown				Perform. Deficiencies	
Condition	Units	Exc.	Good	Fair	Poor		
Data:	Each	0	1	0	0		
Comments: Deterioration to deck top, exposed concrete deck. Pot holes forming throughout deck.							
Recommended Work:    Rehab <input type="checkbox"/> Replace <input type="checkbox"/>					Maintenance Needs:    Bridge Surface Repair		
Timing:    Urgent <input type="checkbox"/> < 1yr <input type="checkbox"/> 1 - 5 yr <input type="checkbox"/> 6 - 10 yr <input type="checkbox"/>					<input type="checkbox"/> Urgent <input checked="" type="checkbox"/> 1 year <input type="checkbox"/> 2 year

Figure 12 Potholes and Longitudinal Cracks in Deck
