CONCESSION 4 (WOODHOUSE) CULVERT

Site Number 970505

COUNTY ROAD 5, WOODHOUSE

Ontario Structure Inspection Manual - Inspection Form

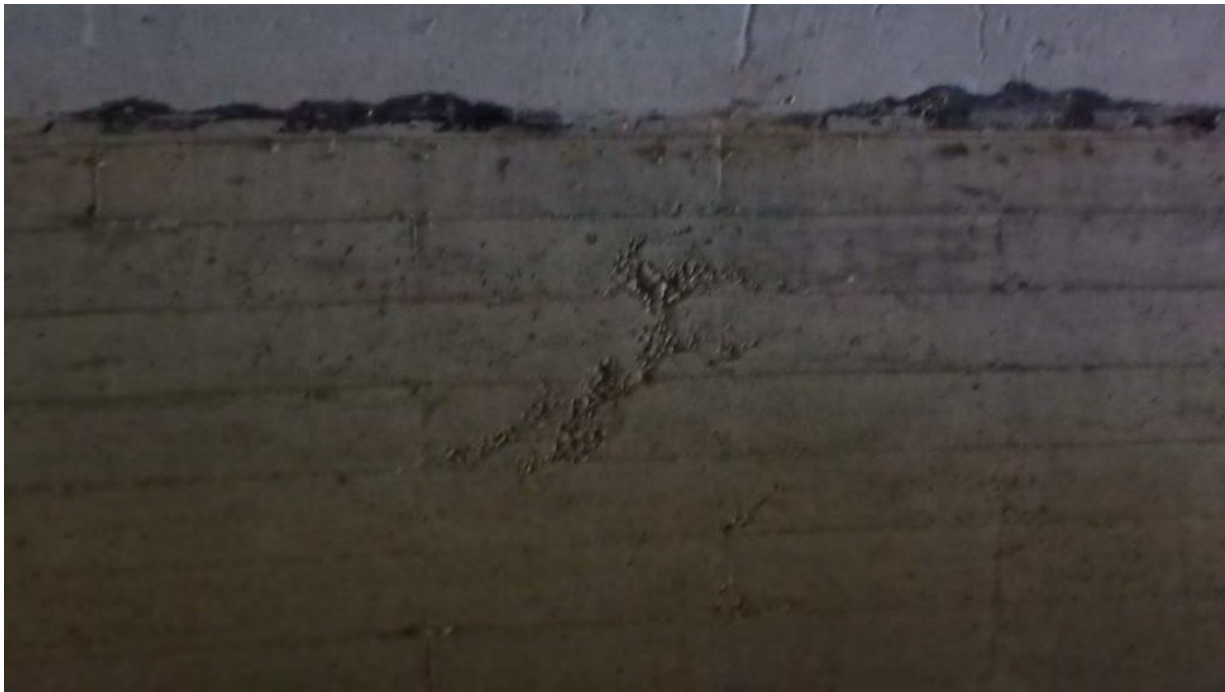
Figure 8 Honeycombing at North Wall

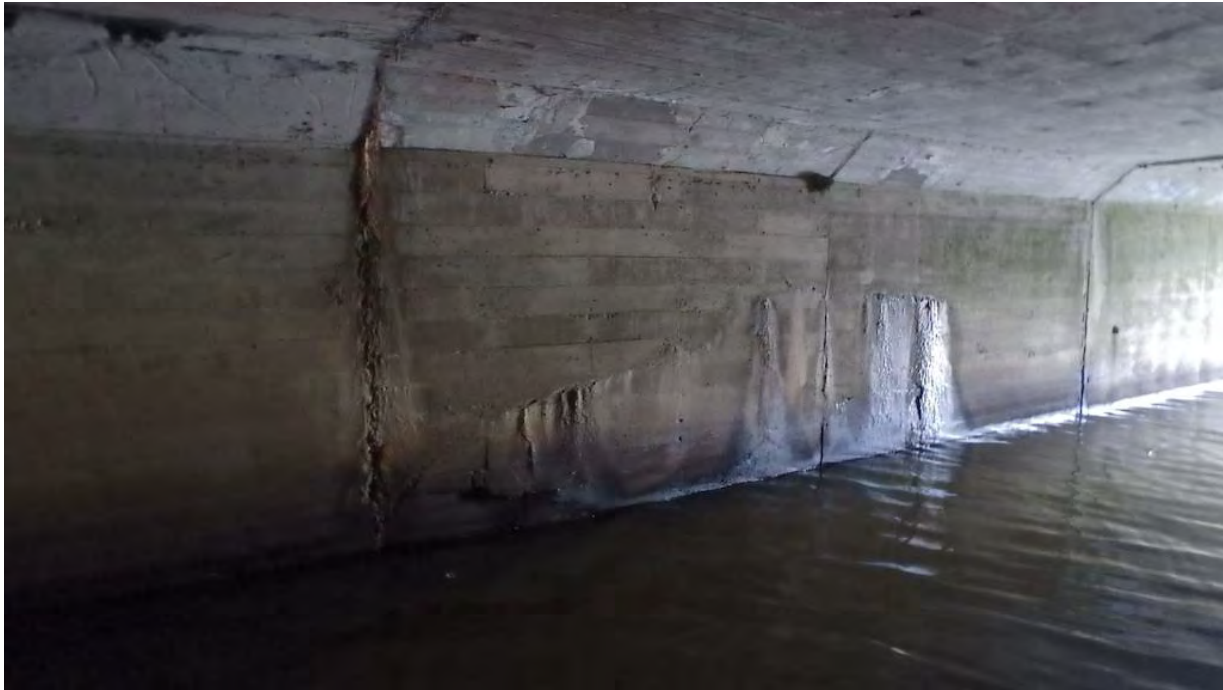
Figure 9 Narrow Crack and Staining at North Wall

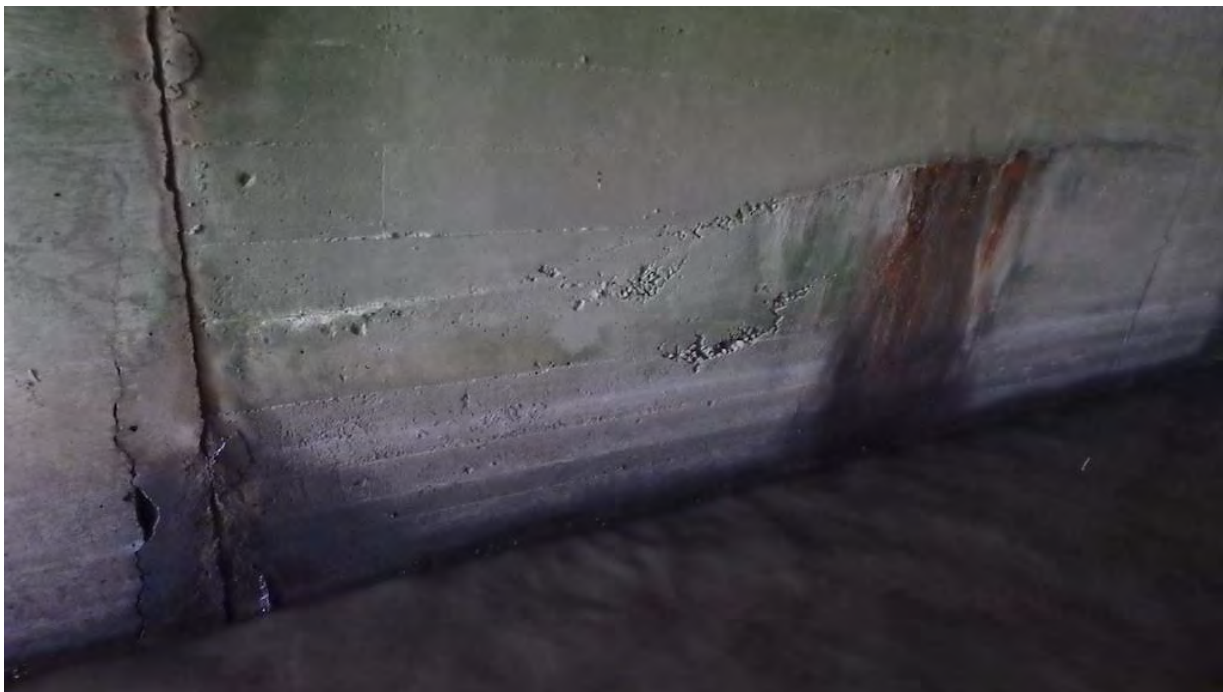
Figure 10 Narrow Crack and Staining at South Wall

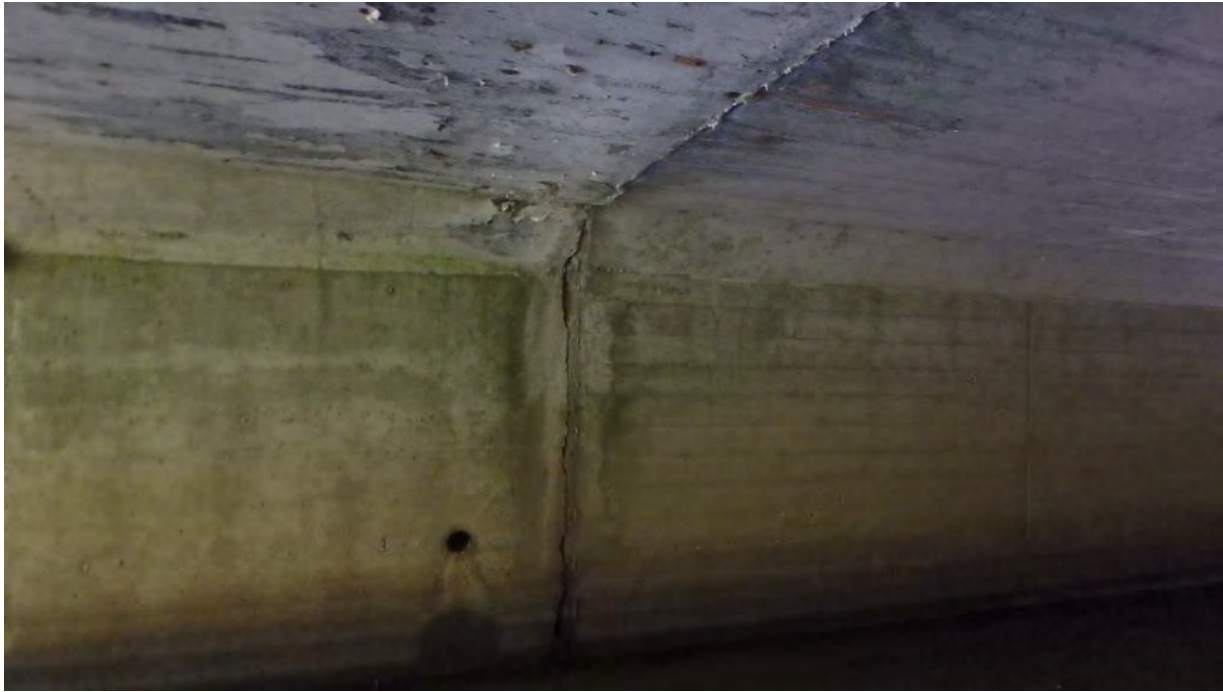
Figure 11 Leakage at Joints

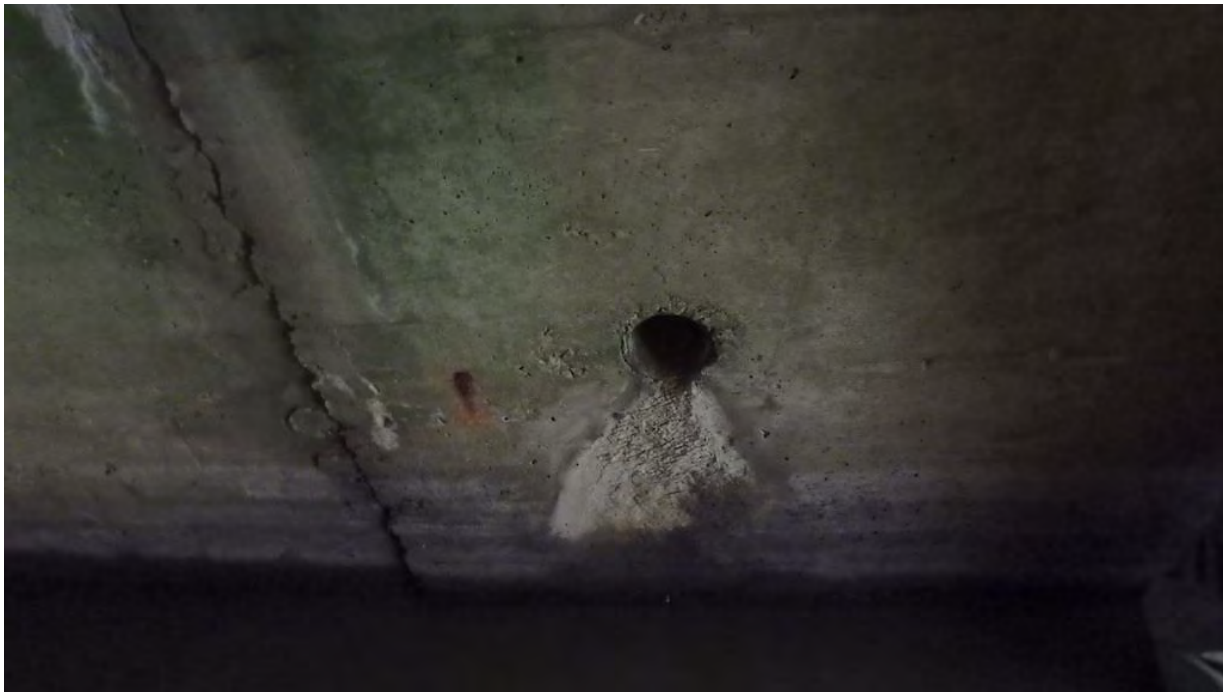
Figure 12 Typical Deterioration at Drains

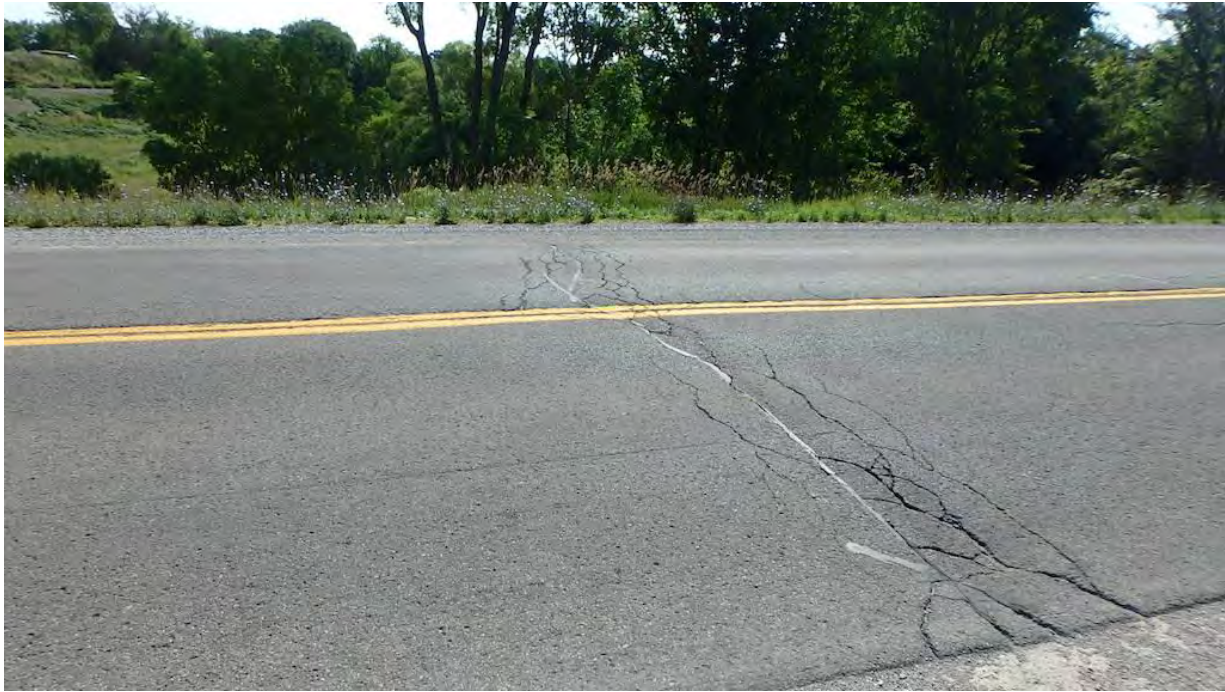
Figure 13 Wearing Surface, Note Transverse Crack
