THOMPSON ROAD CULVERT

Site Number 970901

COUNTY ROAD 9, TOWNSEND

Ontario Structure Inspection Manual - Inspection Form

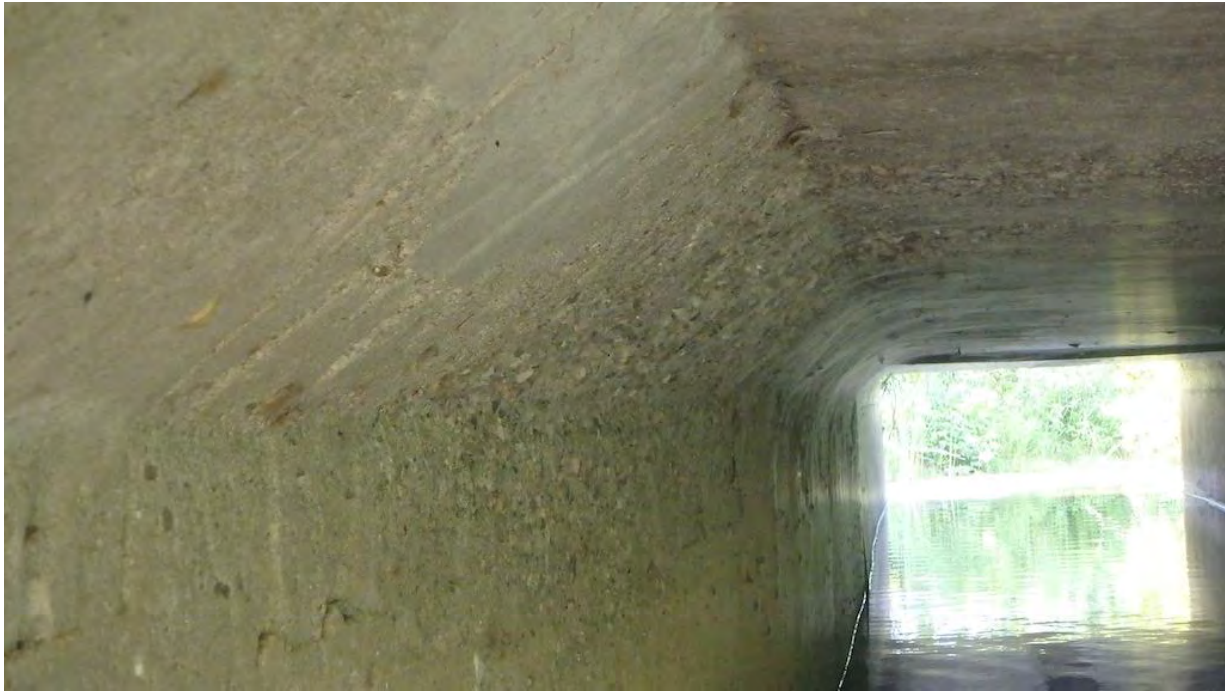
Element Group:		1200 Culverts				Length:	24.3
Element Name:		1203 Barrels				Width:	5.9
Location:		Inside				Height:	
Material:		4 Cast-in-place Concrete				Count:	1
Element Type:		Frames - Rigid				Total Quantity:	143.4 sq.m
Environment:		Moderate				Limited Inspection:	
Protection System:		Unknown				Perform. Deficiencies	
Condition	Units	Exc.	Good	Fair	Poor		
Data:	sq.m	0	143.4	0	0		
Comments: Narrow vertical cracks. North end is an extension to the original culvert. Severe scaling throughout culvert.							
Recommended Work: Rehab <input type="checkbox"/> Replace <input type="checkbox"/>					Maintenance Needs: Repair of Bridge Concrete		
Timing: Urgent <input type="checkbox"/> < 1yr <input type="checkbox"/> 1 - 5 yr <input type="checkbox"/> 6 - 10 yr <input type="checkbox"/>					<input type="checkbox"/> Urgent <input checked="" type="checkbox"/> 1 year <input type="checkbox"/> 2 year

Figure 9 Typical Scaling in Barrel

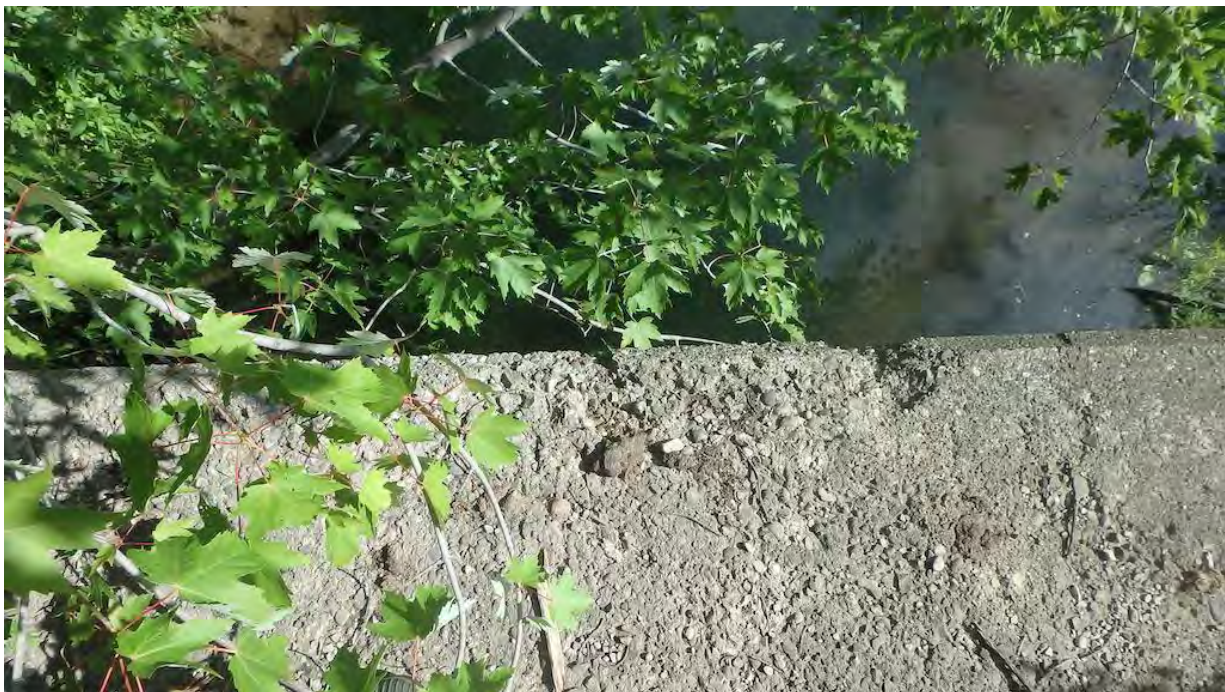
Element Group:		1200 Culverts				Length:	3.7
Element Name:		1201 Inlet Components				Width:	0.3
Location:		North and South End				Height:	1.4
Material:						Count:	1
Element Type:						Total Quantity:	1.5 sq.m
Environment:		Moderate				Limited Inspection:	
Protection System:		Unknown				Perform. Deficiencies	
Condition	Units	Exc.	Good	Fair	Poor		
Data:	sq.m	0	0	1.5	0		
Comments: Scaling and deterioration.							
Recommended Work: Rehab <input type="checkbox"/> Replace <input type="checkbox"/>					Maintenance Needs:		
Timing: Urgent <input type="checkbox"/> < 1yr <input type="checkbox"/> 1 - 5 yr <input type="checkbox"/> 6 - 10 yr <input type="checkbox"/>					<input type="checkbox"/> Urgent <input type="checkbox"/> 1 year <input type="checkbox"/> 2 year

Figure 10 Edge Spalling and Deterioration at Inlet

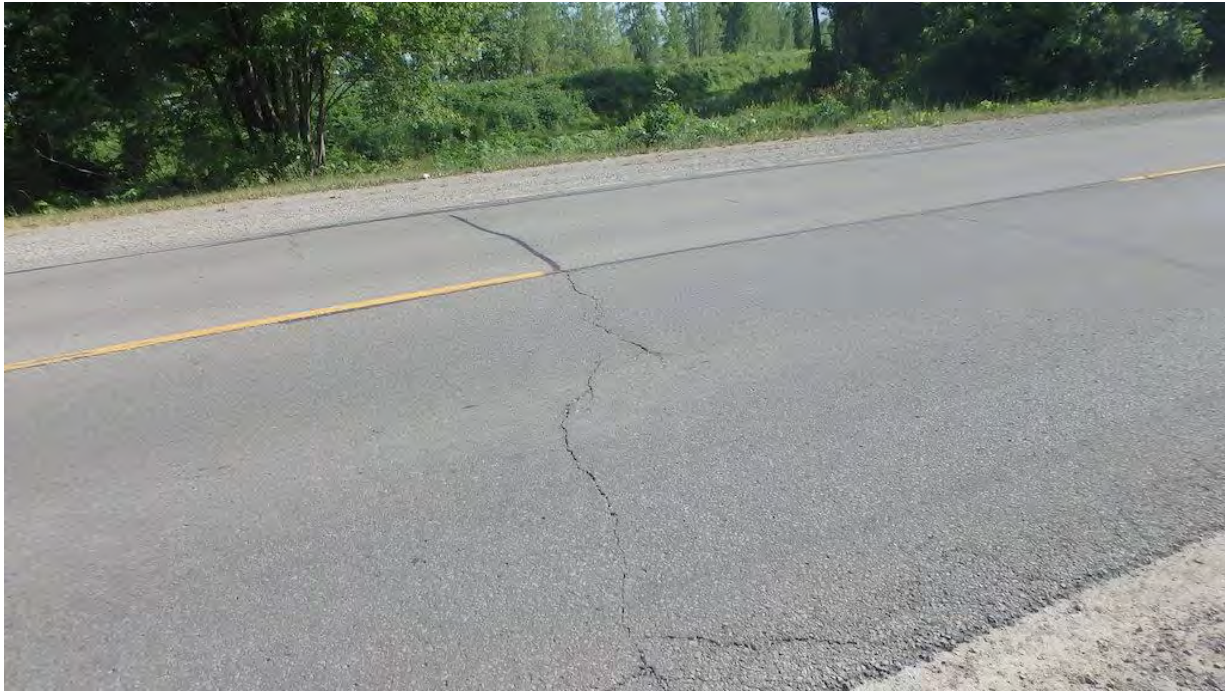
Element Group:		100 Decks				Length:		
Element Name:		101 Wearing Surface				Width:		
Location:						Height:		
Material:		2 Asphalt				Count:		1
Element Type:						Total Quantity:		1 Each
Environment:		Severe				Limited Inspection:		
Protection System:		Unknown				Perform. Deficiencies		
Condition	Units	Exc.	Good	Fair	Poor			
Data:	Each	0	1	0	0			
Comments:								
Resurfaced with asphalt. Transverse and longitudinal cracks in wearing surface at culvert.								
Recommended Work:				Rehab <input type="checkbox"/>		Replace <input type="checkbox"/>		
Timing:				Urgent <input type="checkbox"/>		< 1yr <input type="checkbox"/>		
				1 - 5 yr <input type="checkbox"/>		6 - 10 yr <input type="checkbox"/>		
Maintenance Needs:				Rout and Seal				
				<input type="checkbox"/>		Urgent <input type="checkbox"/>		
				<input type="checkbox"/>		1 year <input type="checkbox"/>		
				<input checked="" type="checkbox"/>		2 year <input type="checkbox"/>

Figure 11 Longitudinal and Transverse Cracks in Wearing Surface
