DEDRICK CREEK CULVERT

Site Number 971601

NORFOLK 16, ST. WILLIAMS ROAD, CHARLOTTEVILLE

Ontario Structure Inspection Manual - Inspection Form

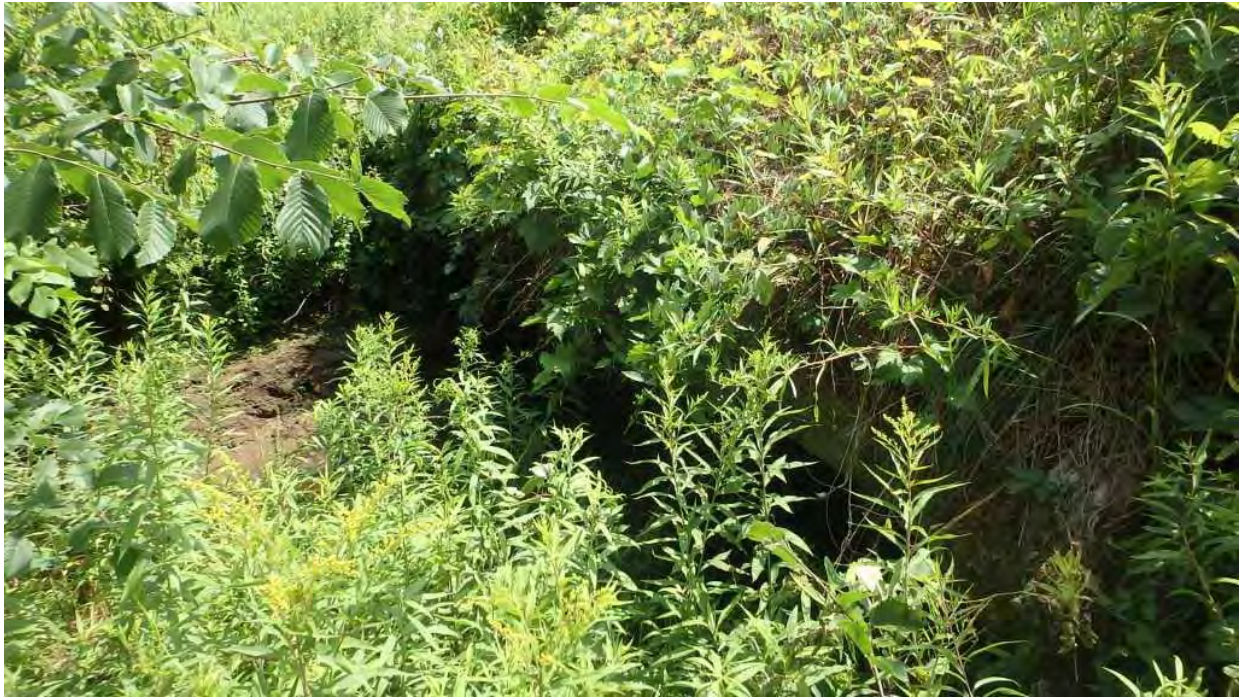
Figure 3 East Profile, Inlet

Element Group:		1200 Culverts				Length:		7
Element Name:		1201 Inlet Components				Width:		0.4
Location:		East				Height:		1.3
Material:						Count:		1
Element Type:						Total Quantity:		3.6 sq.m
Environment:		Moderate				Limited Inspection:		
Protection System:		Unknown				Perform. Deficiencies		
Condition	Units	Exc.	Good	Fair	Poor			
Data:	sq.m	0	0	1	2.6			
Comments:								
Deterioration of fascia. Efflorescence and spalling present. Slope above culvert is eroding. Overgrown.								
Recommended Work:				Rehab <input checked="" type="checkbox"/>		Replace <input type="checkbox"/>		
Timing:				Urgent <input type="checkbox"/>		< 1yr <input type="checkbox"/>		
				1 - 5 yr <input type="checkbox"/>		6 - 10 yr <input checked="" type="checkbox"/>		
				Maintenance Needs:				
				Repair of Bridge Concrete, E				
				<input type="checkbox"/> Urgent <input type="checkbox"/> 1 year <input checked="" type="checkbox"/> 2 year

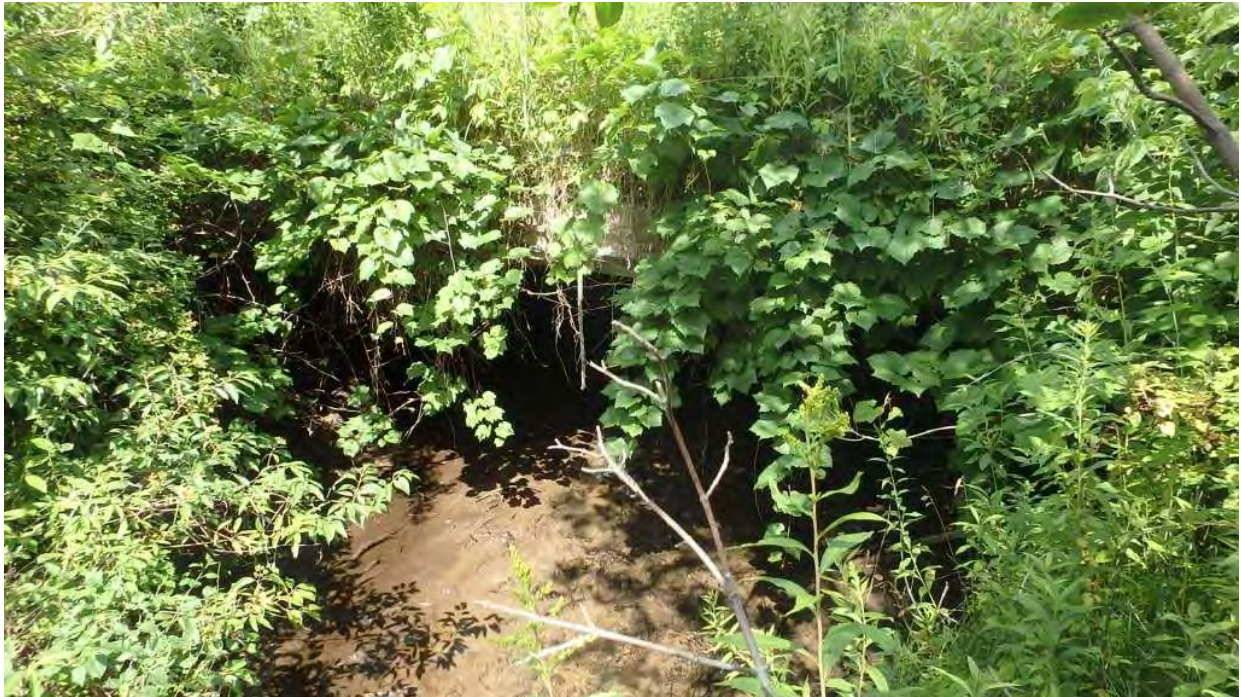
Figure 4 West Profile, Outlet

Element Group:		1200 Culverts				Length:		7
Element Name:		1202 Outlet Components				Width:		0.4
Location:		West				Height:		1.3
Material:						Count:		1
Element Type:						Total Quantity:		3.6 sq.m
Environment:		Severe				Limited Inspection:		
Protection System:		Unknown				Perform. Deficiencies		
Condition Data:	Units	Exc.	Good	Fair	Poor			
	sq.m	0	0	0	3.6			
Comments:								
Severe deterioration and delamination. Utility present and casing is broken. Slope above culvert is eroding. Limited inspection due to overgrowth.								
Recommended Work:				Maintenance Needs:				
Rehab <input checked="" type="checkbox"/> Replace <input type="checkbox"/>				Bridge Concrete Repair				
Timing: Urgent <input type="checkbox"/> < 1yr <input type="checkbox"/> 1 - 5 yr <input type="checkbox"/> 6 - 10 yr <input checked="" type="checkbox"/>				<input type="checkbox"/> Urgent <input type="checkbox"/> 1 year <input checked="" type="checkbox"/> 2 year

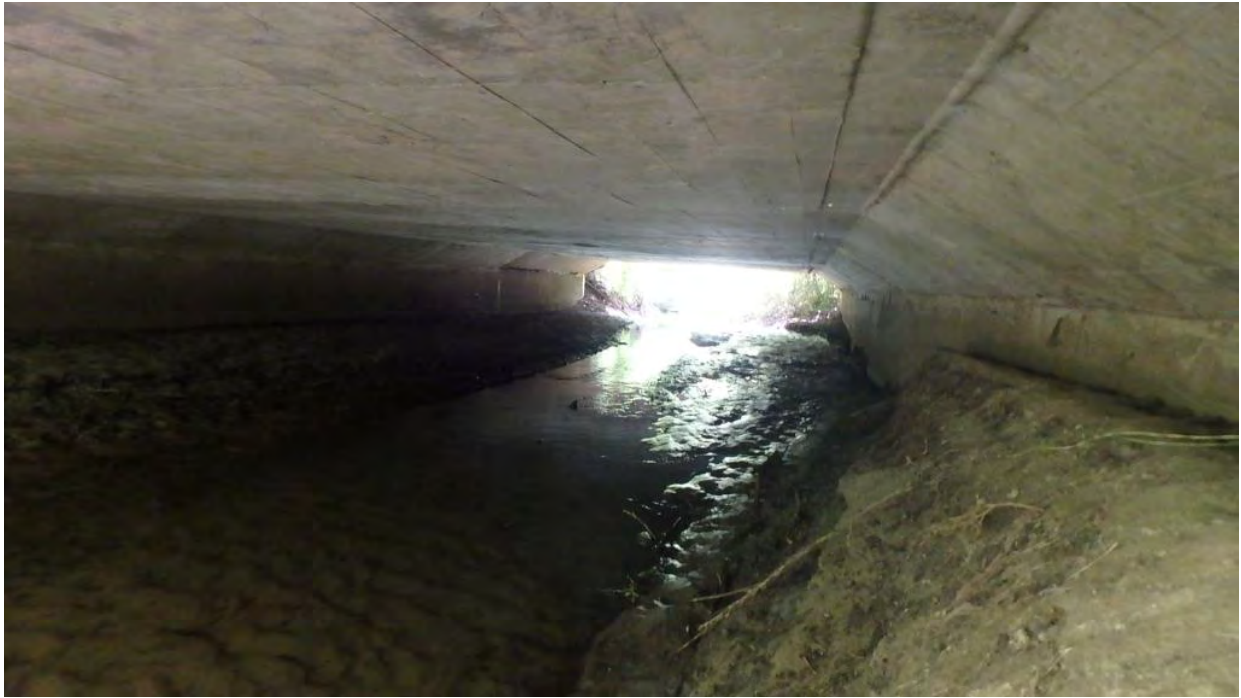
Figure 7 Barrel, Looking West

Element Group:		1200 Culverts				Length:		18.5
Element Name:		1203 Barrels				Width:		8.8
Location:						Height:		
Material:						Count:		1
Element Type:						Total Quantity:		162.8 sq.m
Environment:		Moderate				Limited Inspection:		
Protection System:		Unknown				Perform. Deficiencies		
Condition	Units	Exc.	Good	Fair	Poor			
Data:	sq.m	0	0	162.8	0			
Comments:								
Recommended Work:				Rehab <input type="checkbox"/>		Replace <input type="checkbox"/>		
Timing:				Urgent <input type="checkbox"/>		< 1yr <input type="checkbox"/>		
				1 - 5 yr <input type="checkbox"/>		6 - 10 yr <input type="checkbox"/>		
				Maintenance Needs:				
				<input type="checkbox"/> Urgent <input type="checkbox"/> 1 year <input type="checkbox"/> 2 year

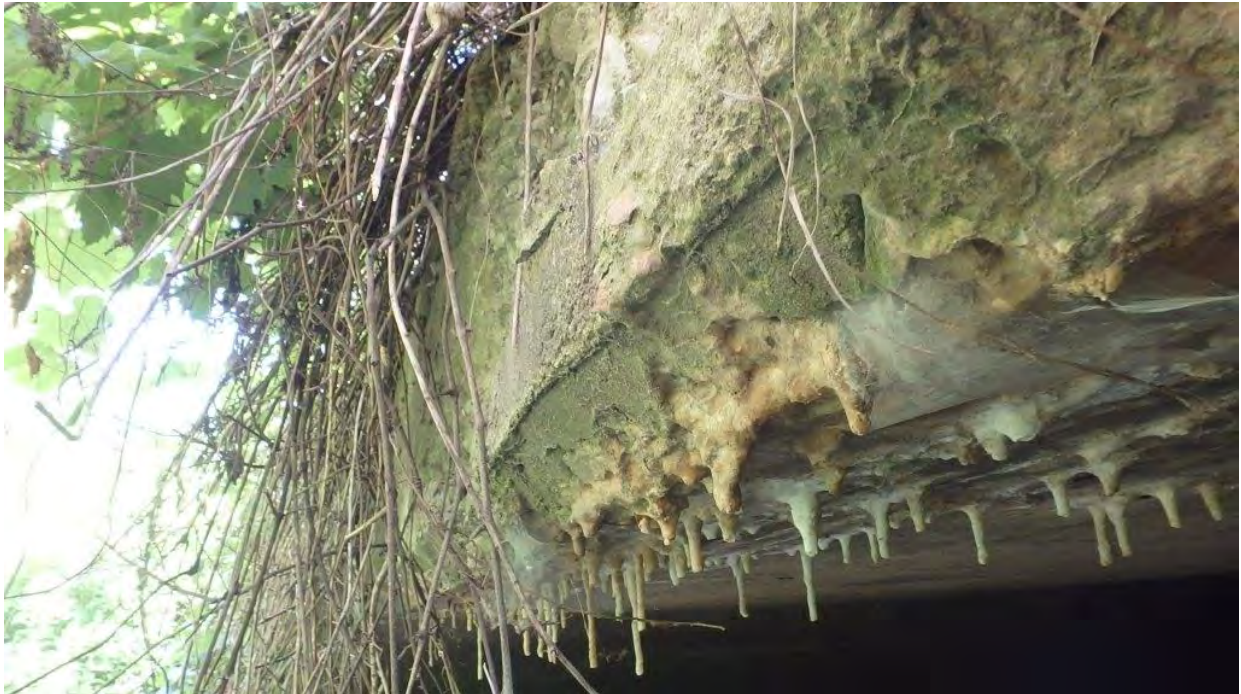
Figure 8 East Fascia Deterioration, Efflorescence & Stalactites

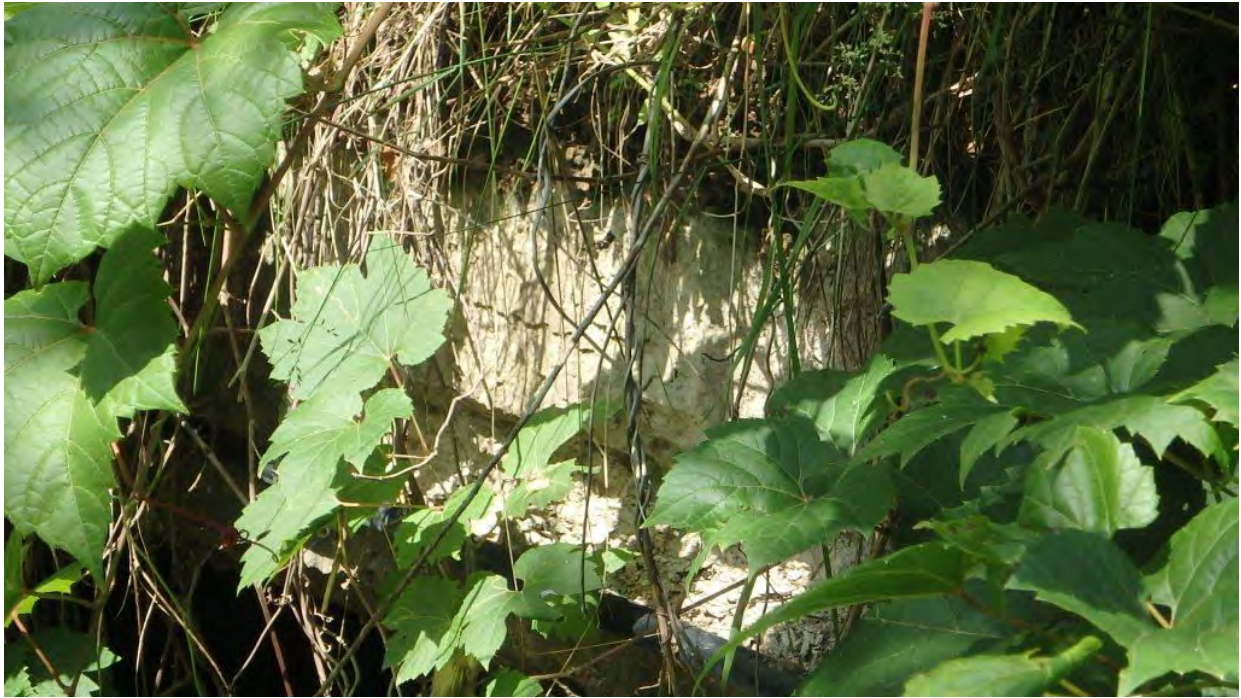
Figure 9 West Fascia Deterioration

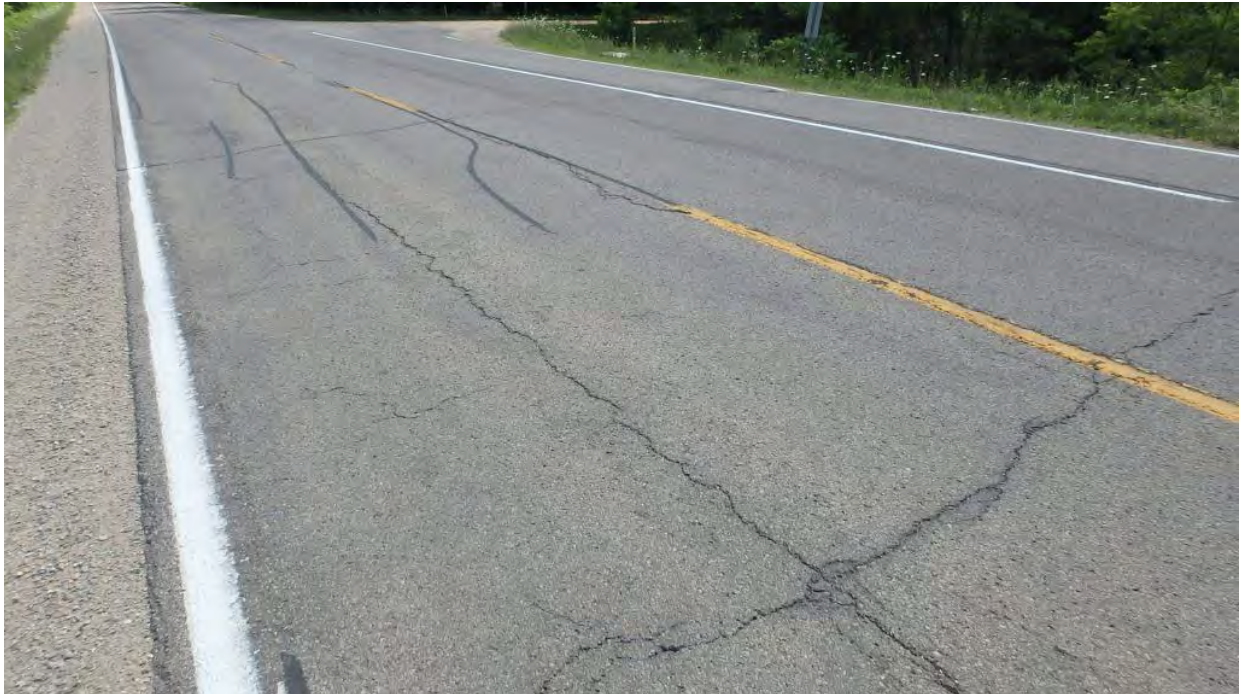
Element Group:		1600 Approaches				Length:		
Element Name:		1601 Wearing Surface (Approaches)				Width:		
Location:		Top of Fill				Height:		
Material:						Count:		2
Element Type:						Total Quantity:		2 Each
Environment:		Severe				Limited Inspection:		
Protection System:		Unknown				Perform. Deficiencies		
Condition	Units	Exc.	Good	Fair	Poor			
Data:	Each	0	2	0	0			
Comments:								
Sealed cracks at South structure edges. Unsealed cracks throughout wearing surface.								
Recommended Work:				Rehab <input type="checkbox"/>		Replace <input type="checkbox"/>		
Timing:				Urgent <input type="checkbox"/>		< 1yr <input type="checkbox"/>		
				1 - 5 yr <input type="checkbox"/>		6 - 10 yr <input type="checkbox"/>		
				Maintenance Needs:				
				<input type="checkbox"/> Urgent <input type="checkbox"/> 1 year <input type="checkbox"/> 2 year

Figure 10 Cracks in Wearing Surface
