**BOOKTON DRAIN CULVERT**

Site Number 971901

**COUNTY ROAD 19, WINDHAM**

**Ontario Structure Inspection Manual - Inspection Form**

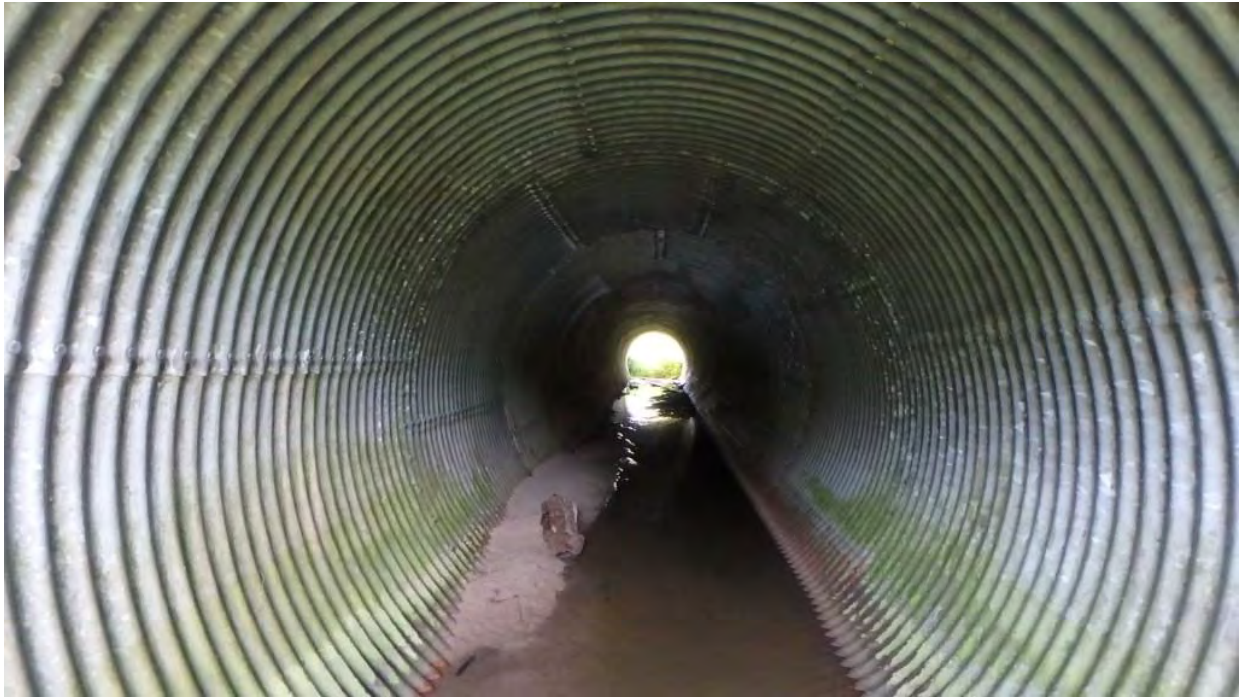
Figure 7 Barrel

Element Group:		1200 Culverts				Length:		51.9
Element Name:		1203 Barrels				Width:		10
Location:		N & S				Height:		
Material:						Count:		1
Element Type:						Total Quantity:		519 sq.m
Environment:		Moderate				Limited Inspection:		
Protection System:		Unknown				Perform. Deficiencies		
Condition	Units	Exc.	Good	Fair	Poor			
Data:	sq.m	0	509	10	0			
Comments: Corrosion in upper plate joints approximately 20m from north end. Chloride stains at plate joints.								
Recommended Work: Rehab <input type="checkbox"/> Replace <input type="checkbox"/>				Maintenance Needs:				
Timing: Urgent <input type="checkbox"/> < 1yr <input type="checkbox"/> 1 - 5 yr <input type="checkbox"/> 6 - 10 yr <input type="checkbox"/>				<input type="checkbox"/> Urgent <input type="checkbox"/> 1 year <input type="checkbox"/> 2 year

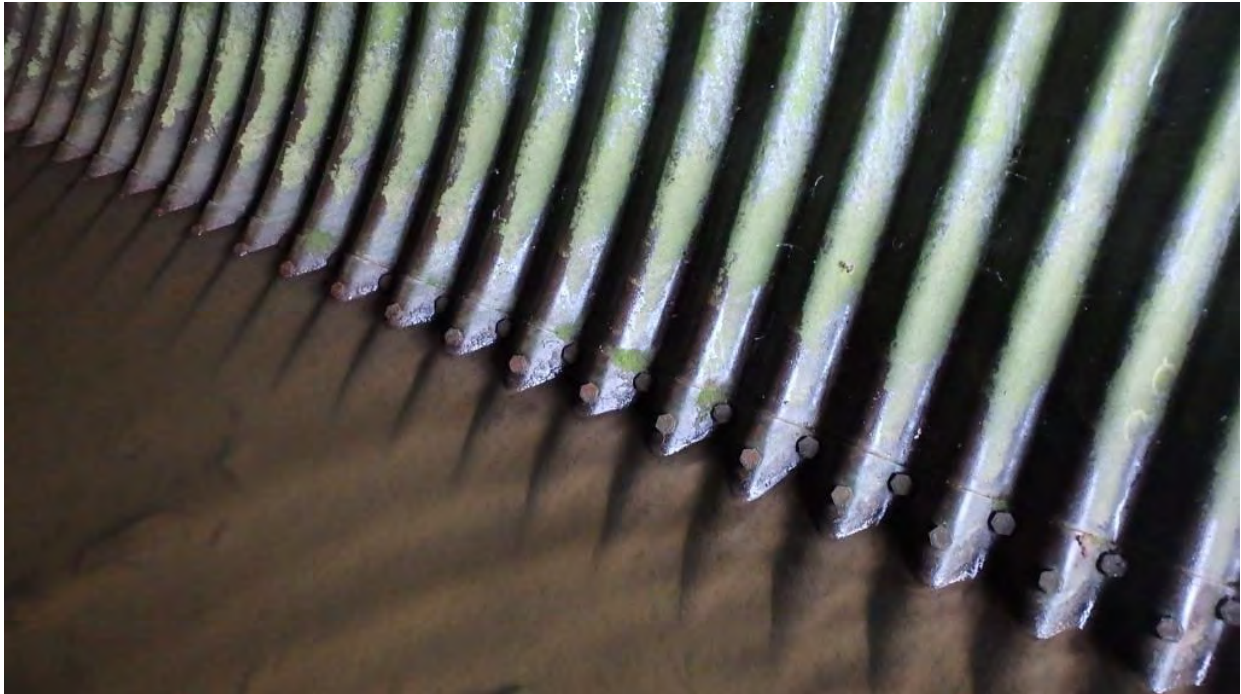
Figure 8 Corrosion and Staining at Water Line

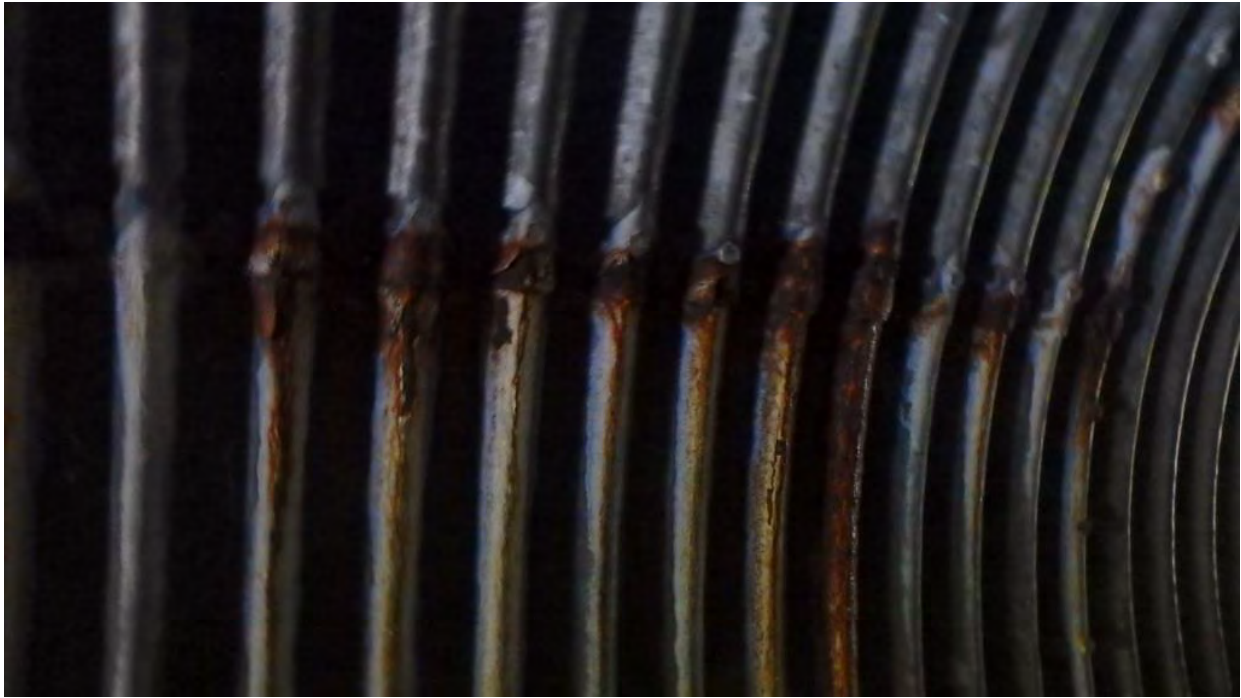
Figure 9 Corrosion at Plate Joints

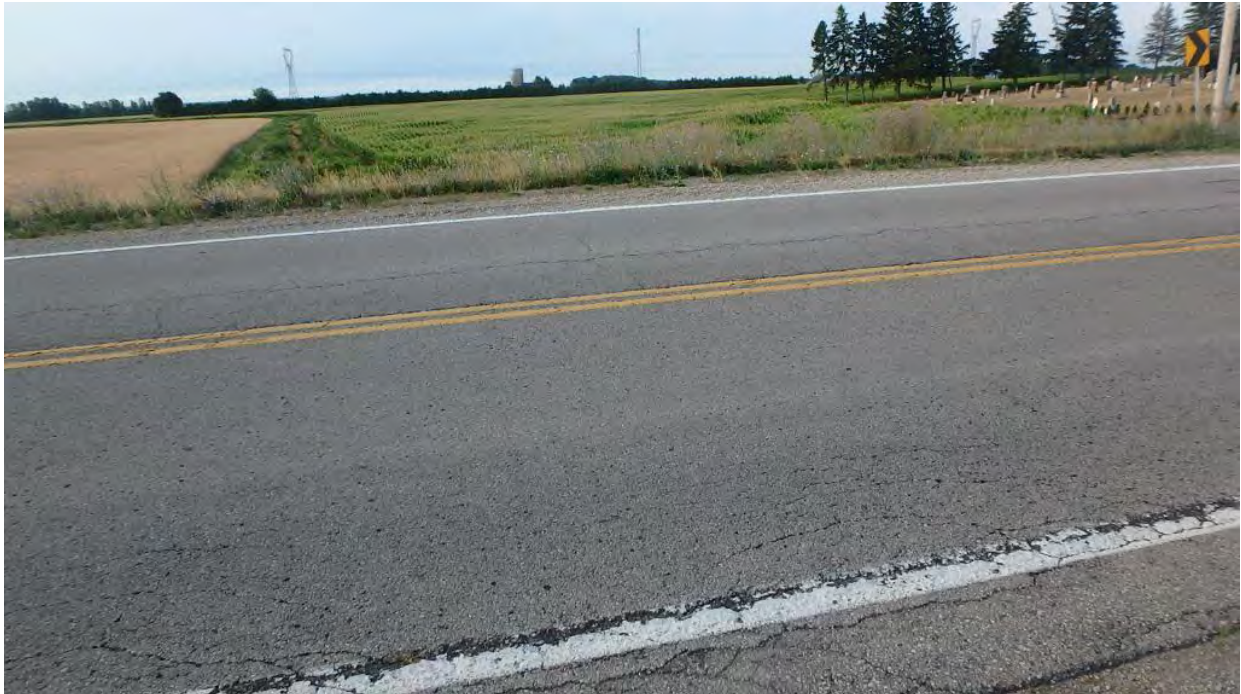
Figure 10 Wearing Surface

Element Group:		1600 Approaches				Length:		
Element Name:		1601 Wearing Surface (Approaches)				Width:		
Location:		Top of Fill				Height:		
Material:		2 Asphalt				Count:		1
Element Type:						Total Quantity:		1 Each
Environment:		Severe				Limited Inspection:		
Protection System:		Unknown				Perform. Deficiencies		
Condition	Units	Exc.	Good	Fair	Poor			
Data:	Each	0	0.8	0.2	0			
Comments: Alligator cracking noted.								
Recommended Work: Rehab <input type="checkbox"/> Replace <input type="checkbox"/>				Maintenance Needs:				
Timing: Urgent <input type="checkbox"/> < 1yr <input type="checkbox"/> 1 - 5 yr <input type="checkbox"/> 6 - 10 yr <input type="checkbox"/>				<input type="checkbox"/> Urgent <input type="checkbox"/> 1 year <input type="checkbox"/> 2 year

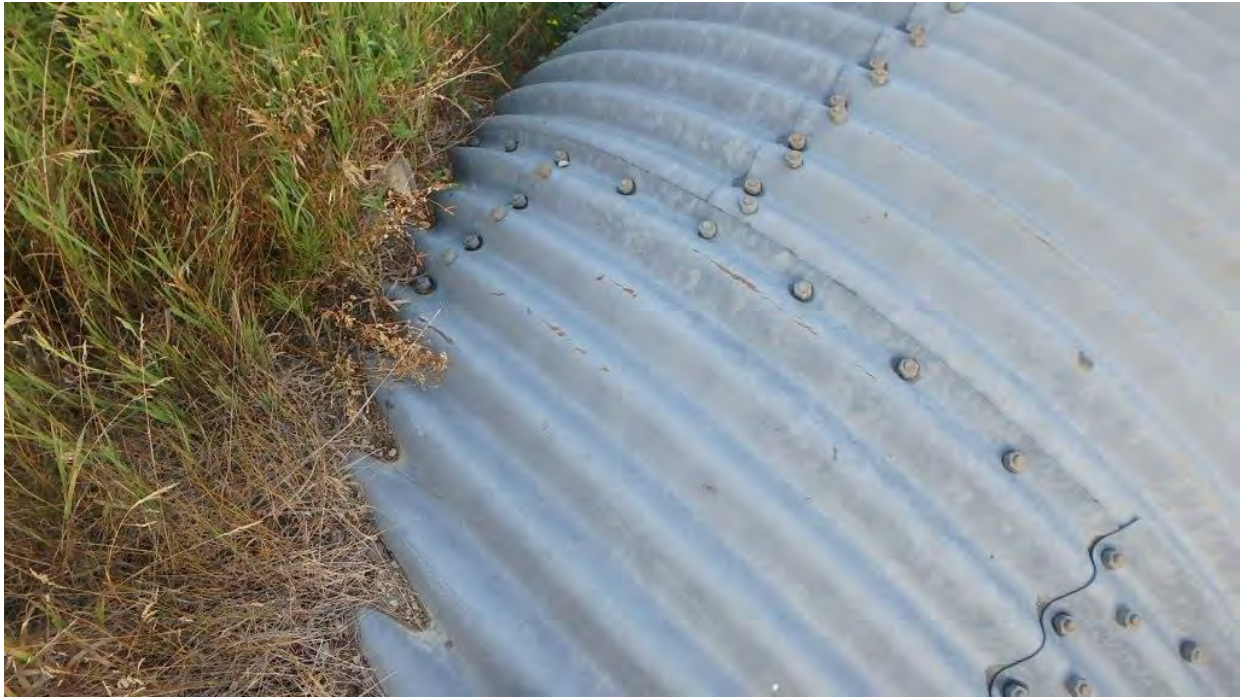
Figure 11 Minor Damage and Rusting on Culvert at Inlet
