LOT 16 CONCESSION 3-4

Site Number 971902

COUNTY ROAD 19, WINDHAM

Ontario Structure Inspection Manual - Inspection Form

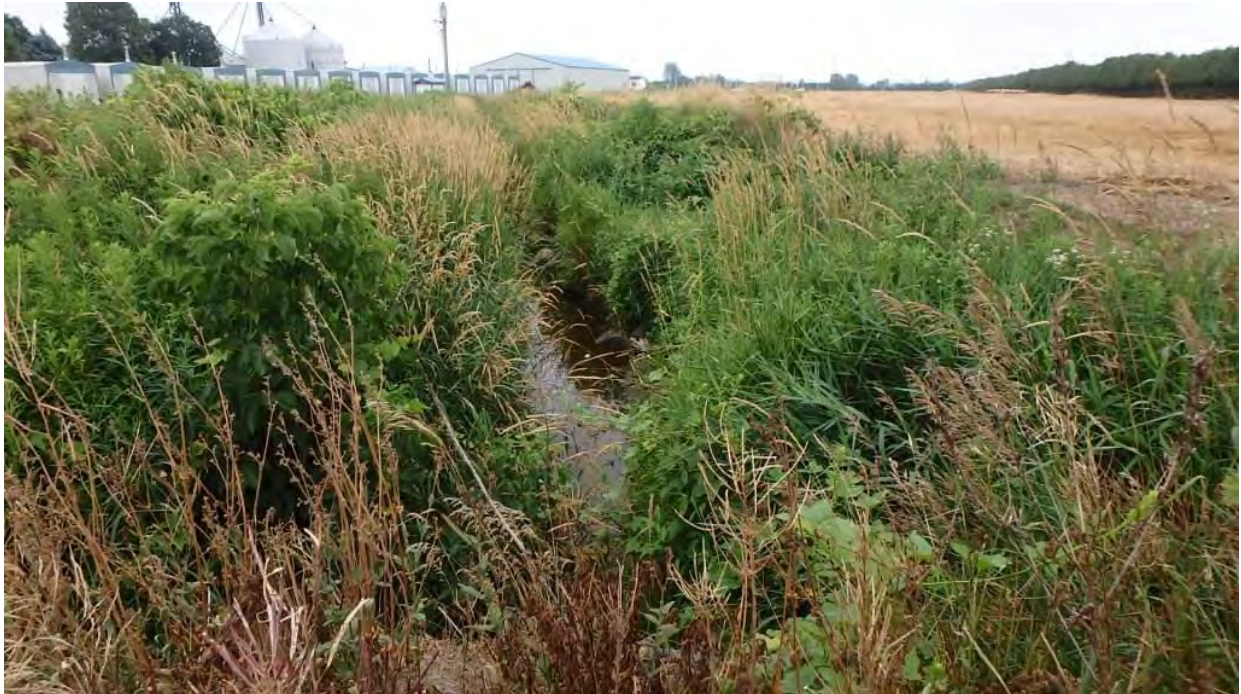
Figure 6 Downstream

Element Group:	1400 Embankments & Streams					Length:	
Element Name:	1401 Streams and Waterways					Width:	
Location:						Height:	
Material:						Count:	1
Element Type:						Total Quantity:	1 Each
Environment:						Limited Inspection:	
Protection System:	Unknown					Perform. Deficiencies	
Condition Data:	Units Each	Exc. 0	Good 1	Fair 0	Poor 0		
Comments: Concrete rubble on east approach quad. Erosion control at all quad's req'd.							
Recommended Work: Rehab <input type="checkbox"/> Replace <input type="checkbox"/>						Maintenance Needs: Erosion Control at Bridges	
Timing: Urgent <input type="checkbox"/> < 1yr <input type="checkbox"/> 1 - 5 yr <input type="checkbox"/> 6 - 10 yr <input type="checkbox"/>						<input type="checkbox"/> Urgent <input type="checkbox"/> 1 year <input checked="" type="checkbox"/> 2 year

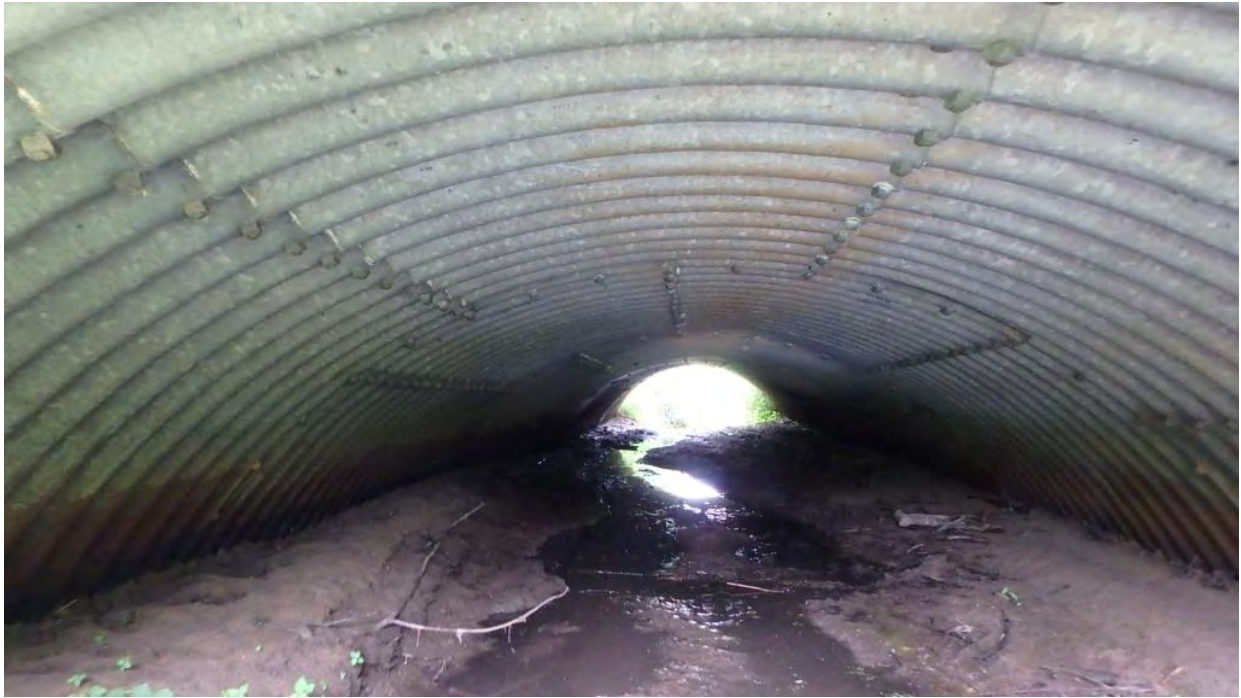
Figure 7 Barrel

Element Group:		1200 Culverts				Length:		16.7
Element Name:		1203 Barrels				Width:		5
Location:		Inside				Height:		
Material:		5 Corrugated Steel				Count:		1
Element Type:						Total Quantity:		83.5 sq.m
Environment:		Moderate				Limited Inspection:		
Protection System:		Unknown				Perform. Deficiencies		
Condition	Units	Exc.	Good	Fair	Poor			
Data:	sq.m	0	73.5	10	0			
Comments: Slight deflection in center of barrel with localized cusping under travelled portion. Corrosion near water level. Minor corrosion at bolts. Minor damage at inlet. Pipe is too short for existing road bed.								
Recommended Work: Rehab <input type="checkbox"/> Replace <input type="checkbox"/>				Maintenance Needs:				
Timing: Urgent <input type="checkbox"/> < 1yr <input type="checkbox"/> 1 - 5 yr <input type="checkbox"/> 6 - 10 yr <input type="checkbox"/>				<input type="checkbox"/> Urgent <input type="checkbox"/> 1 year <input type="checkbox"/> 2 year

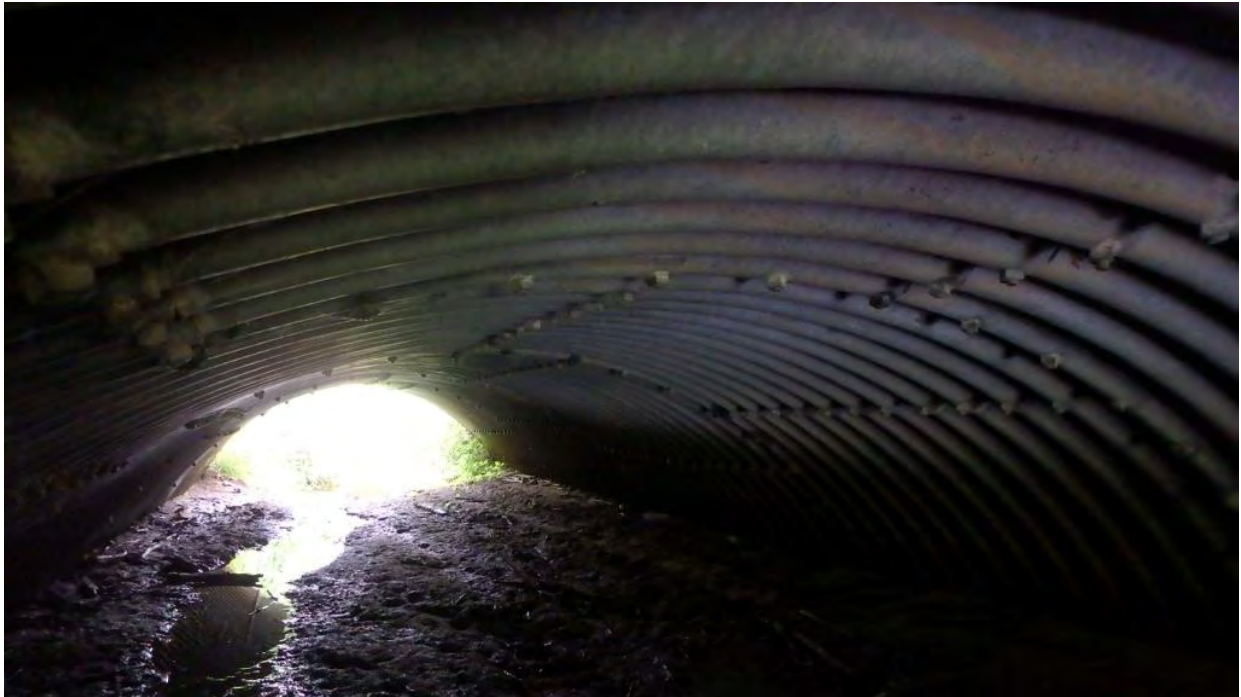
Figure 8 Deflection of Barrel

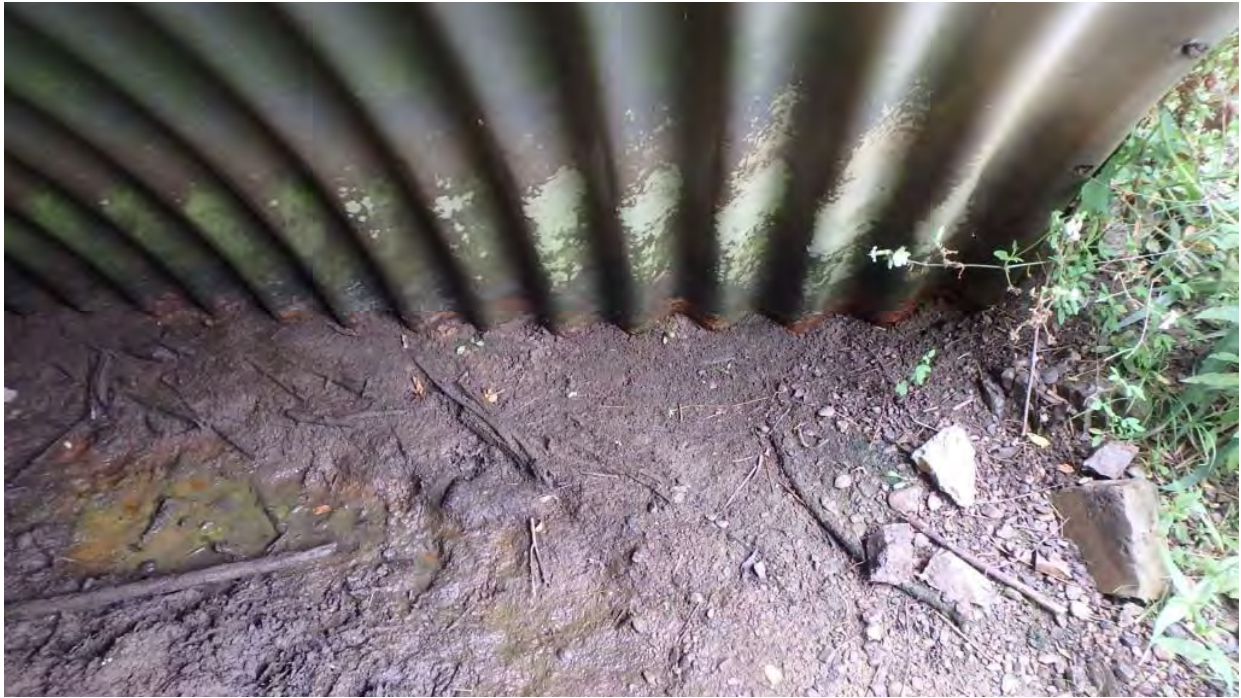
Element Group:	1200 Culverts					Length:	
Element Name:	1202 Outlet Components					Width:	
Location:						Height:	
Material:						Count:	1
Element Type:						Total Quantity:	1 Each
Environment:						Limited Inspection:	
Protection System:	Unknown					Perform. Deficiencies	
Condition Data:	Units Each	Exc. 0	Good 1	Fair 0	Poor 0		
Comments:							
Recommended Work: Rehab <input type="checkbox"/> Replace <input type="checkbox"/>						Maintenance Needs:	
Timing: Urgent <input type="checkbox"/> < 1yr <input type="checkbox"/> 1 - 5 yr <input type="checkbox"/> 6 - 10 yr <input type="checkbox"/>						<input type="checkbox"/> Urgent <input type="checkbox"/> 1 year <input type="checkbox"/> 2 year

Figure 9 Corrosion at Outlet

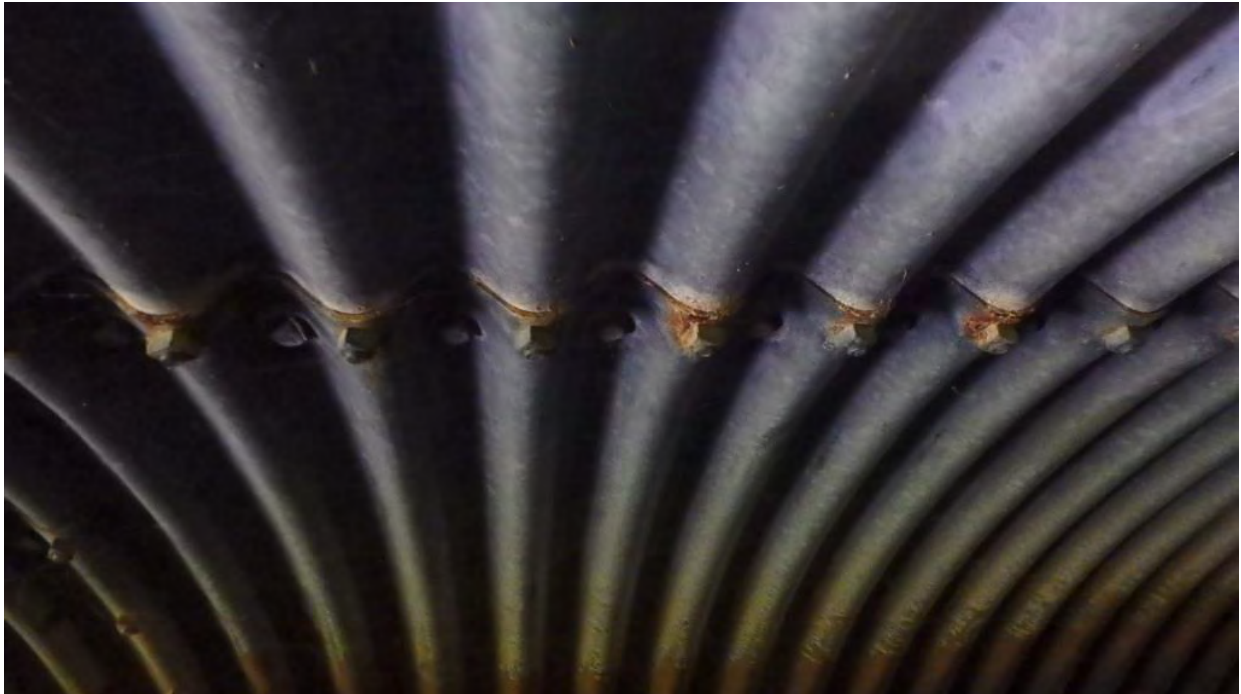
Figure 10 Corrosion of Bolts

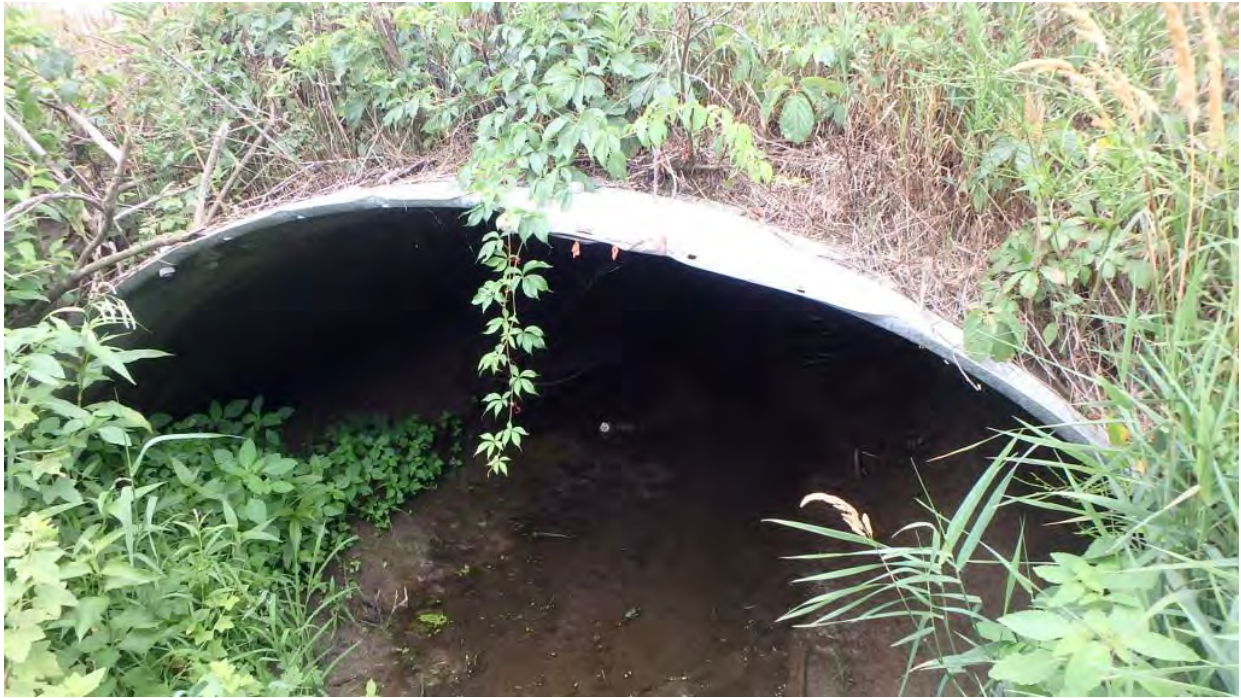
Element Group:		1200 Culverts				Length:		
Element Name:		1201 Inlet Components				Width:		
Location:						Height:		
Material:						Count:		1
Element Type:						Total Quantity:		1 Each
Environment:						Limited Inspection:		
Protection System:		Unknown				Perform. Deficiencies		
Condition	Units	Exc.	Good	Fair	Poor			
Data:	Each	0	0.9	0.1	0			
Comments: Top of inlet is damaged with light corrosion.								
Recommended Work: Rehab <input type="checkbox"/> Replace <input type="checkbox"/>				Maintenance Needs:				
Timing: Urgent <input type="checkbox"/> < 1yr <input type="checkbox"/> 1 - 5 yr <input type="checkbox"/> 6 - 10 yr <input type="checkbox"/>				<input type="checkbox"/> Urgent <input type="checkbox"/> 1 year <input type="checkbox"/> 2 year

Figure 11 Damage at Top of Inlet

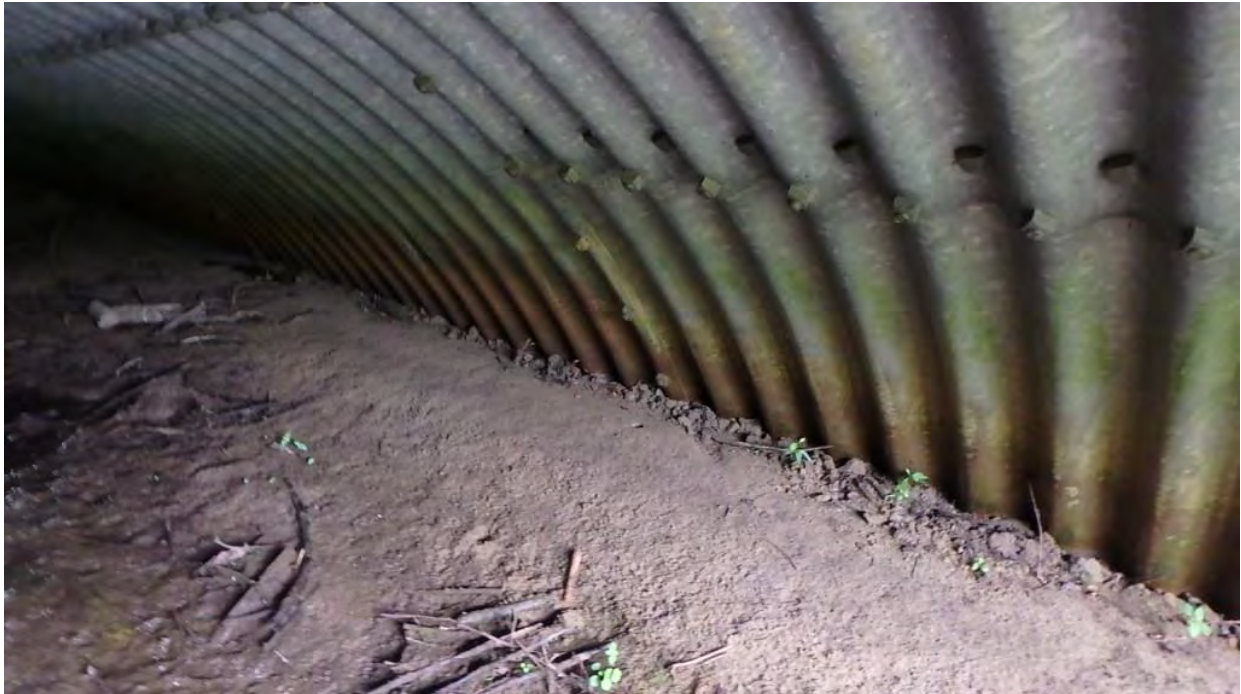
Figure 12 Corrosion, Staining at Water Line

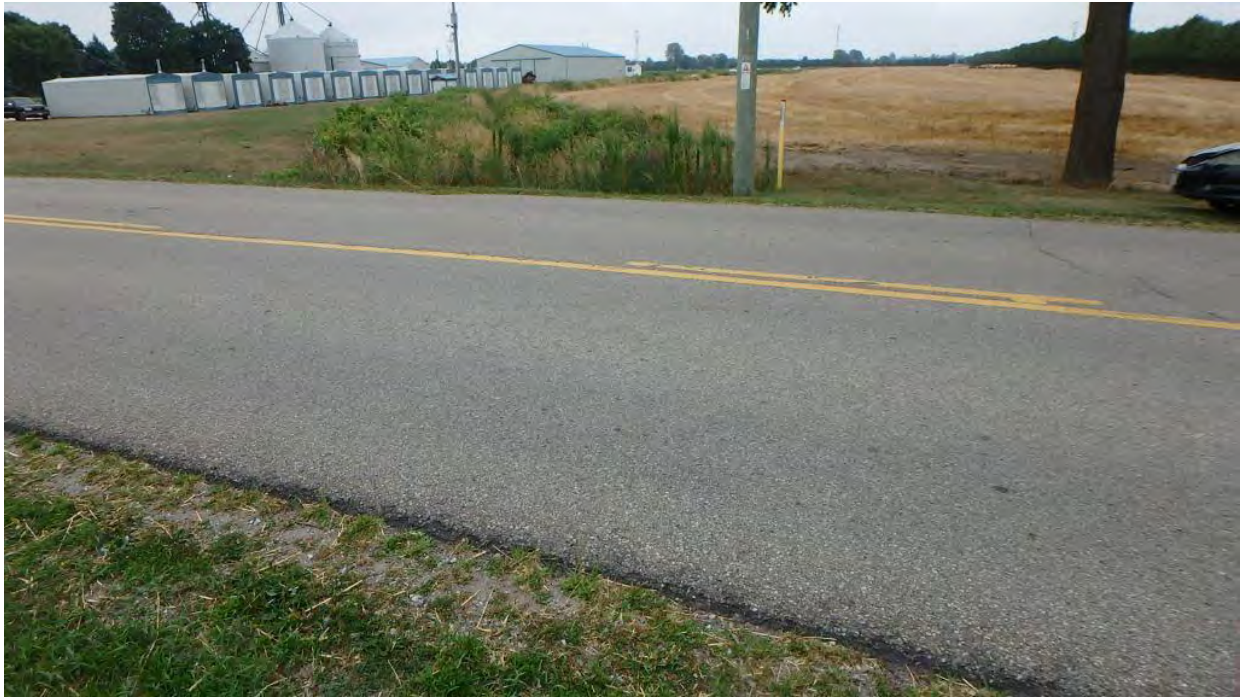
Figure 13 Wearing Surface

Element Group:		1600 Approaches				Length:		
Element Name:		1601 Wearing Surface (Approaches)				Width:		
Location:		Top of Road				Height:		
Material:		2 Asphalt				Count:		1
Element Type:						Total Quantity:		1 Each
Environment:		Severe				Limited Inspection:		
Protection System:		Unknown				Perform. Deficiencies		
Condition	Units	Exc.	Good	Fair	Poor			
Data:	Each	0	1	0	0			
Comments: Asphalt slopes are stable. One (1) transverse crack on the west approach.								
Recommended Work: Rehab <input type="checkbox"/> Replace <input type="checkbox"/>				Maintenance Needs: Rout and Seal				
Timing: Urgent <input type="checkbox"/> < 1yr <input type="checkbox"/> 1 - 5 yr <input type="checkbox"/> 6 - 10 yr <input type="checkbox"/>				<input type="checkbox"/> Urgent <input type="checkbox"/> 1 year <input checked="" type="checkbox"/> 2 year
