COUNTY ROAD 28 CULVERT

Site Number 972801

COUNTY ROAD 28, HOUGHTON

Ontario Structure Inspection Manual - Inspection Form

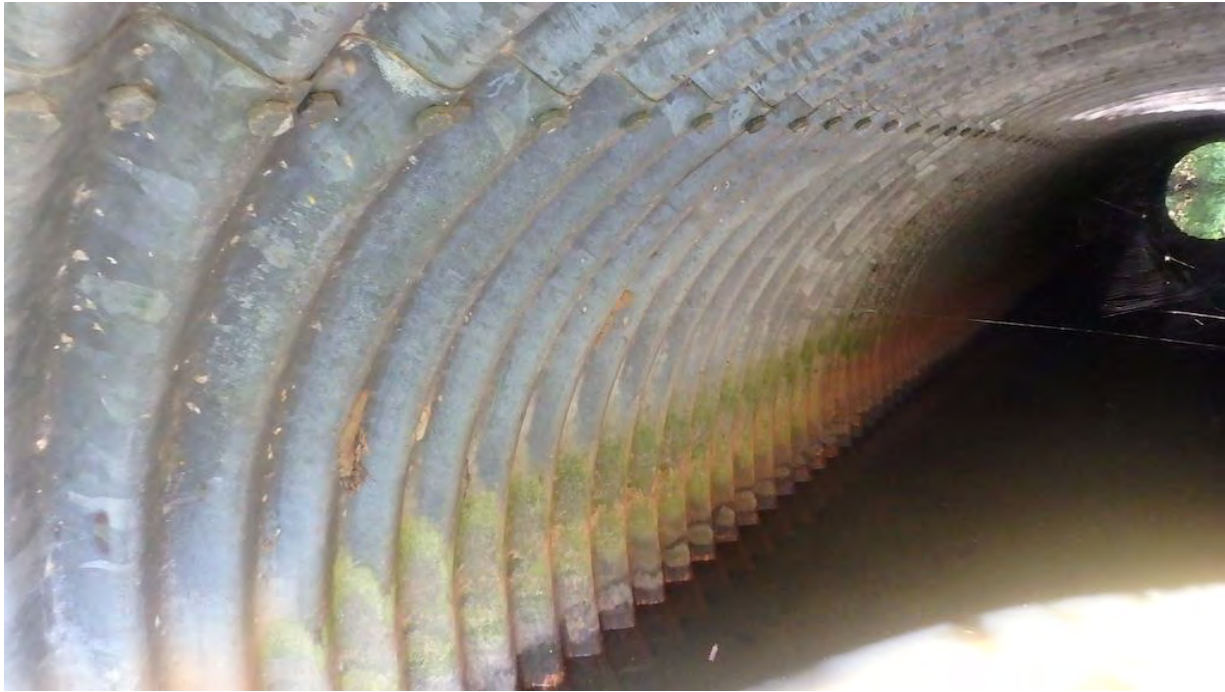
Figure 7 Corrosion at Waterline

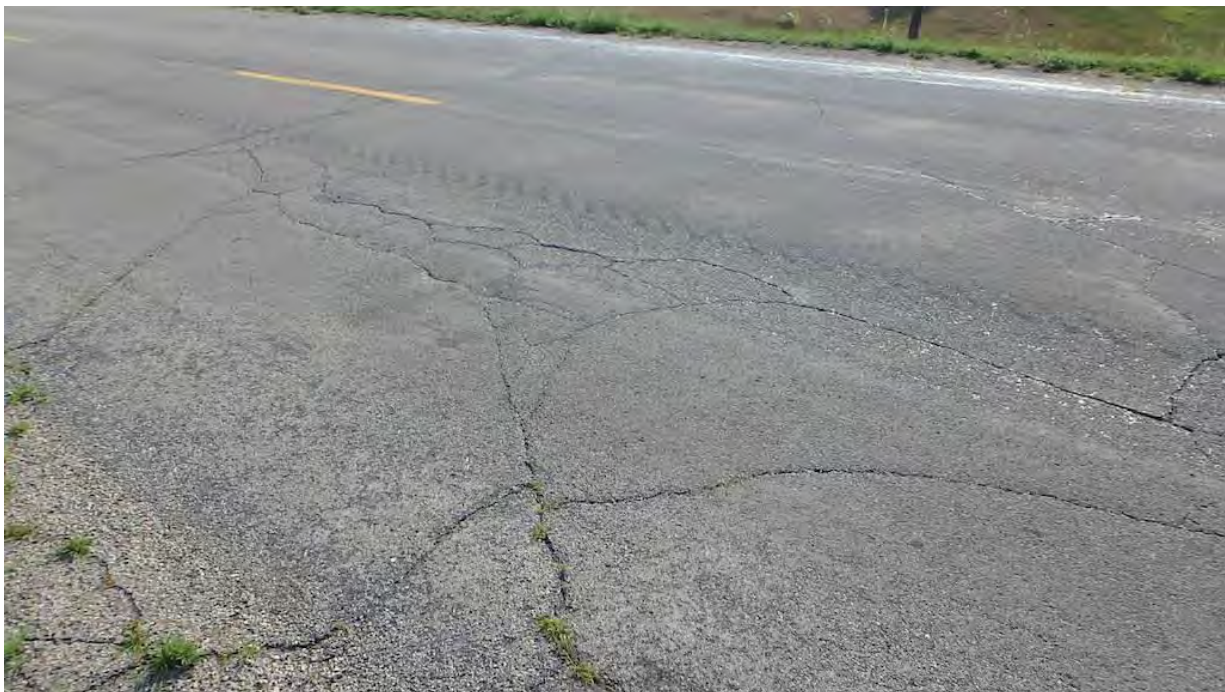
Figure 8 Cracking on Wearing Surface

Structure Evaluation:	<input checked="" type="checkbox"/>		
Monitoring			
<input checked="" type="checkbox"/> Monitoring of Deformations, Settlements and Movements:	<input checked="" type="checkbox"/>		
<input checked="" type="checkbox"/> Monitoring Crack Widths:	<input checked="" type="checkbox"/>		
Investigation Notes:			
Wearing Surface - Rout and Seal
