**COUNTY ROAD 28 CULVERT**

Site Number 972802

**NORFOLK COUNTY ROAD 28, HOUGHTON**

**Ontario Structure Inspection Manual - Inspection Form**

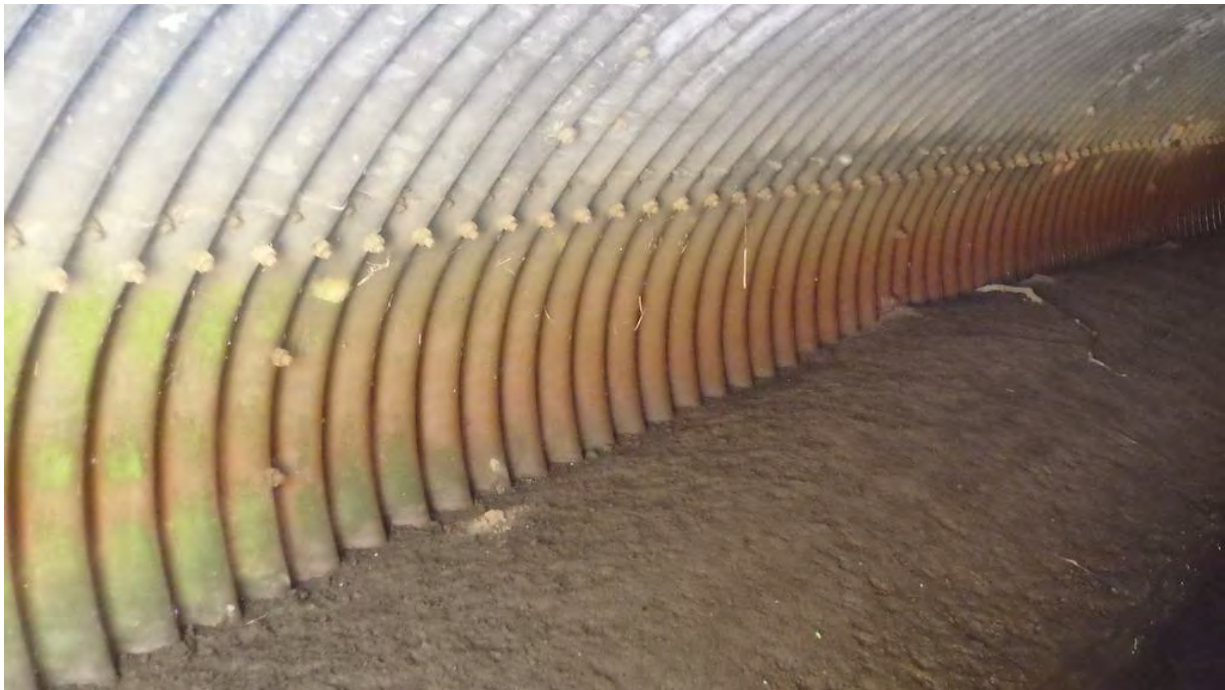
Figure 10 Corrosion at Waterline

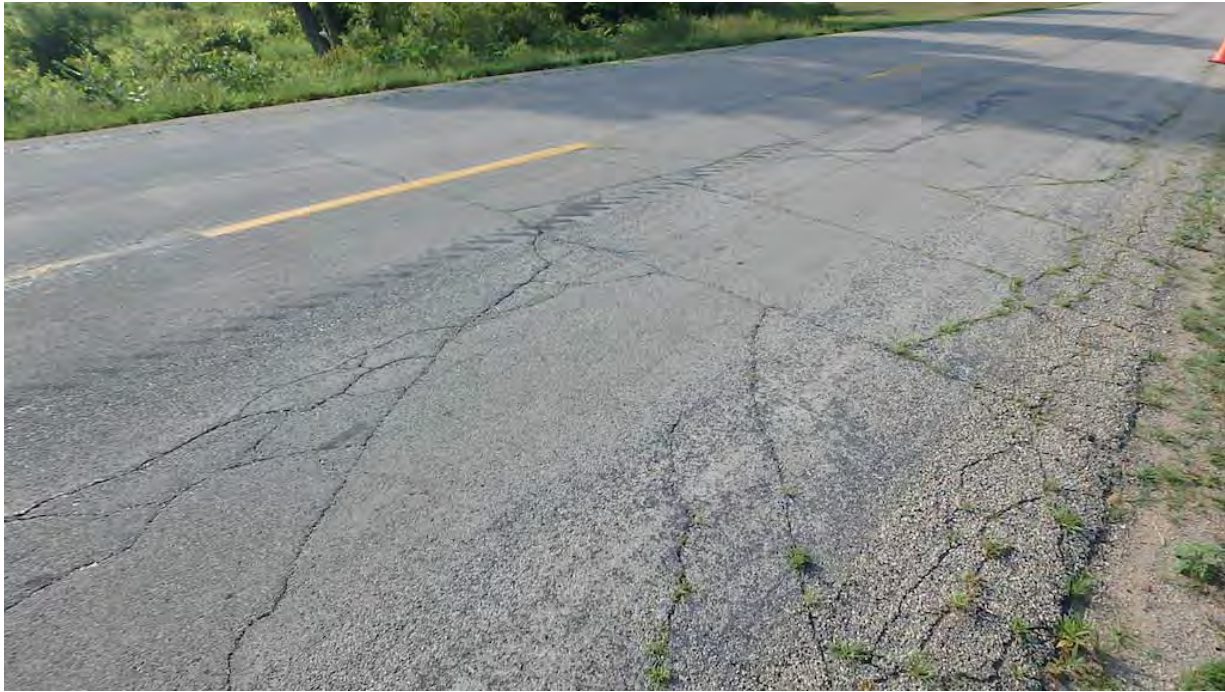
Element Group:		1600 Approaches				Length:		
Element Name:		1601 Wearing Surface (Approaches)				Width:		
Location:		Top of Fill				Height:		
Material:		2 Asphalt				Count:		1
Element Type:						Total Quantity:		1 Each
Environment:		Severe				Limited Inspection:		
Protection System:		Unknown				Perform. Deficiencies		
Condition	Units	Exc.	Good	Fair	Poor			
Data:	Each	0	0	1	0			
Comments:								
Cracking in surface. Drainage is in open ditches. Slopes are stable.								
Recommended Work:				Rehab <input type="checkbox"/>		Replace <input type="checkbox"/>		
Timing:				Urgent <input type="checkbox"/>		< 1yr <input type="checkbox"/>		
				1 - 5 yr <input type="checkbox"/>		6 - 10 yr <input type="checkbox"/>		
Maintenance Needs:				Rout and Seal				
				<input type="checkbox"/> Urgent		<input type="checkbox"/> 1 year		
						<input checked="" type="checkbox"/> 2 year

Figure 11      Cracking on Wearing Surface

Additional Investigation Required:	Priority		
	None	Normal	Urgent
Material Condition Survey			
<input checked="" type="checkbox"/> Detailed Deck Condition Survey:	X		
<input checked="" type="checkbox"/> Non-destructive Delamination Survey of Asphalt-Covered Deck:	X		
<input checked="" type="checkbox"/> Concrete Substructure Condition Survey:	X		
<input checked="" type="checkbox"/> Detailed Coating Condition Survey:	X		
<input checked="" type="checkbox"/> Detailed Timber Investigation	X		
<input checked="" type="checkbox"/> Post-Tensioned Strand Investigation	X		
Underwater Investigation:	X		
Fatigue Investigation:	X		
Seismic Investigation:	X		
Structure Evaluation:	X		
Monitoring			
<input checked="" type="checkbox"/> Monitoring of Deformations, Settlements and Movements:	X		
<input checked="" type="checkbox"/> Monitoring Crack Widths:	X		
Investigation Notes:			
Outlet - Bridge Cleaning, Wearing Surface - Rout and Seal
