**SECOND AVENUE CULVERT**

Site Number 973501

**SECOND AVENUE, SIMCOE**

**Ontario Structure Inspection Manual - Inspection Form**

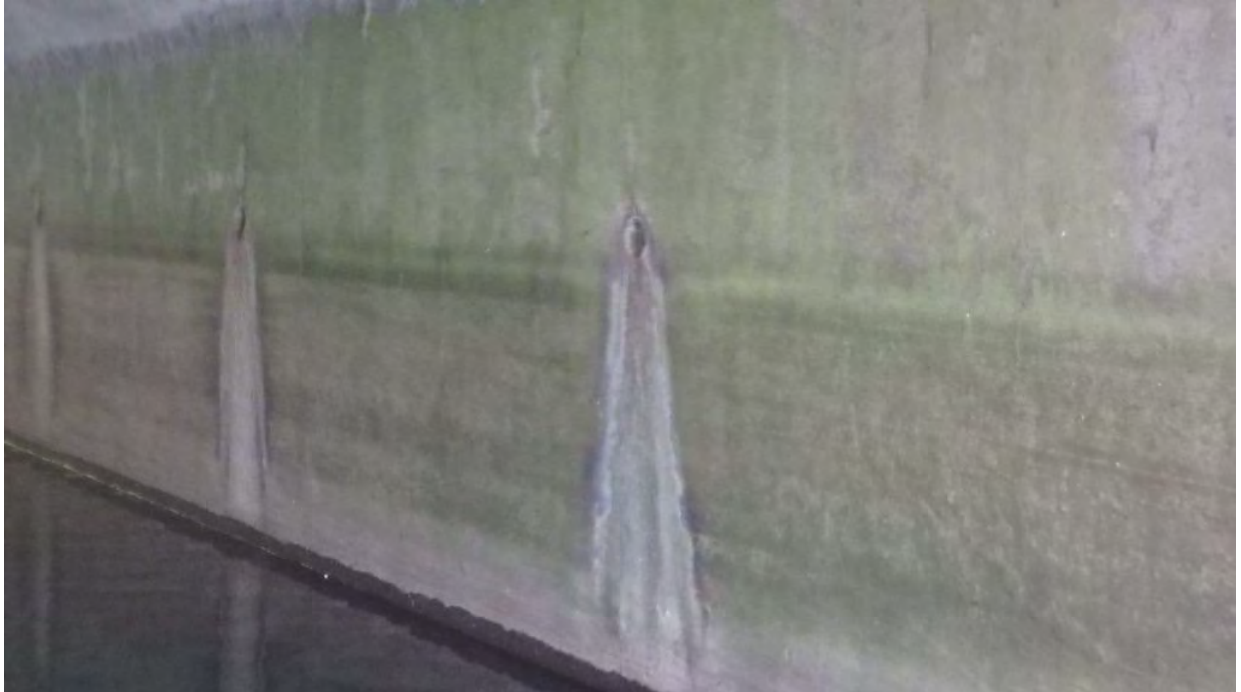
Figure 10 Staining at drains

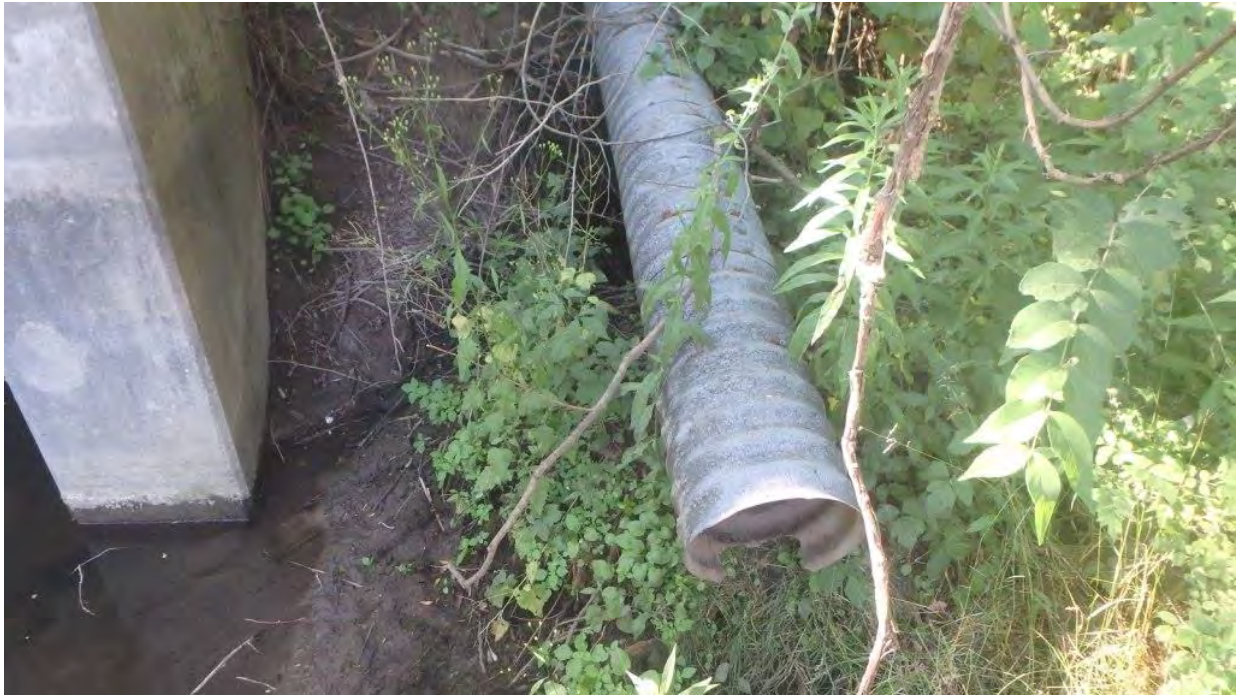
Figure 13 Drain at Outlet

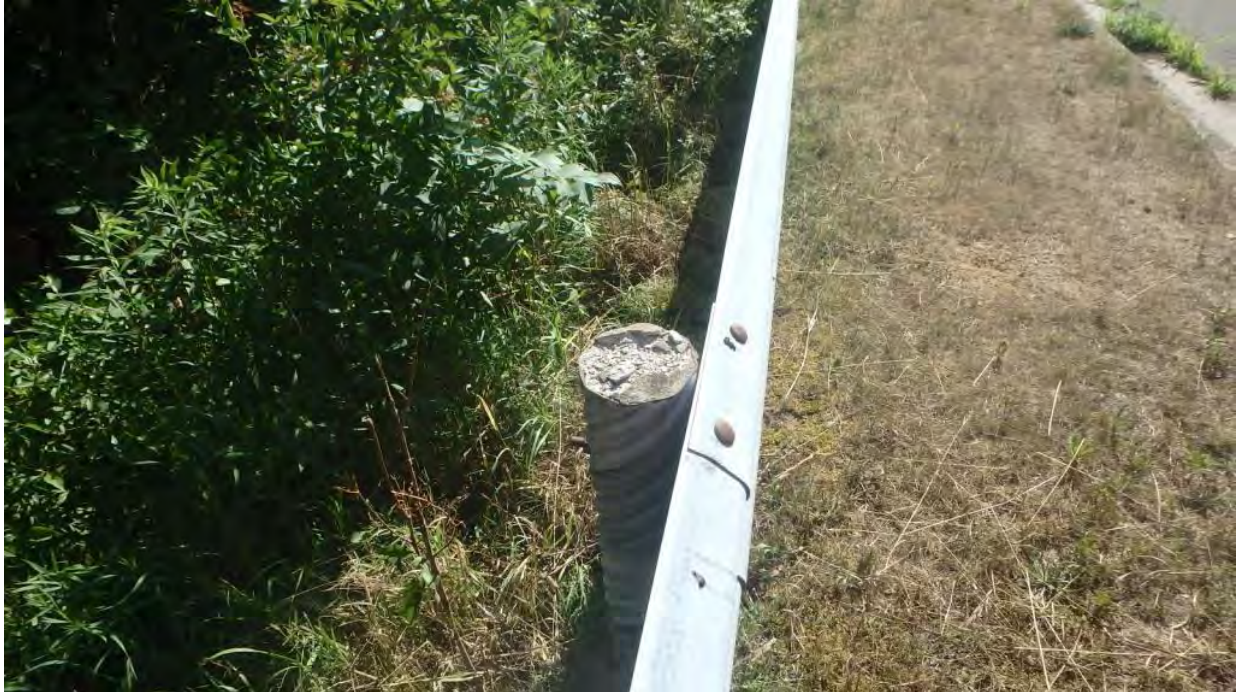
Figure 14 Typical Barrier Post Filled with Concrete

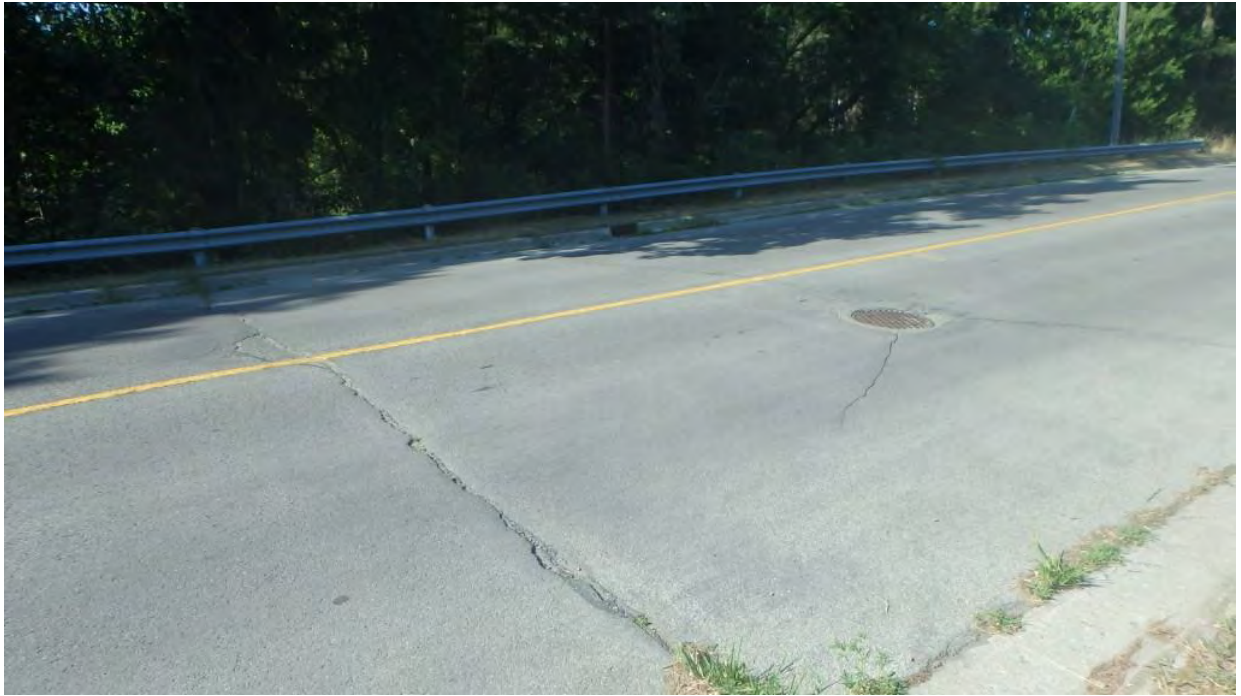
Figure 15 Transverse Cracks in Wearing Surface at Culvert Joints
