LITTLE OTTER CREEK CULVERT

Site Number 973801

TALBOT ROAD (COUNTY ROAD 38), MIDDLETON

Ontario Structure Inspection Manual - Inspection Form

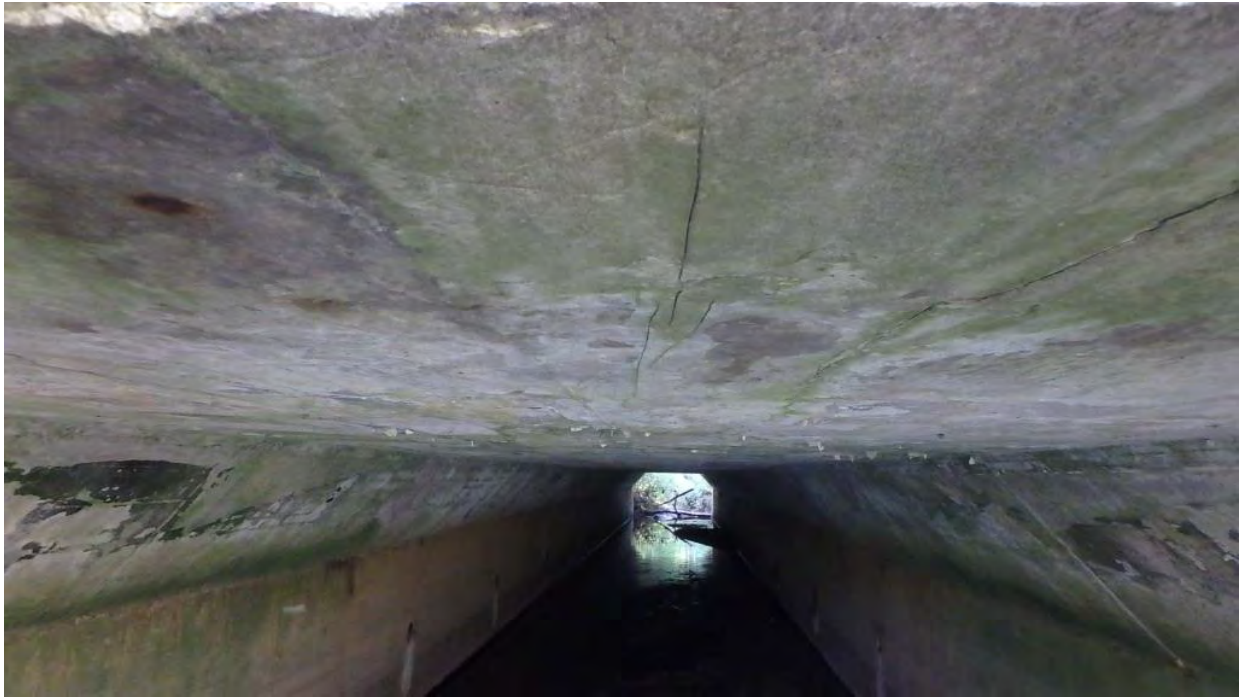
Figure 7 Culvert Barrel

Element Group:		1200 Culverts				Length:		36.5
Element Name:		1203 Barrels				Width:		3.7
Location:		Inside				Height:		2
Material:		4 Cast-in-place Concrete				Count:		1
Element Type:						Total Quantity:		281.1 sq.m
Environment:		Moderate				Limited Inspection:		
Protection System:		None				Perform. Deficiencies		
Condition	Units	Exc.	Good	Fair	Poor			
Data:	sq.m	0	279.1	2	0			
Comments:								
Minor deterioration, staining and hairline cracking at wall drain outlets. Deterioration on east wall at midspan construction joint. Drains appear to be clogged.								
Recommended Work:				Rehab <input type="checkbox"/>		Replace <input type="checkbox"/>		
Timing:				Urgent <input type="checkbox"/>		< 1yr <input type="checkbox"/>		
				1 - 5 yr <input type="checkbox"/>		6 - 10 yr <input type="checkbox"/>		
Maintenance Needs:				Bridge Concrete Repair				
				<input type="checkbox"/>		Urgent <input checked="" type="checkbox"/>

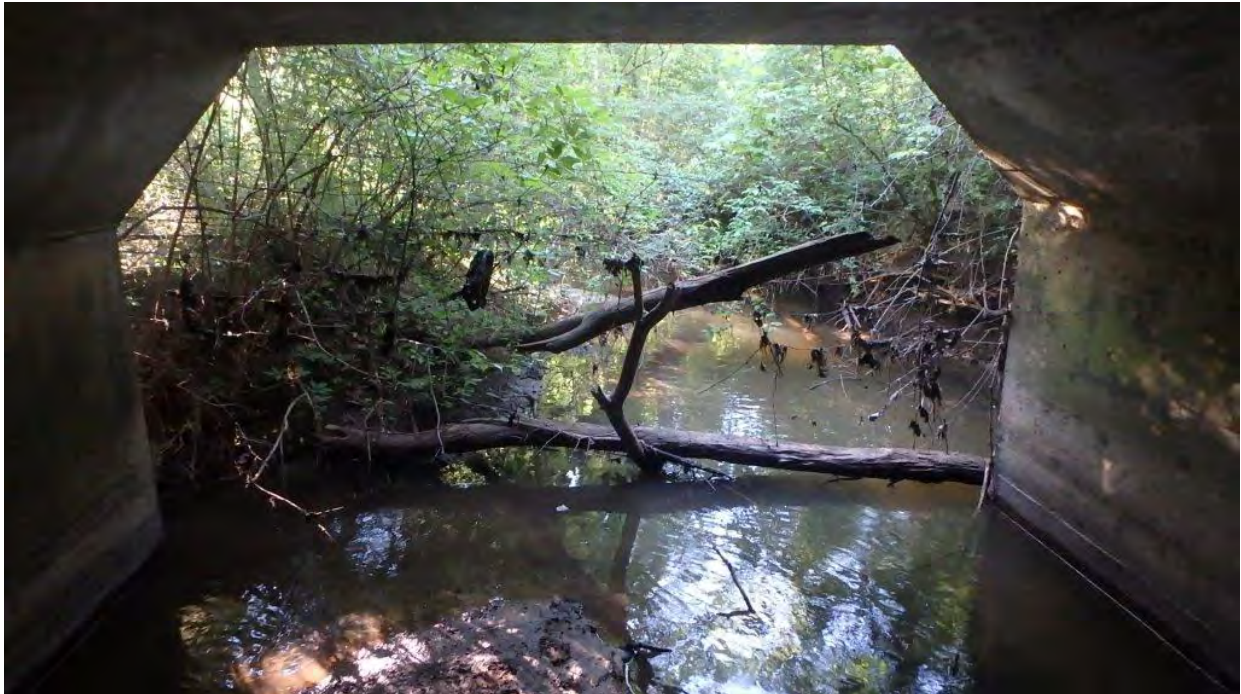
Element Group:		1200 Culverts				Length:		
Element Name:		1201 Inlet Components				Width:		
Location:						Height:		
Material:						Count:		1
Element Type:						Total Quantity:		1 Each
Environment:		Moderate				Limited Inspection:		
Protection System:		None				Perform. Deficiencies		
Condition	Units	Exc.	Good	Fair	Poor			
Data:	Each	0	1	0	0			
Comments:								
Inlet partially blocked by debris and wire fence. Minor erosion at both quadrants.								
Recommended Work:				Rehab <input type="checkbox"/>		Replace <input type="checkbox"/>		
Timing:				Urgent <input type="checkbox"/>		< 1yr <input type="checkbox"/>		
				1 - 5 yr <input type="checkbox"/>		6 - 10 yr <input type="checkbox"/>		
Maintenance Needs:				Erosion Control, Remove Blo				
				<input type="checkbox"/>		Urgent <input checked="" type="checkbox"/>		
				<input type="checkbox"/>		1 year <input type="checkbox"/>		
				<input type="checkbox"/>		2 year <input type="checkbox"/>

Figure 8 Debris Blockage at Inlet

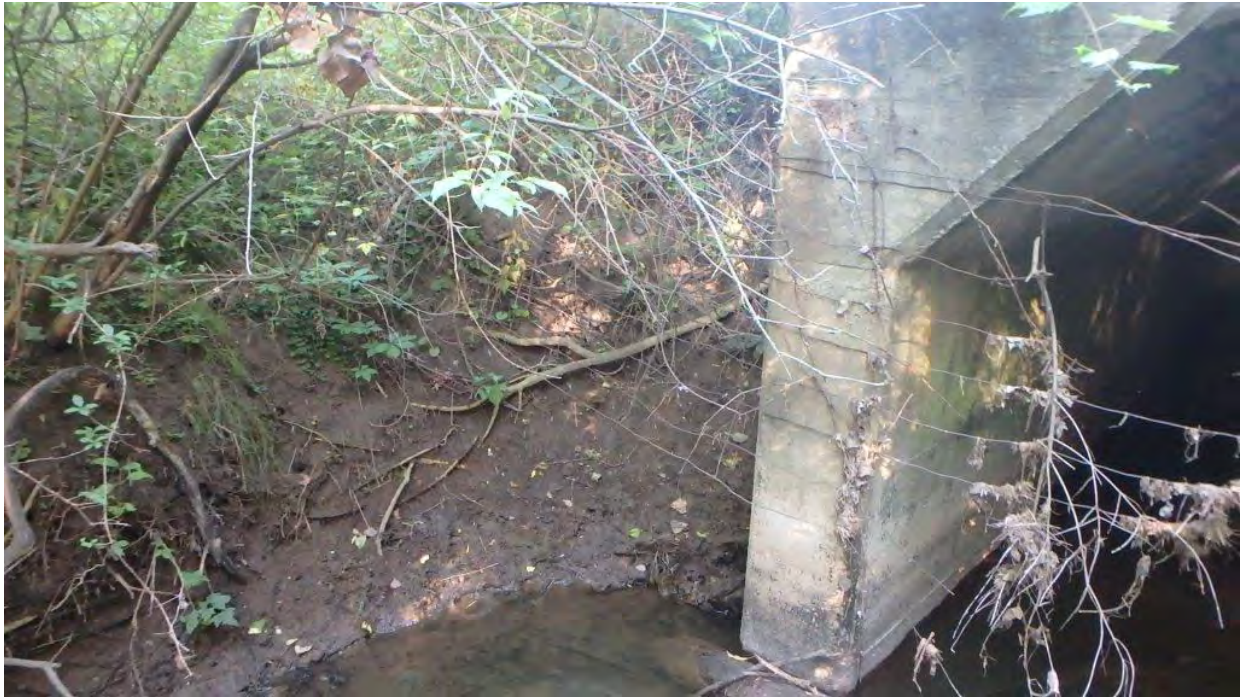
Element Group:		1400 Embankments & Streams				Length:		
Element Name:		1401 Streams and Waterways				Width:		
Location:						Height:		
Material:						Count:		1
Element Type:						Total Quantity:		1 Each
Environment:						Limited Inspection:		
Protection System:		None				Perform. Deficiencies		
Condition	Units	Exc.	Good	Fair	Poor			
Data:	Each	0	1	0	0			
Comments:								
Banks are stable.								
Recommended Work:				Rehab <input type="checkbox"/>		Replace <input type="checkbox"/>		
Timing:				Urgent <input type="checkbox"/>		< 1yr <input type="checkbox"/>		
				1 - 5 yr <input type="checkbox"/>		6 - 10 yr <input type="checkbox"/>		
Maintenance Needs:				<input type="checkbox"/>		Urgent <input type="checkbox"/>		
				<input type="checkbox"/>		1 year <input checked="" type="checkbox"/>		
				<input type="checkbox"/>		2 year <input type="checkbox"/>

Figure 9 Minor Erosion at all Quadrants

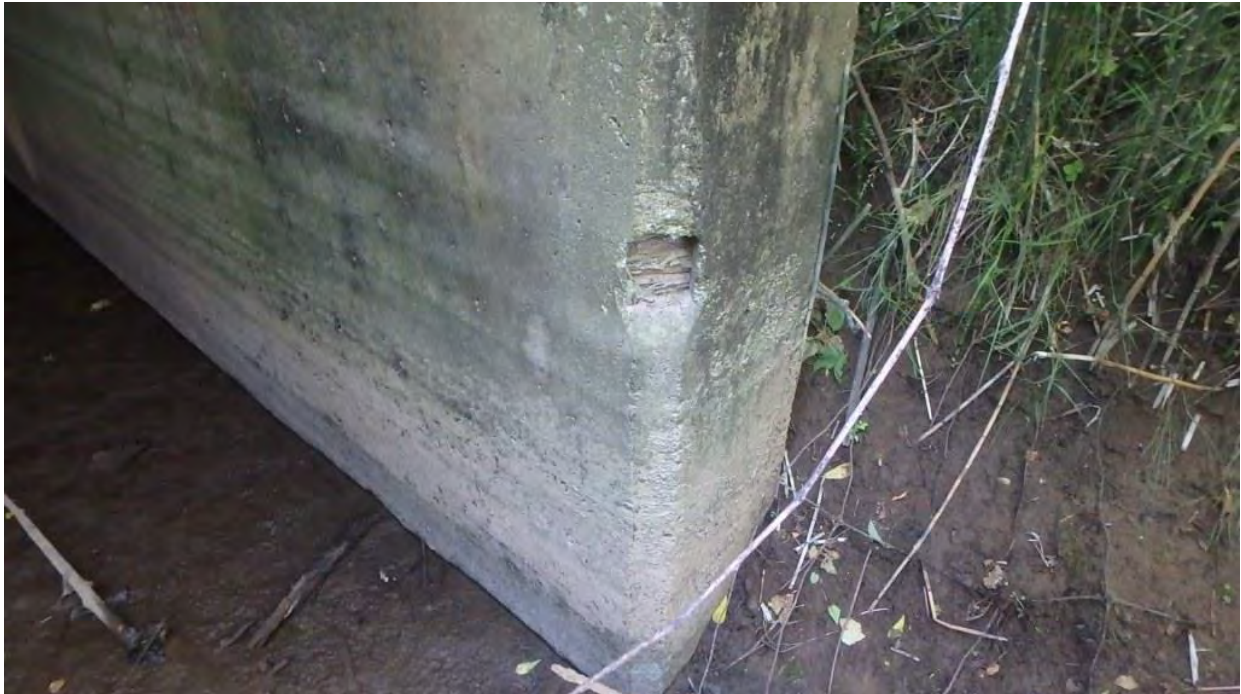
Element Group:		1200 Culverts				Length:		
Element Name:		1202 Outlet Components				Width:		
Location:						Height:		
Material:						Count:		1
Element Type:						Total Quantity:		1 Each
Environment:		Moderate				Limited Inspection:		
Protection System:		None				Perform. Deficiencies		
Condition	Units	Exc.	Good	Fair	Poor			
Data:	Each	0	1	0	0			
Comments:								
Minor erosion at both quadrants, slopes appear stable.								
Recommended Work:				Rehab <input type="checkbox"/>		Replace <input type="checkbox"/>		
Timing:				Urgent <input type="checkbox"/>		< 1yr <input type="checkbox"/>		
				1 - 5 yr <input type="checkbox"/>		6 - 10 yr <input type="checkbox"/>		
Maintenance Needs:				<input type="checkbox"/>		Urgent <input type="checkbox"/>		
				<input type="checkbox"/>		1 year <input type="checkbox"/>		
				<input type="checkbox"/>		2 year <input type="checkbox"/>

Figure 10 Wood Pop-out in Concrete at Outlet

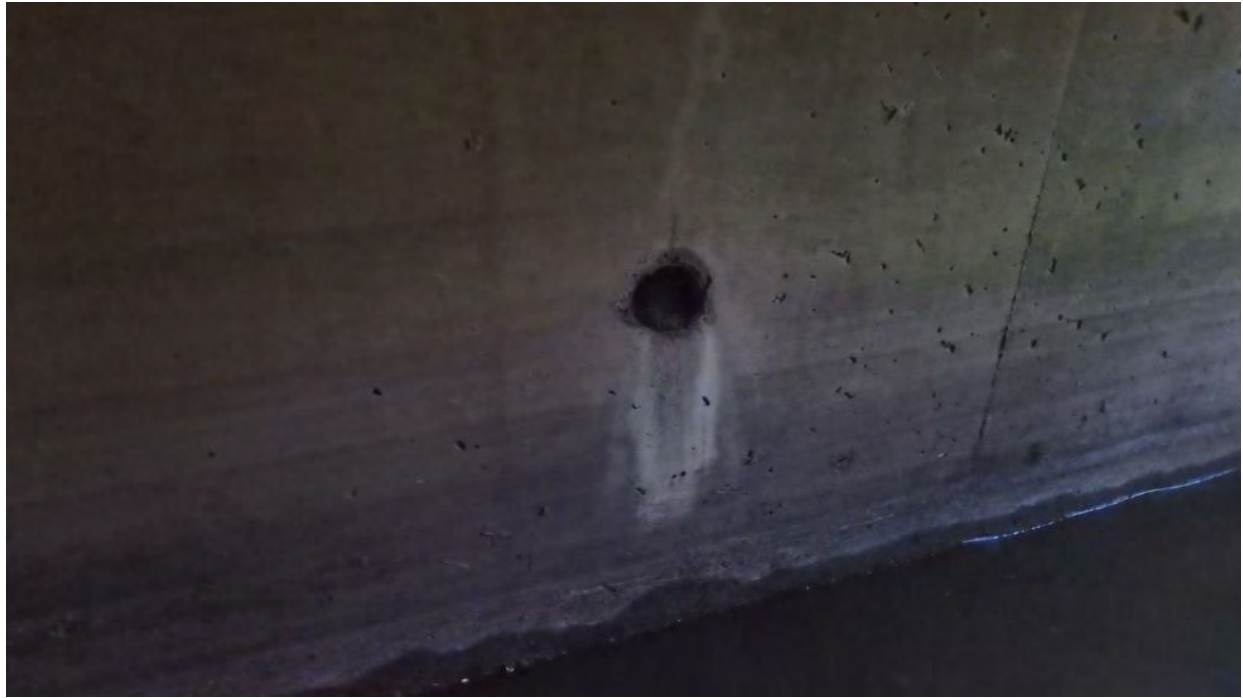
Figure 11 Staining and Hairline Crack at Drains

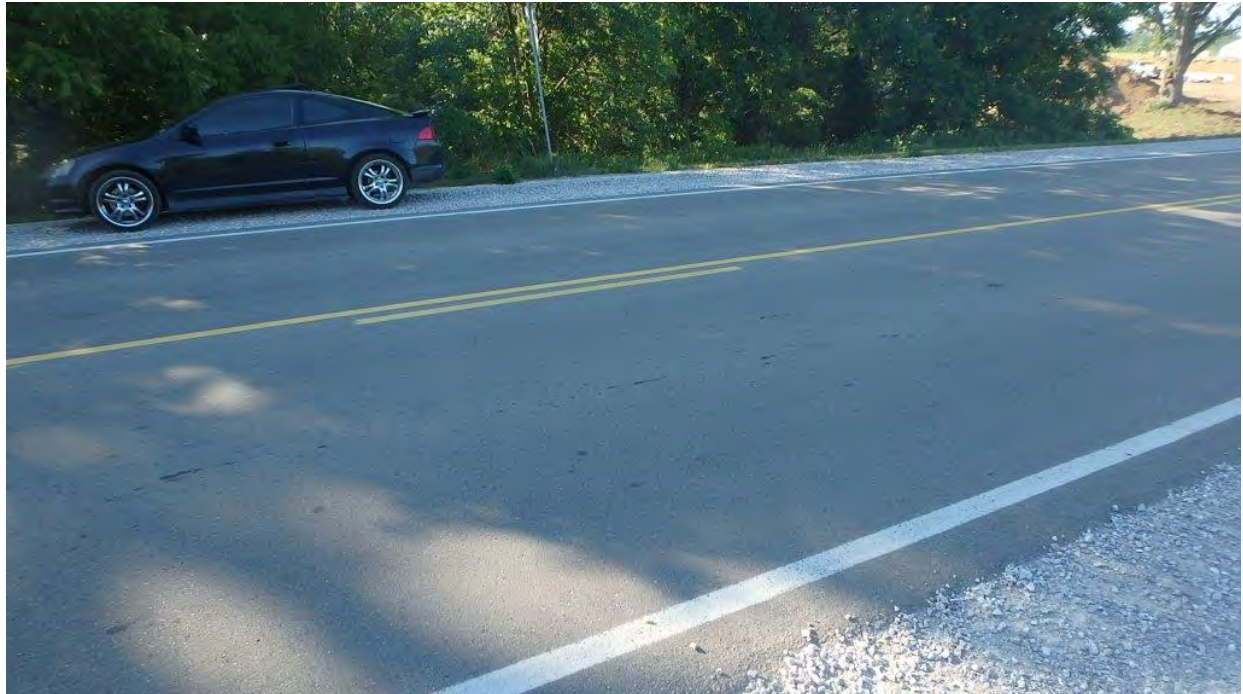
Figure 12 Asphalt Wearing Surface

Element Group:		1600 Approaches				Length:		
Element Name:		1601 Wearing Surface (Approaches)				Width:		
Location:		Top of Fill				Height:		
Material:		2 Asphalt				Count:		1
Element Type:						Total Quantity:		1 Each
Environment:		Severe				Limited Inspection:		
Protection System:		None				Perform. Deficiencies		
Condition	Units	Exc.	Good	Fair	Poor			
Data:	Each	1	0	0	0			
Comments:								
No signs or barriers. Asphalt is new (2016).								
Recommended Work:				Rehab <input type="checkbox"/>		Replace <input type="checkbox"/>		
Timing:				Urgent <input type="checkbox"/>		< 1yr <input type="checkbox"/>		
				1 - 5 yr <input type="checkbox"/>		6 - 10 yr <input type="checkbox"/>		
Maintenance Needs:				<input type="checkbox"/>		Urgent <input type="checkbox"/>		
				<input type="checkbox"/>		1 year <input type="checkbox"/>		
				<input type="checkbox"/>		2 year <input type="checkbox"/>
