14TH STREET WEST CULVERT

Site Number 974001

COUNTY ROAD 40, WINDHAM

Ontario Structure Inspection Manual - Inspection Form

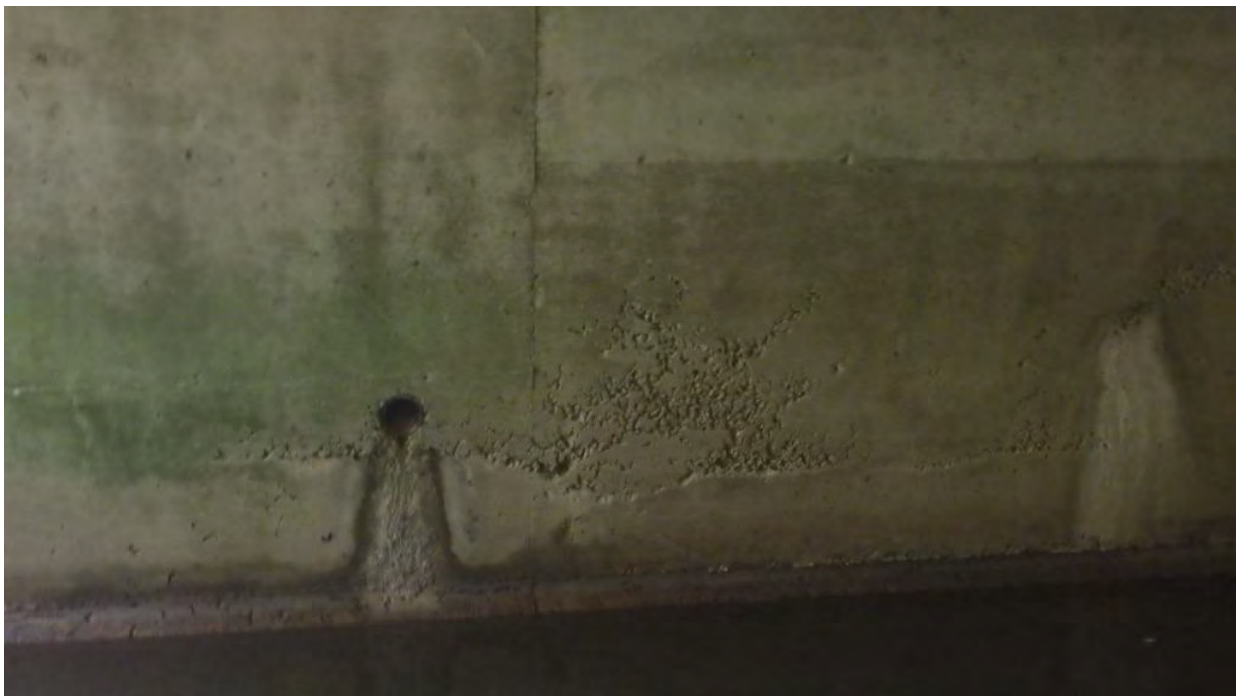
Figure 12 Leakage & Staining at Drains

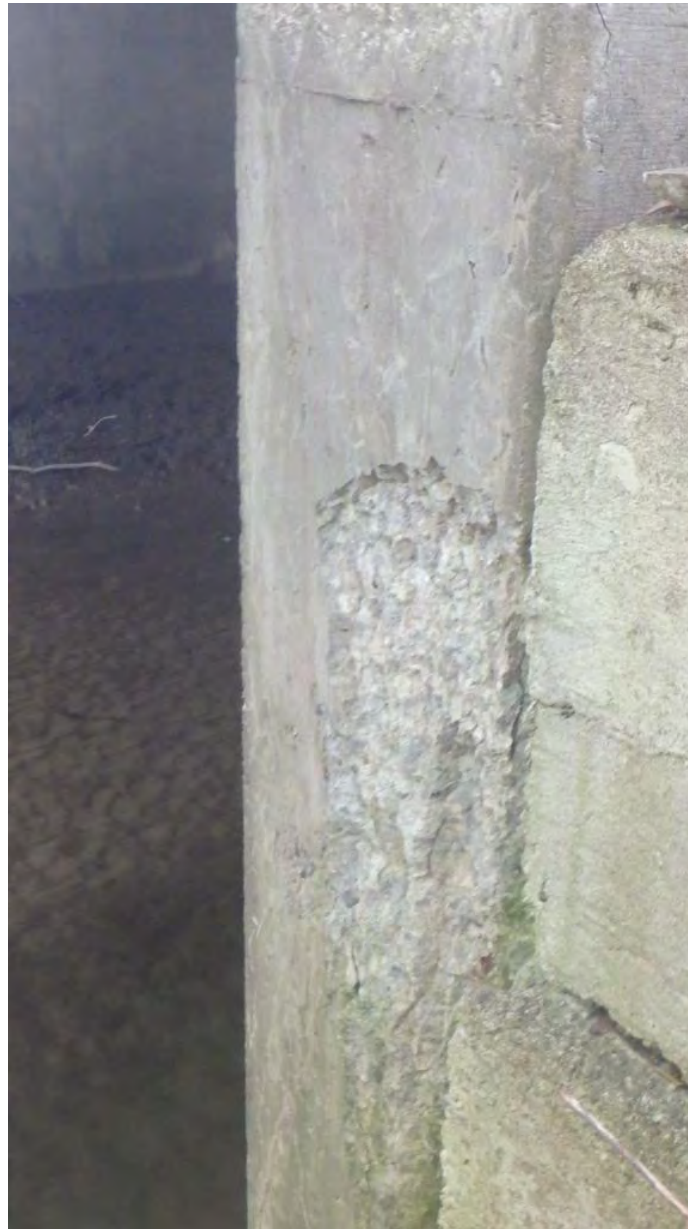
Figure 13 Large Spall at Northwest Quadrant

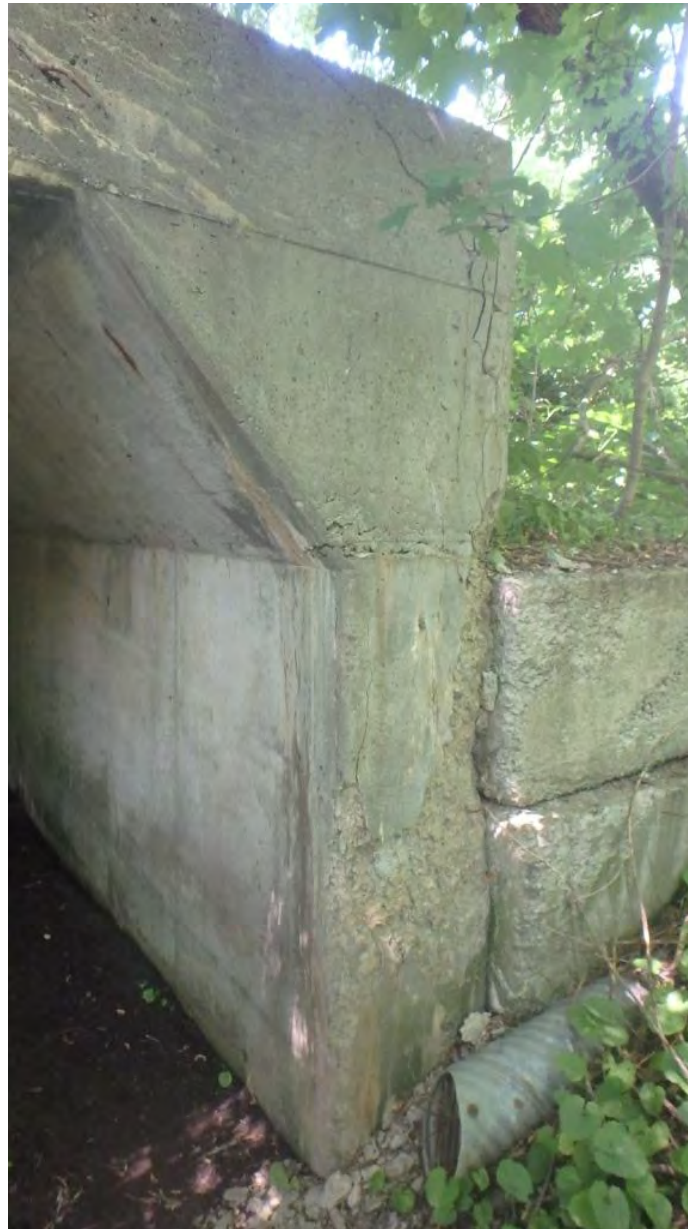
Figure 14 Severe Spalling & Delamination with Leakage & Chlorides at Southeast Quadrant

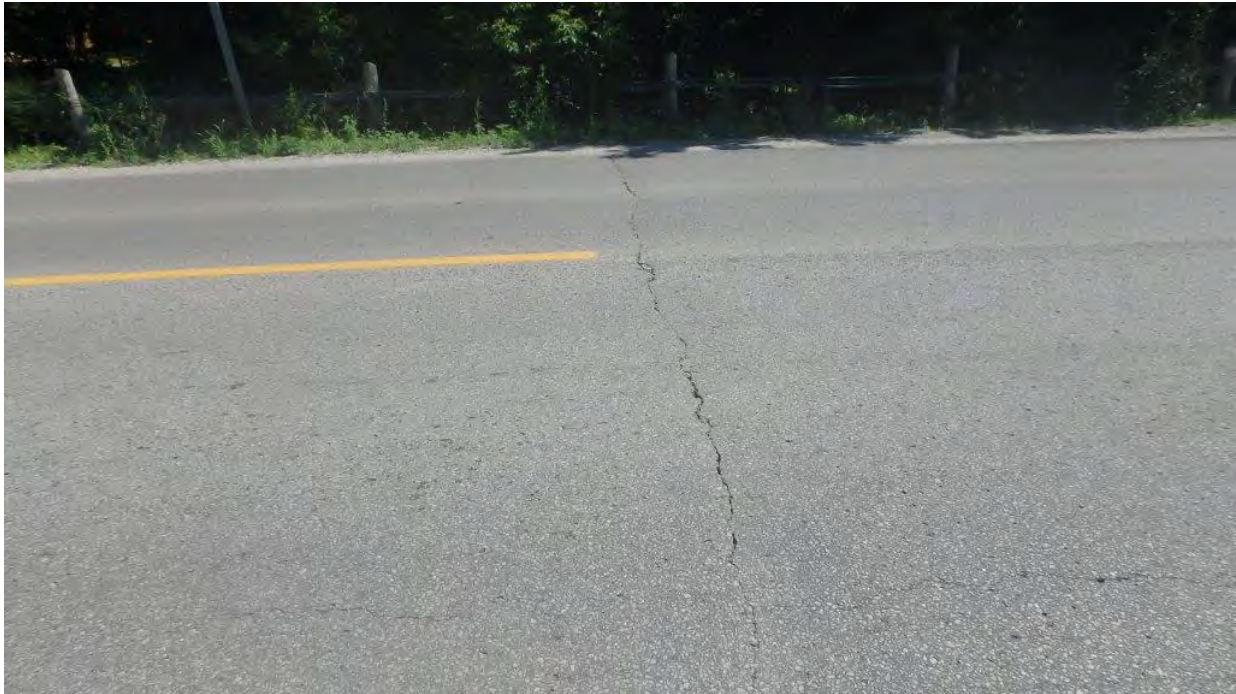
Figure 15 Typical Transverse Crack in Wearing Surface
