PATTERSON CREEK CULVERT

Site Number 974002

COUNTY ROAD 40, WINDHAM

Ontario Structure Inspection Manual - Inspection Form

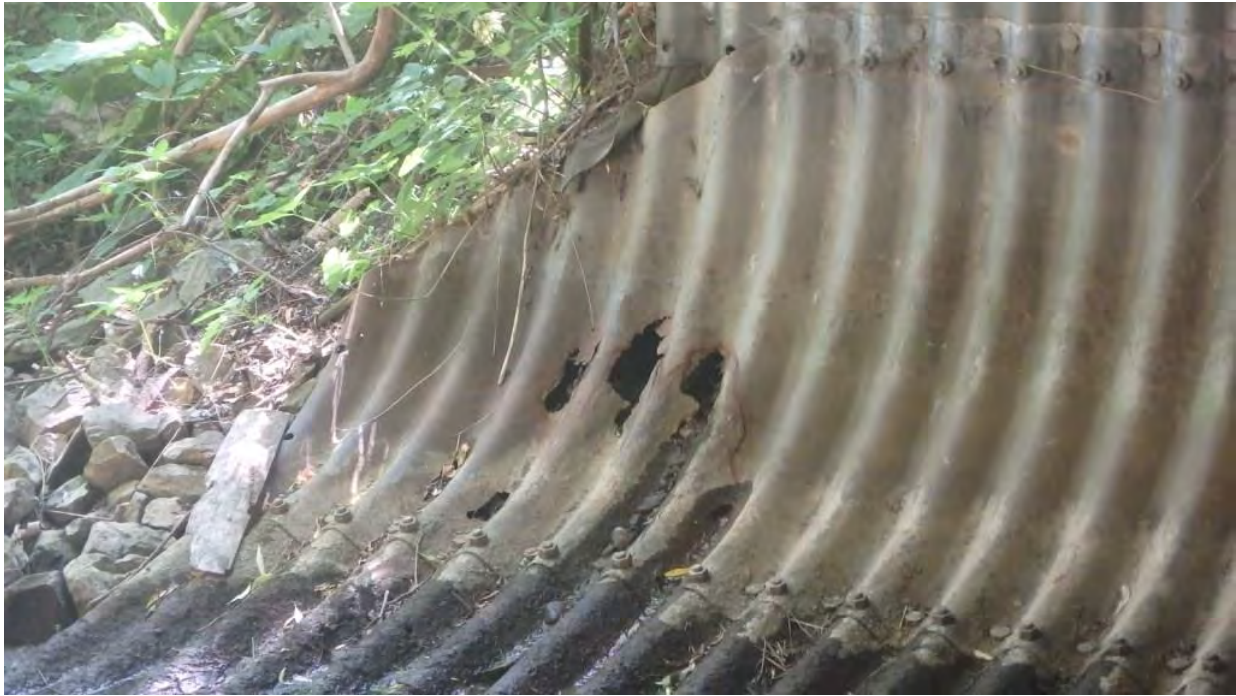
Figure 9 Deteriorated Holes in Culvert at South

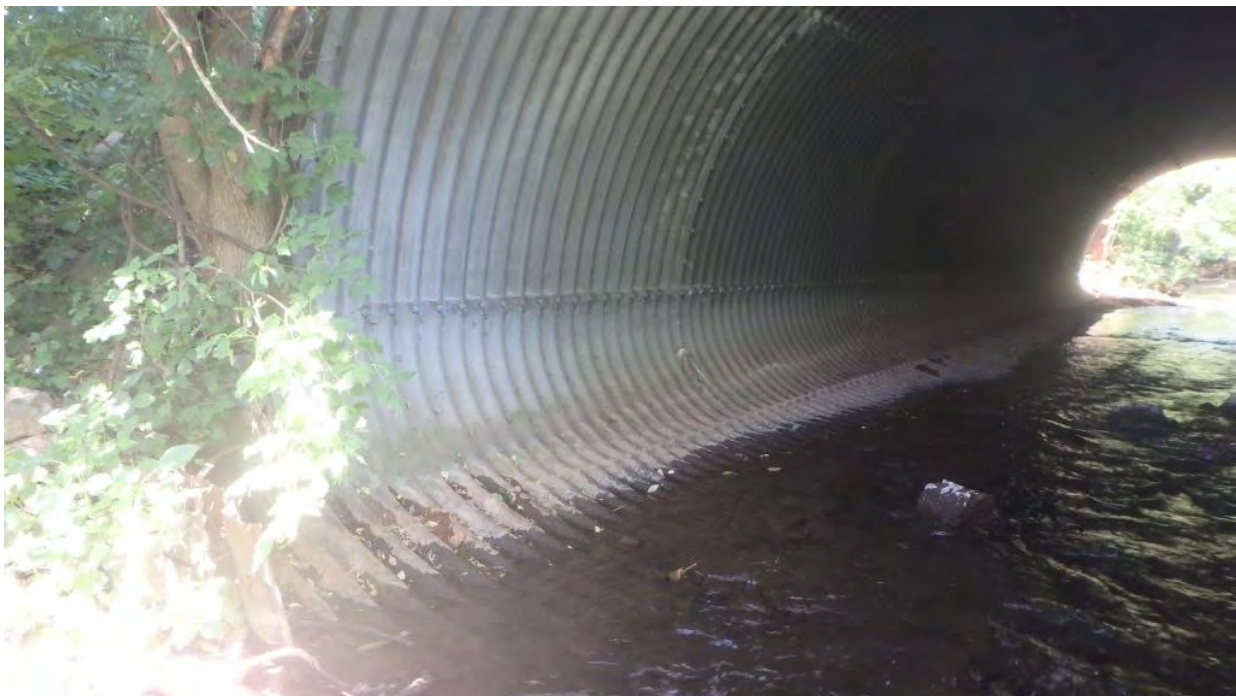
Figure 10 Typical Water level Staining & Corrosion

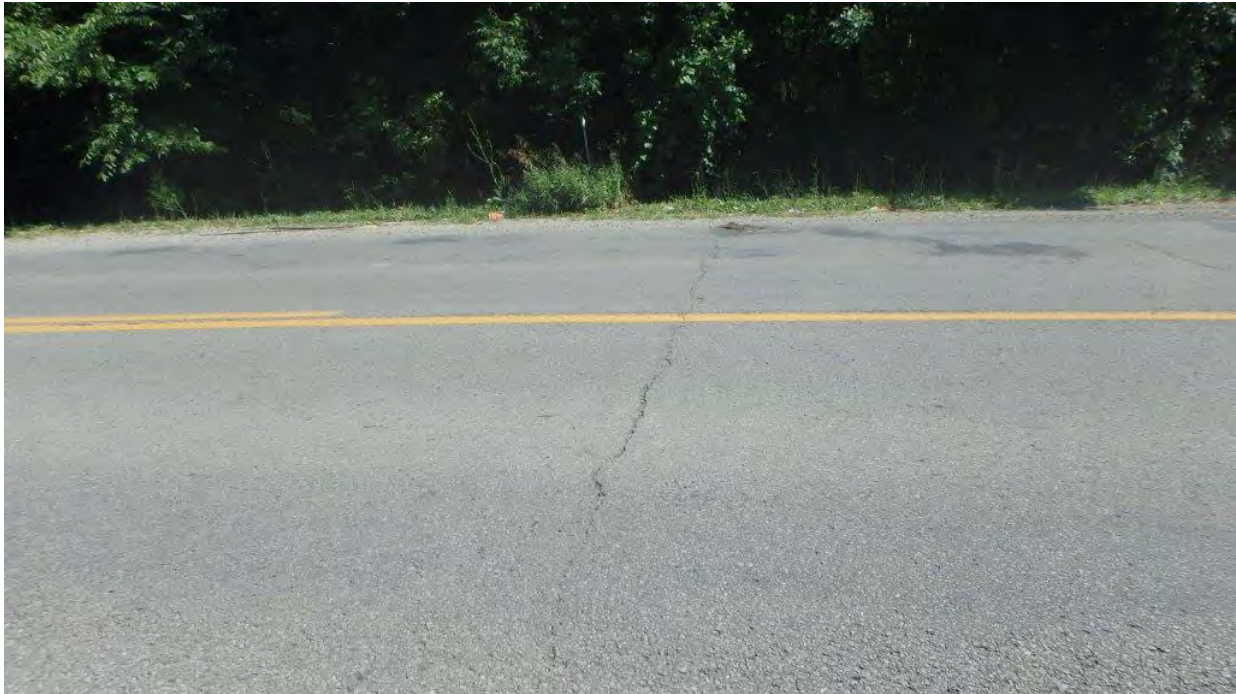
Figure 11 Transverse Crack in Wearing Surface

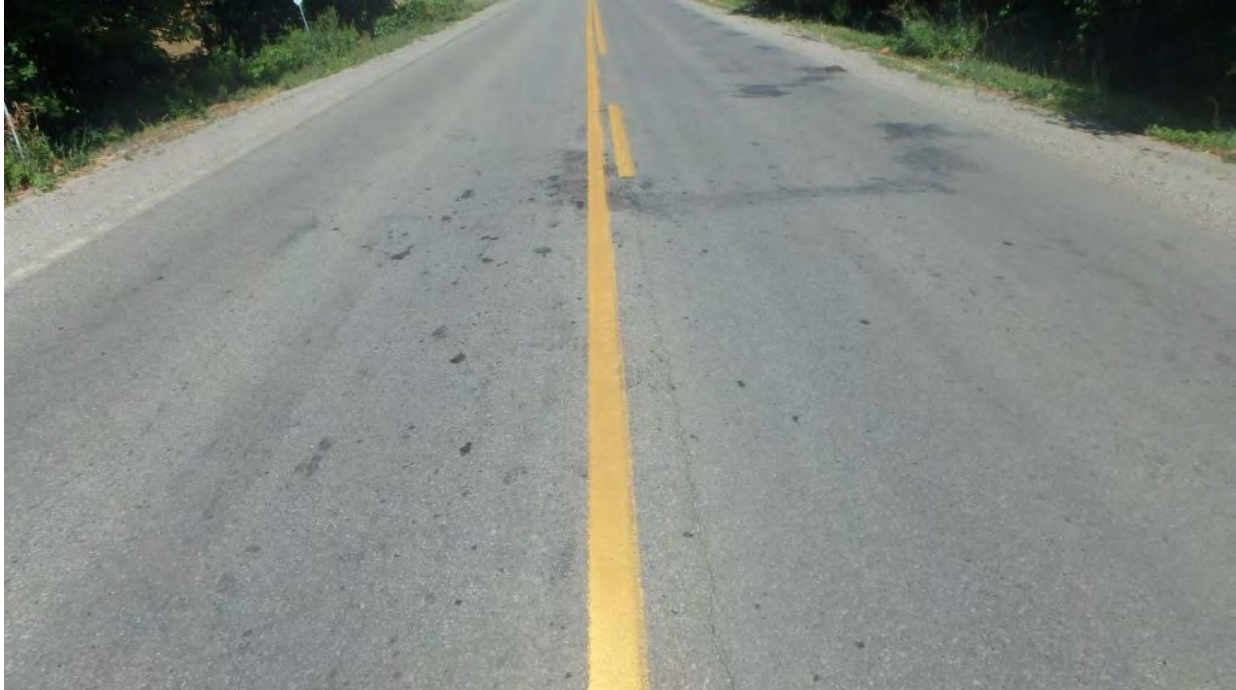
Figure 12 Longitudinal Crack in Wearing Surface
