MUD CREEK CULVERT

Site Number 974202

PORT ROWAN ROAD 42, SOUTH WALSINGHAM

Ontario Structure Inspection Manual - Inspection Form

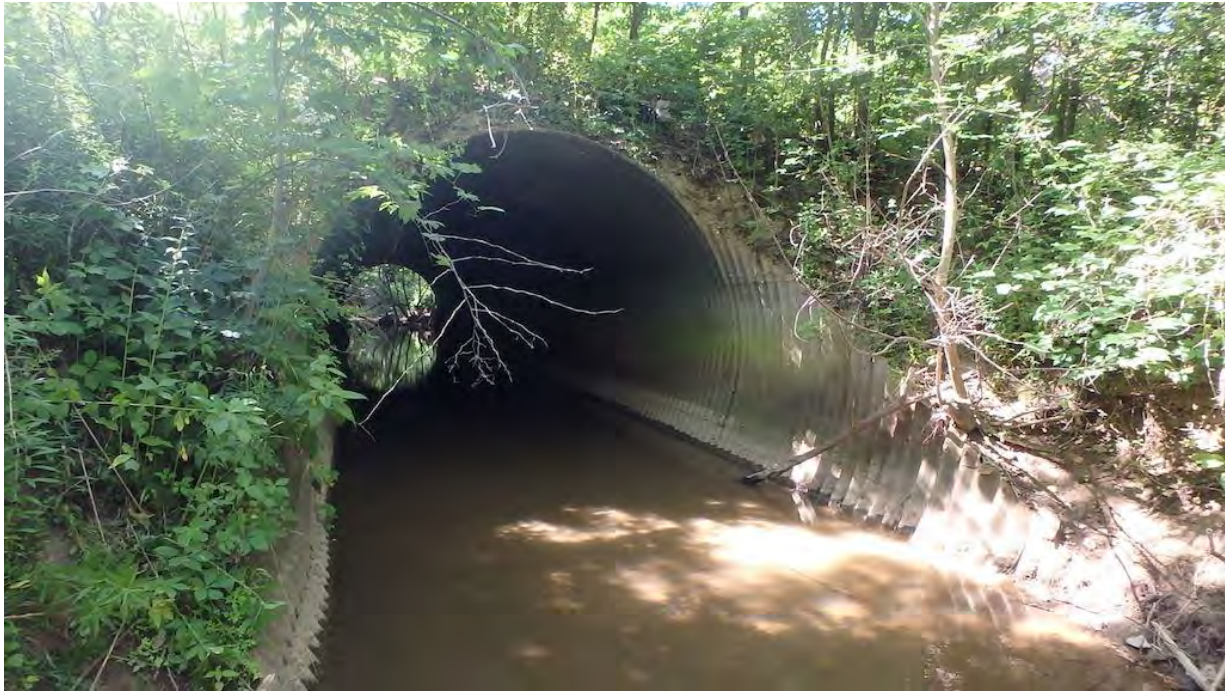
Figure 3 North Profile, Inlet

Element Group:		1200 Culverts				Length:		
Element Name:		1201 Inlet Components				Width:		
Location:						Height:		
Material:		14 Steel				Count:		1
Element Type:						Total Quantity:		1 Each
Environment:		Moderate				Limited Inspection:		
Protection System:		Unknown				Perform. Deficiencies		
Condition	Units	Exc.	Good	Fair	Poor			
Data:	Each	0	1	0	0			
Comments: Overgrown.								
Recommended Work: Rehab <input type="checkbox"/> Replace <input type="checkbox"/>				Maintenance Needs:				
Timing: Urgent <input type="checkbox"/> < 1yr <input type="checkbox"/> 1 - 5 yr <input type="checkbox"/> 6 - 10 yr <input type="checkbox"/>				<input type="checkbox"/> Urgent <input type="checkbox"/> 1 year <input type="checkbox"/> 2 year

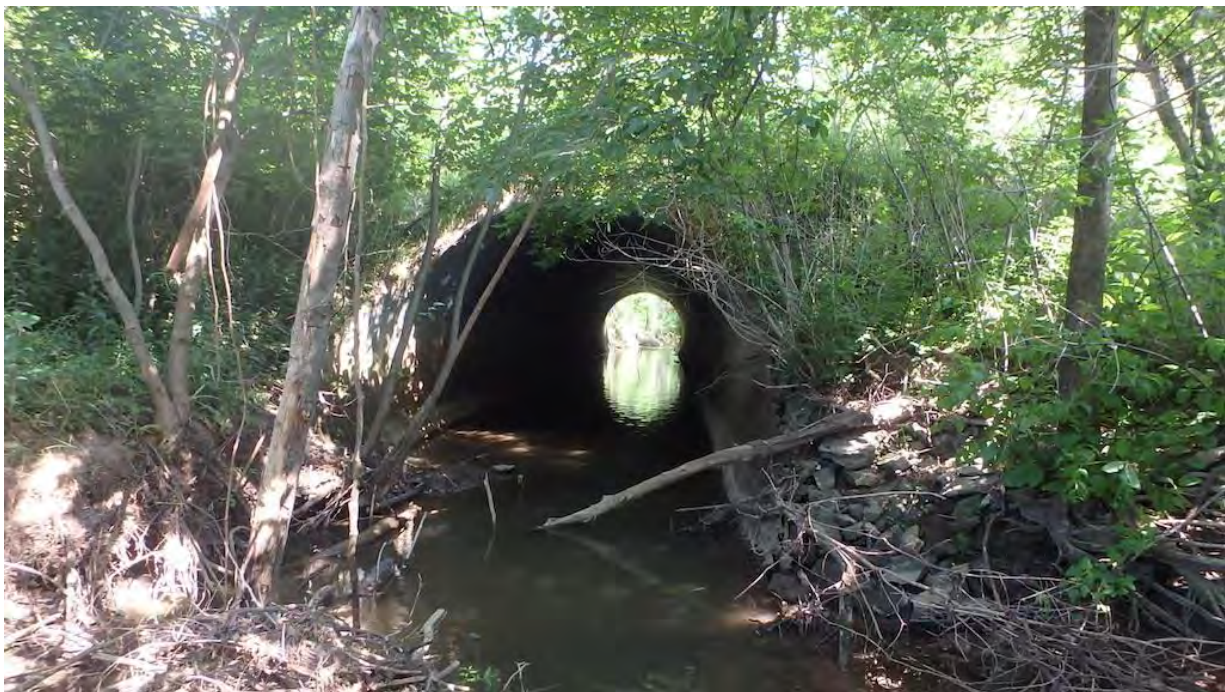
Figure 4 South Profile, Outlet

Element Group:		1200 Culverts				Length:		
Element Name:		1202 Outlet Components				Width:		
Location:						Height:		
Material:		14 Steel				Count:		1
Element Type:						Total Quantity:		1 Each
Environment:		Moderate				Limited Inspection:		
Protection System:		Unknown				Perform. Deficiencies		
Condition Data:	Units	Exc.	Good	Fair	Poor			
	Each	0	1	0	0			
Comments: Overgrown.								
Recommended Work:				Rehab <input type="checkbox"/>		Replace <input type="checkbox"/>		
Timing:				Urgent <input type="checkbox"/>		< 1yr <input type="checkbox"/>		
				1 - 5 yr <input type="checkbox"/>		6 - 10 yr <input type="checkbox"/>		
				Maintenance Needs:		<input type="checkbox"/> Urgent <input type="checkbox"/> 1 year <input type="checkbox"/> 2 year

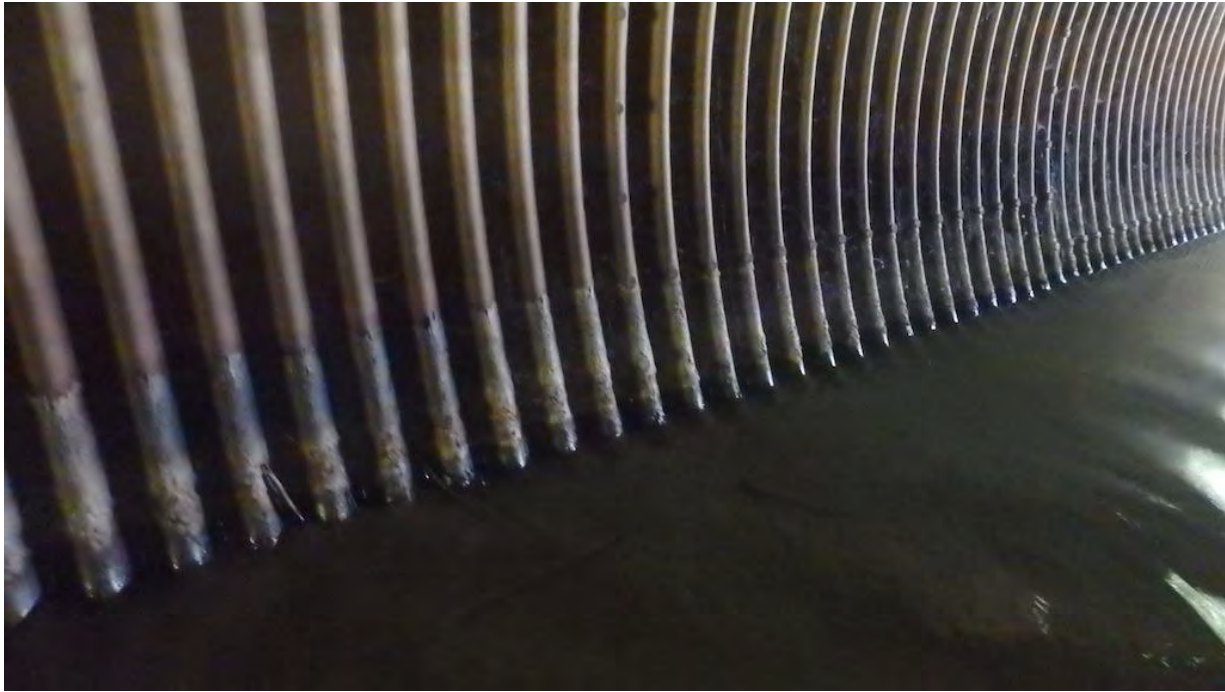
Element Group:		1200 Culverts				Length:		36
Element Name:		1203 Barrels				Width:		4.3
Location:						Height:		3.1
Material:		5 Corrugated Steel				Count:		1
Element Type:						Total Quantity:		486.3 sq.m
Environment:		Severe				Limited Inspection:		
Protection System:		Unknown				Perform. Deficiencies		
Condition	Units	Exc.	Good	Fair	Poor			
Data:	sq.m	0	386.3	100	0			
Comments: Some corrosion at water level.								
Recommended Work: Rehab <input type="checkbox"/> Replace <input type="checkbox"/>				Maintenance Needs:				
Timing: Urgent <input type="checkbox"/> < 1yr <input type="checkbox"/> 1 - 5 yr <input type="checkbox"/> 6 - 10 yr <input type="checkbox"/>				<input type="checkbox"/> Urgent <input type="checkbox"/> 1 year <input type="checkbox"/> 2 year

Figure 9 Corrosion at Waterline

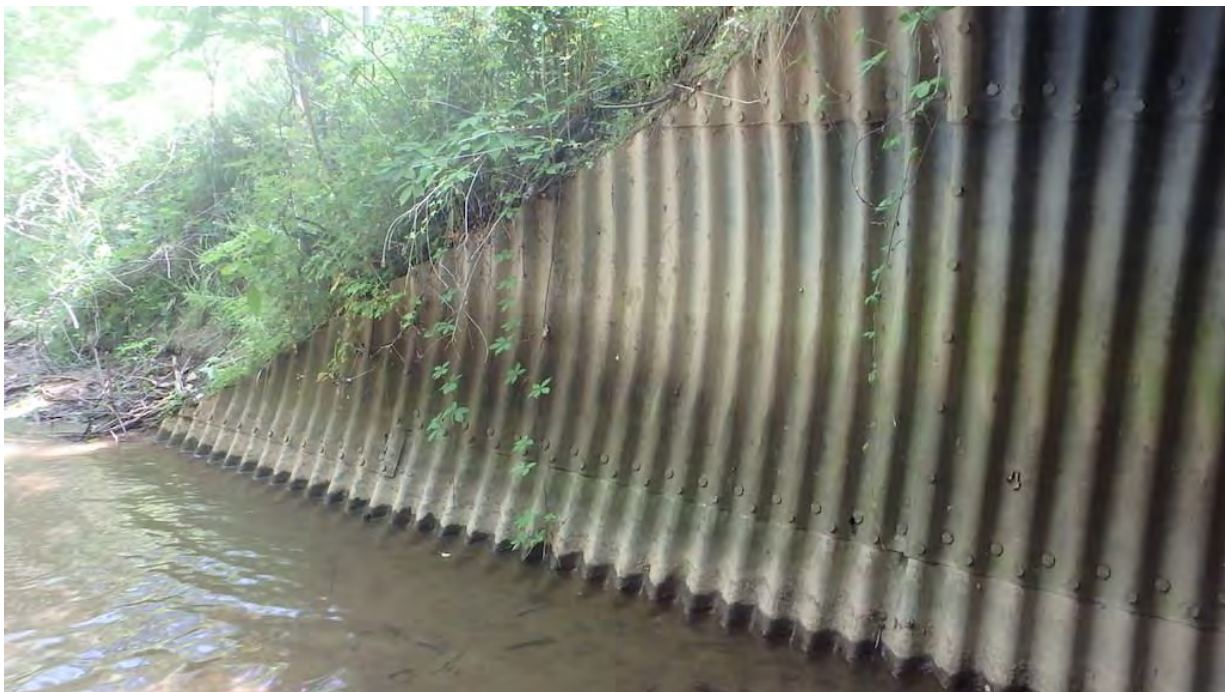
Figure 10 Northeast Wingwall

Element Group:		1400 Embankments & Streams				Length:		
Element Name:		1402 Embankments				Width:		
Location:						Height:		
Material:						Count:		4
Element Type:						Total Quantity:		4 Each
Environment:						Limited Inspection:		
Protection System:		Unknown				Perform. Deficiencies		
Condition Data:	Units	Exc.	Good	Fair	Poor			
	Each	0	0	4	0			
Comments: Scour and erosion at ends of culvert. Overgrown								
Recommended Work:				Rehab <input type="checkbox"/>		Replace <input type="checkbox"/>		
Timing:				Urgent <input type="checkbox"/>		< 1yr <input type="checkbox"/>		
				1 - 5 yr <input type="checkbox"/>		6 - 10 yr <input type="checkbox"/>		
				Maintenance Needs:		Erosion Control at Bridges		
				<input type="checkbox"/> Urgent <input type="checkbox"/> 1 year		<input checked="" type="checkbox"/> 2 year
