**ROHRER CULVERT**

Site Number 974203

**PORT ROWAN ROAD 42, SOUTH WALSINGHAM**

**Ontario Structure Inspection Manual - Inspection Form**

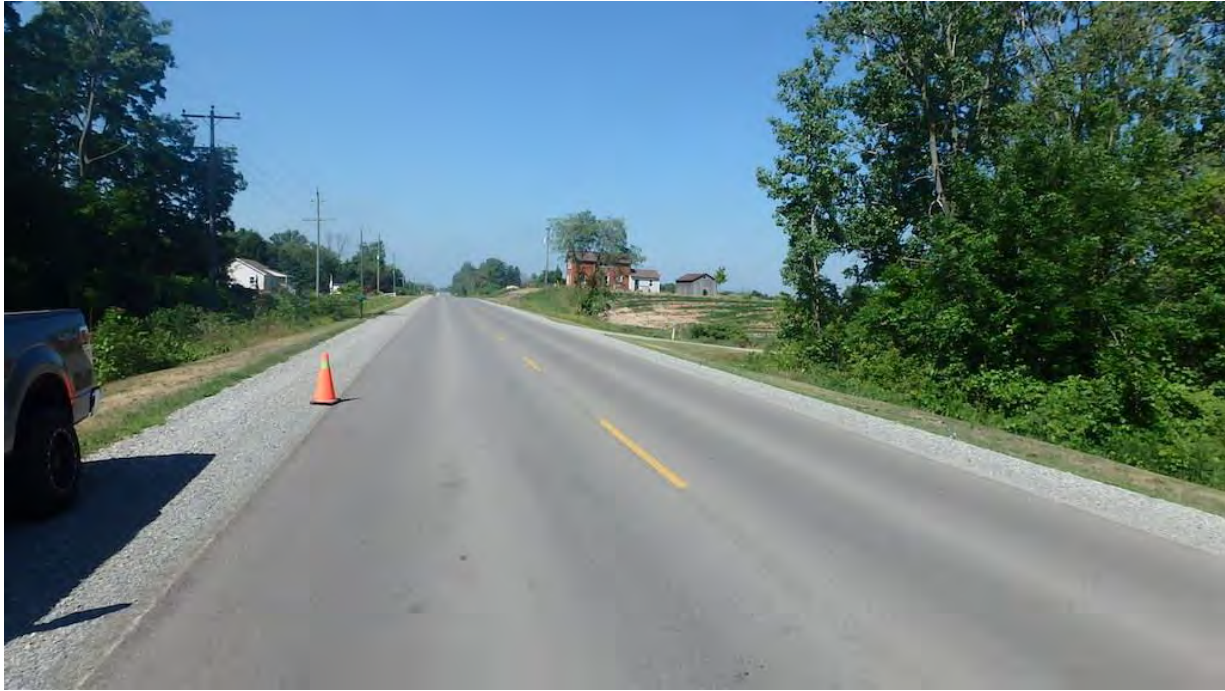
Figure 1 East Approach

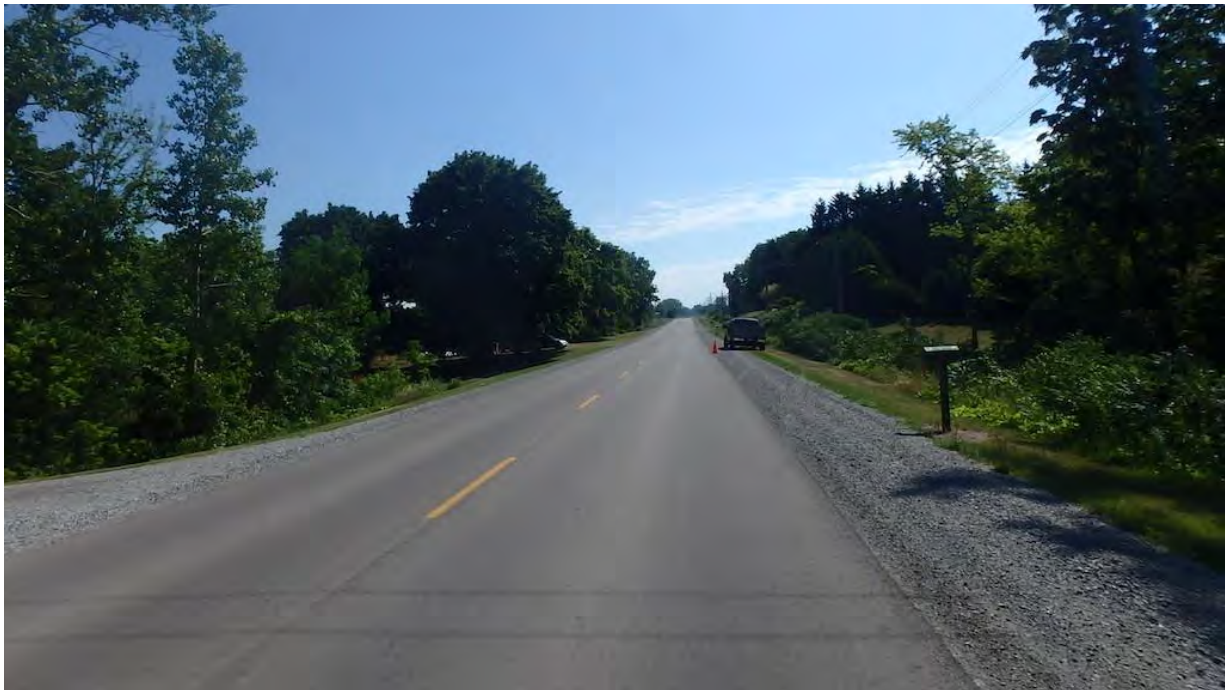
Figure 2 West Approach

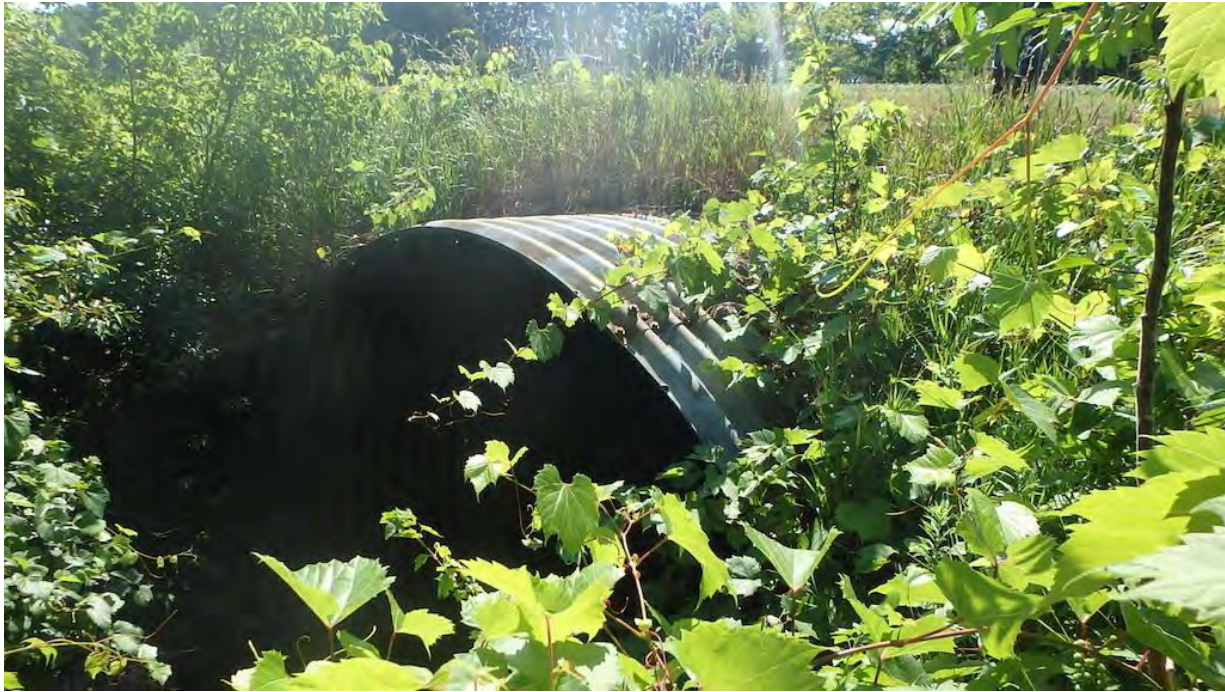
Figure 3 North Profile, Inlet

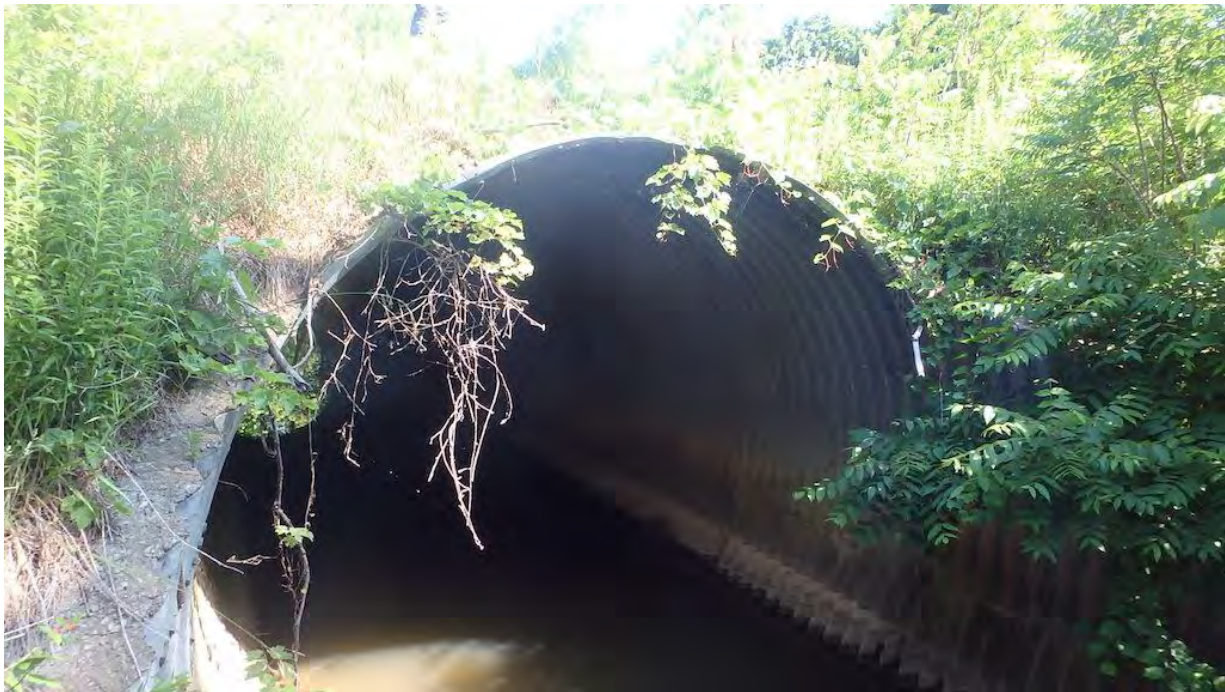
Figure 4 South Profile, Outlet

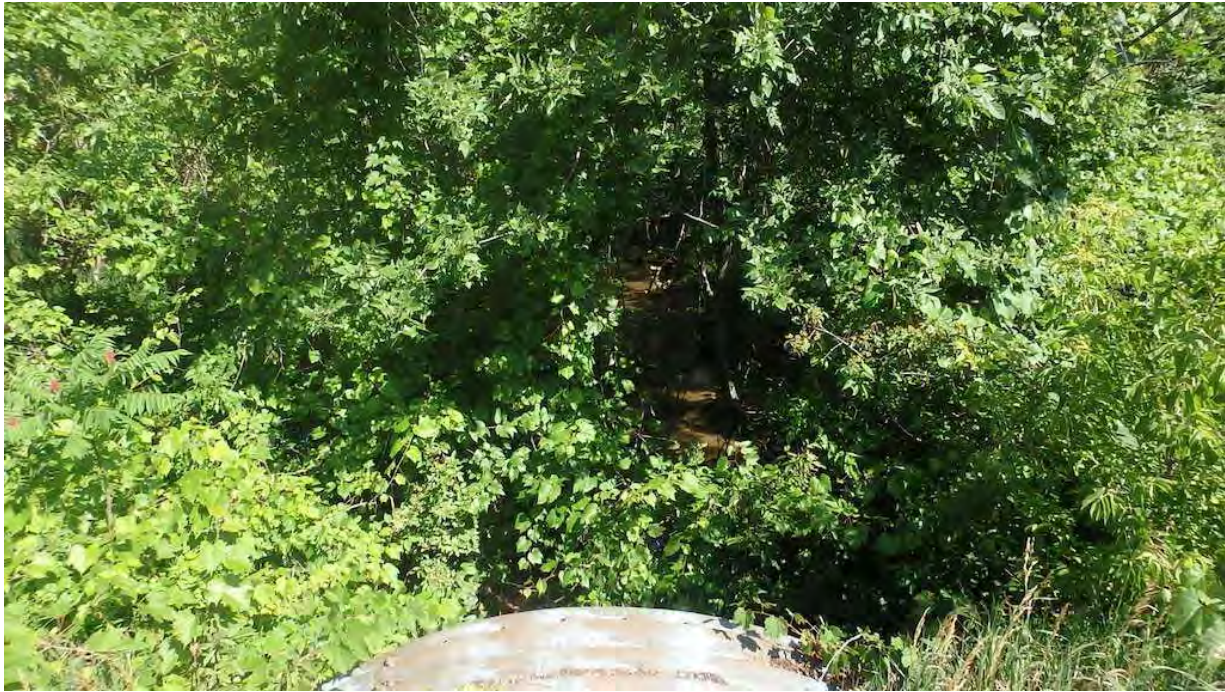
Figure 5 Upstream

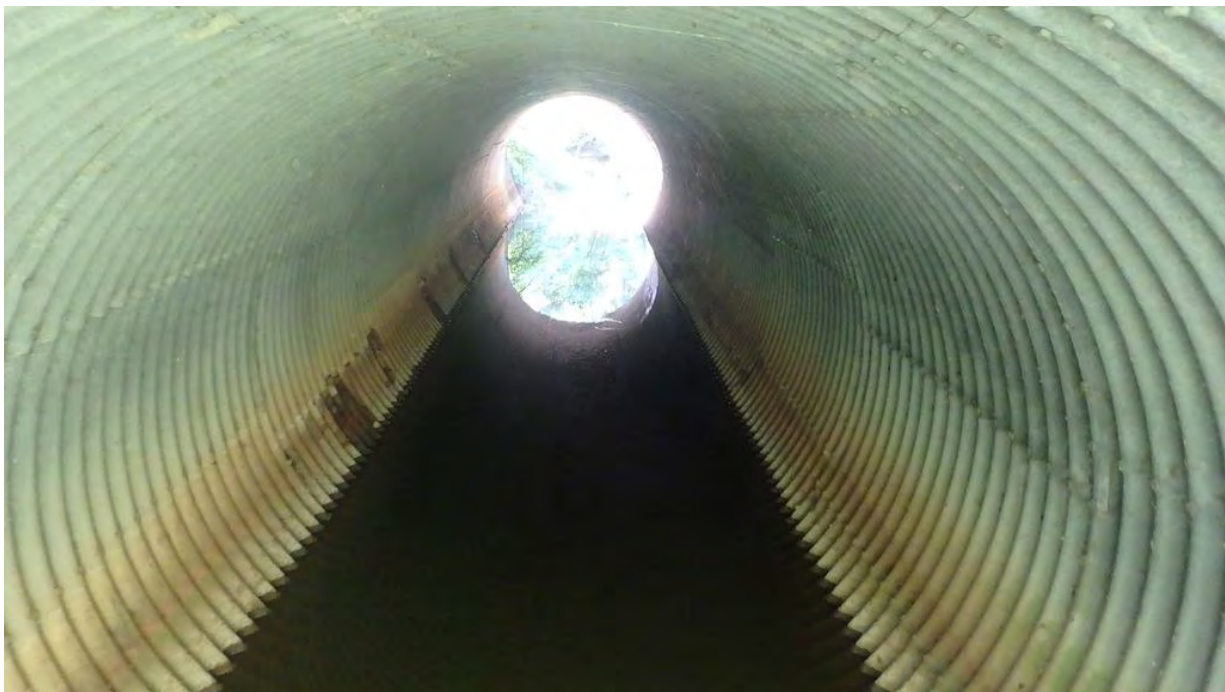
Figure 6 Barrel, Looking South

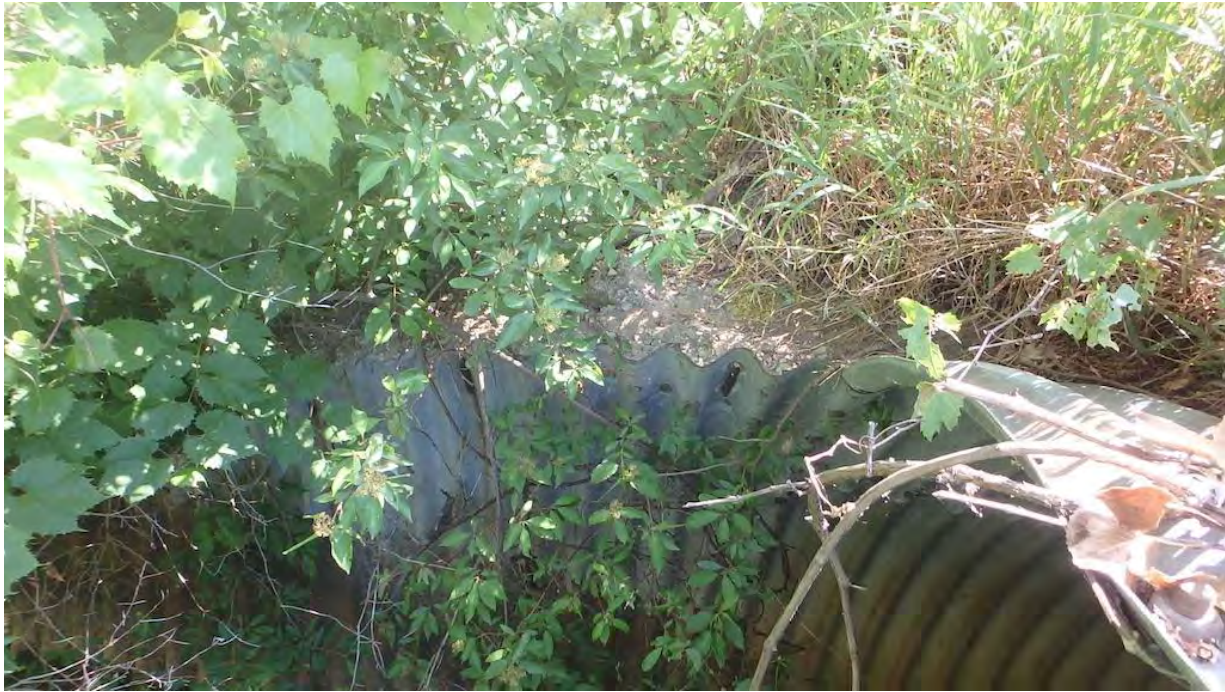
Figure 7 Northeast Wingwall

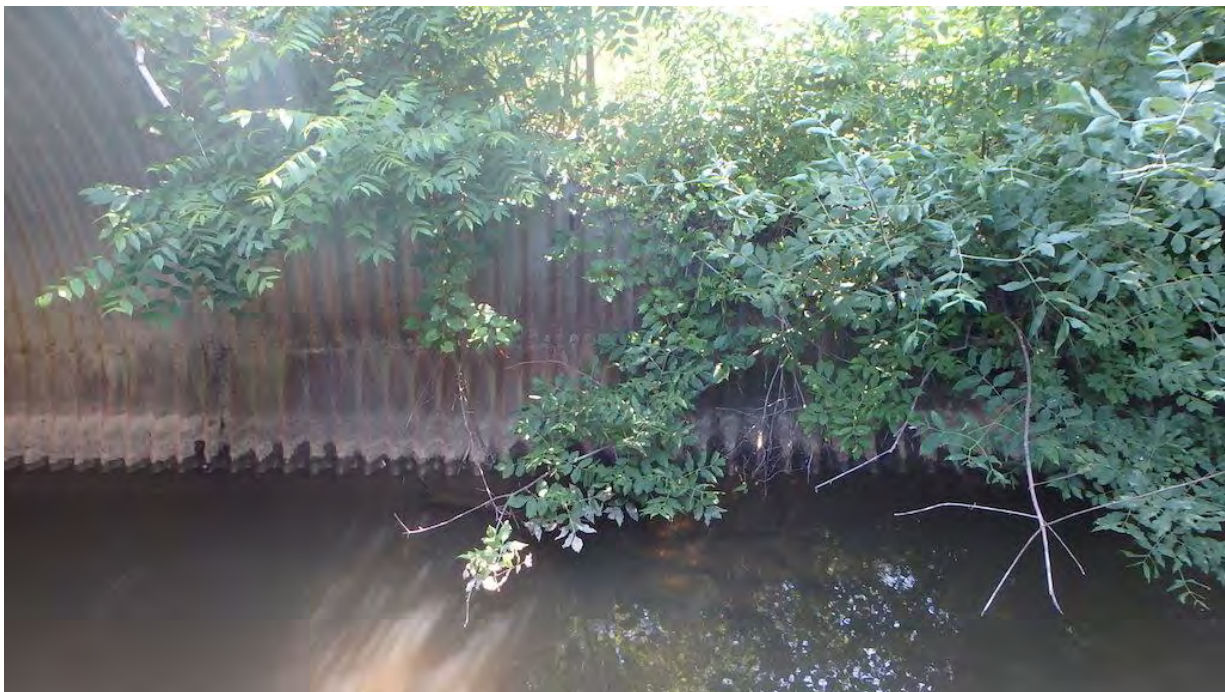
Figure 8 Southwest Wingwall

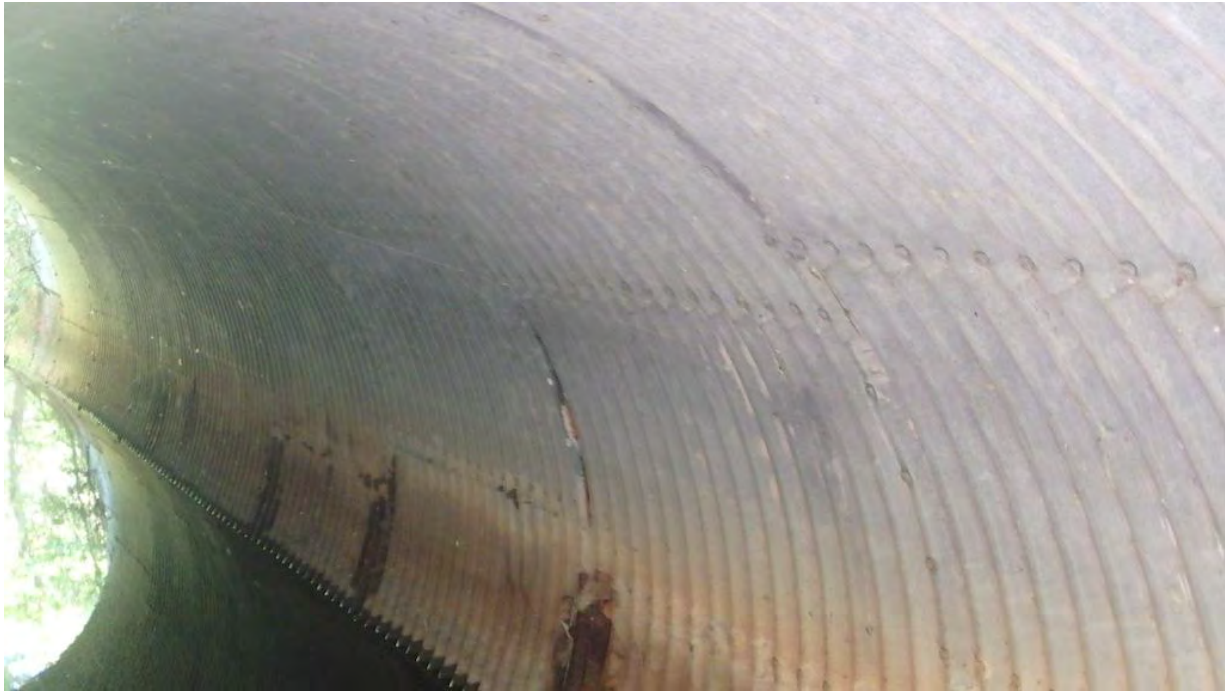
Element Group:		1200 Culverts				Length:		31
Element Name:		1203 Barrels				Width:		4
Location:						Height:		3.14
Material:						Count:		1
Element Type:						Total Quantity:		389.4 sq.m
Environment:		Severe				Limited Inspection:		
Protection System:		Unknown				Perform. Deficiencies		
Condition	Units	Exc.	Good	Fair	Poor			
Data:	sq.m	0	311.6	77.8	0			
Comments:								
Corrosion along waterline. Localized areas of moderate corrosion on barrel walls. Localized at inlet and outlet walls.								
Recommended Work:				Rehab <input type="checkbox"/>		Replace <input type="checkbox"/>		
Timing:				Urgent <input type="checkbox"/>		< 1yr <input type="checkbox"/>		
				1 - 5 yr <input type="checkbox"/>		6 - 10 yr <input type="checkbox"/>		
Maintenance Needs:								
				<input type="checkbox"/> Urgent		<input type="checkbox"/> 1 year		
						<input type="checkbox"/> 2 year

Figure 9 Areas of Corrosion and Leakage in Barrel

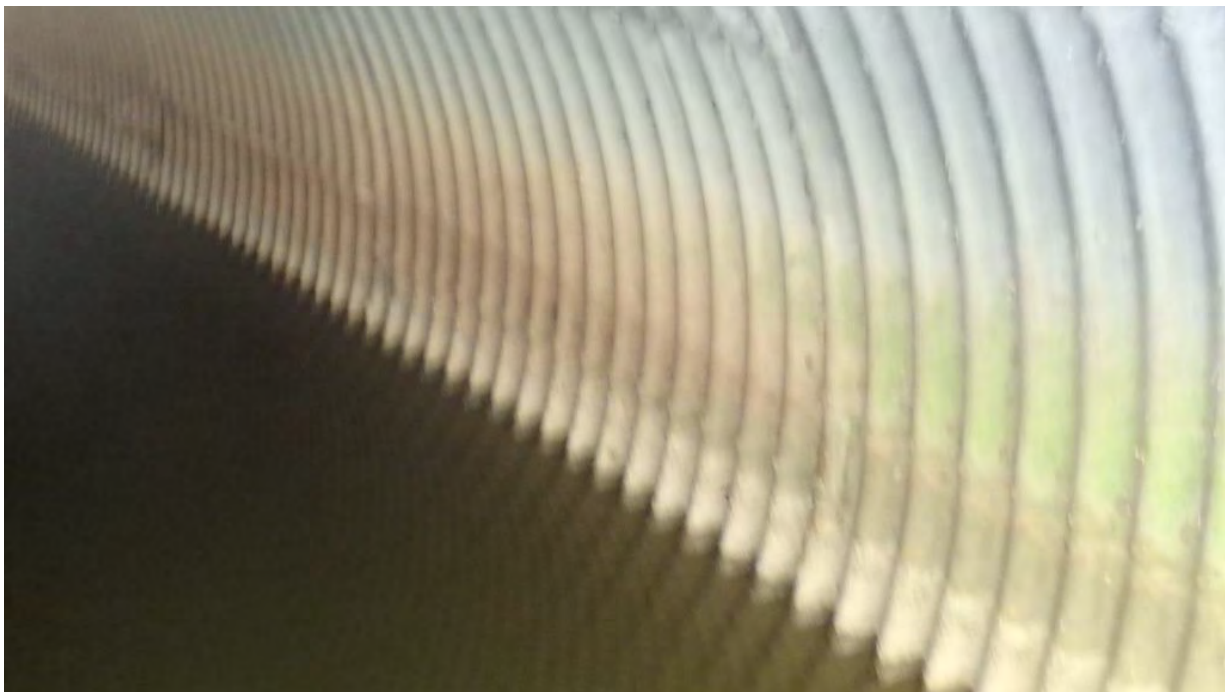
Figure 10 Corrosion at Waterline
