**TULPIN CULVERT**

Site Number 974204

**PORT ROWAN ROAD 42, SOUTH WALSINGHAM**

**Ontario Structure Inspection Manual - Inspection Form**

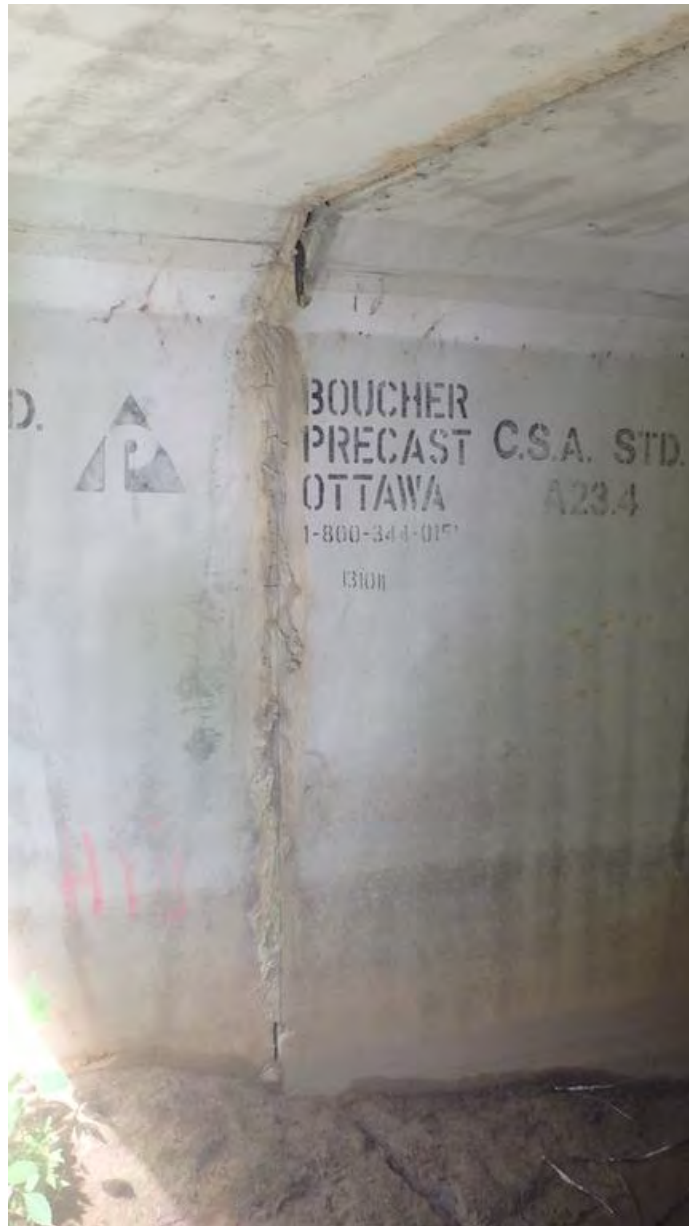
Figure 7 Seal Broken and Hanging at Corner

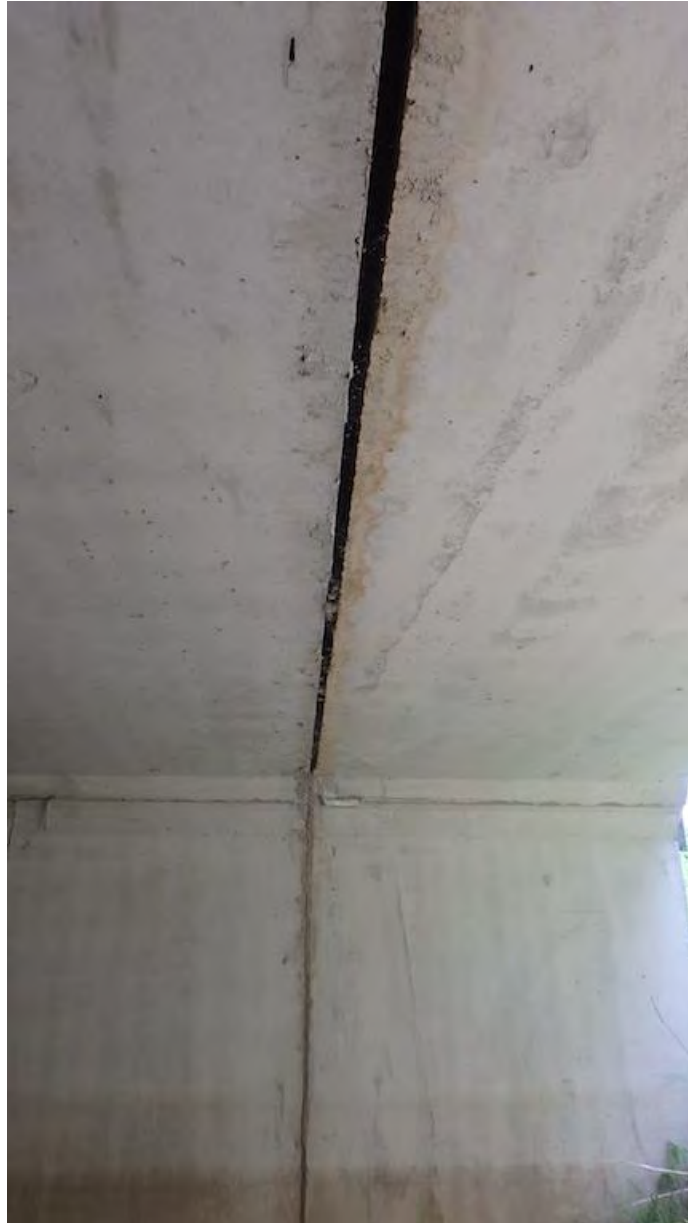
Figure 8 South Box Joint Leaking

Element Group:	1200 Culverts	Length:	5.6										
Element Name:	1202 Outlet Components	Width:	0.3										
Location:	North End	Height:	3										
Material:	4 Cast-in-place Concrete	Count:	1										
Element Type:		Total Quantity:	3.3 sq.m										
Environment:	Severe	Limited Inspection:											
Protection System:	Unknown	Perform. Deficiencies											
Condition Data:	<table border="1" style="width: 100%; border-collapse: collapse;"> <tr> <th style="width: 10%;">Units</th> <th style="width: 10%;">Exc.</th> <th style="width: 10%;">Good</th> <th style="width: 10%;">Fair</th> <th style="width: 10%;">Poor</th> </tr> <tr> <td>sq.m</td> <td>0</td> <td>3</td> <td>0.3</td> <td>0</td> </tr> </table>	Units	Exc.	Good	Fair	Poor	sq.m	0	3	0.3	0		
Units	Exc.	Good	Fair	Poor									
sq.m	0	3	0.3	0									
Comments: Box joint at outlet is wide & leaking. Parging has failed. Seal is broken & hanging at SW corner of joint.													
Recommended Work:    Rehab <input type="checkbox"/> Replace <input type="checkbox"/> Timing:    Urgent <input type="checkbox"/> < 1yr <input type="checkbox"/> 1 - 5 yr <input type="checkbox"/> 6 - 10 yr <input type="checkbox"/>		Maintenance Needs:    Other - Seal Joint <input type="checkbox"/> Urgent <input type="checkbox"/> 1 year <input checked="" type="checkbox"/> 2 year

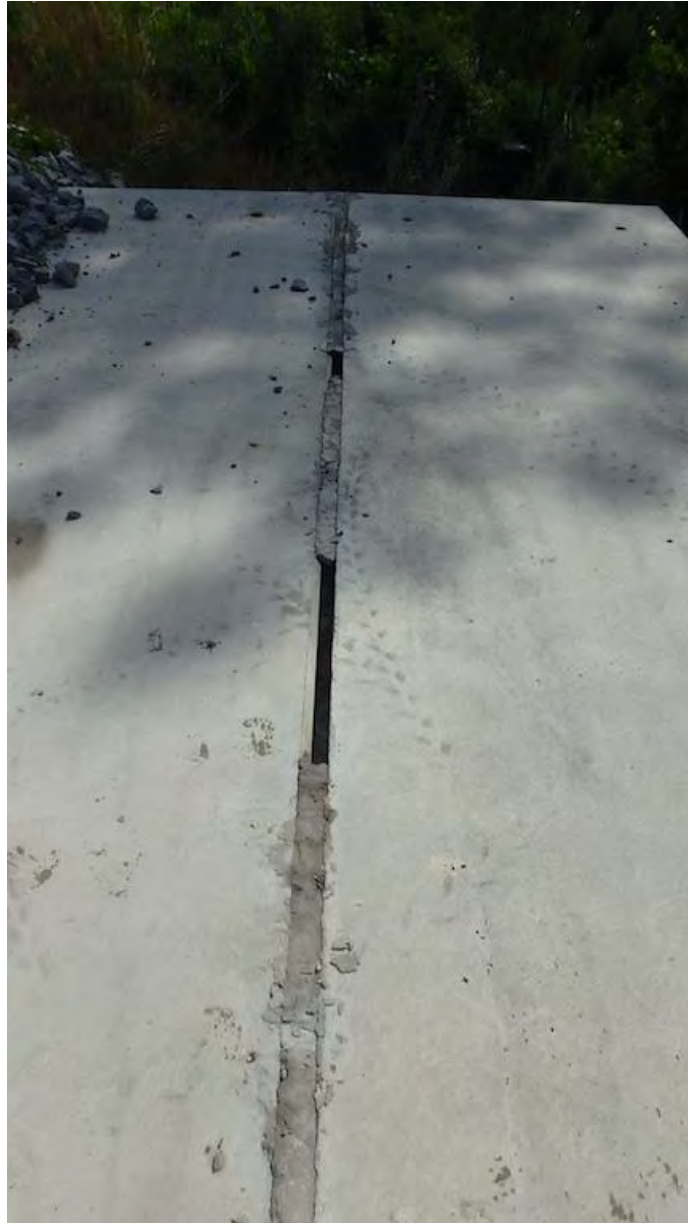
Figure 9 Wide Box Joint at South, Parging Failing and Leaking

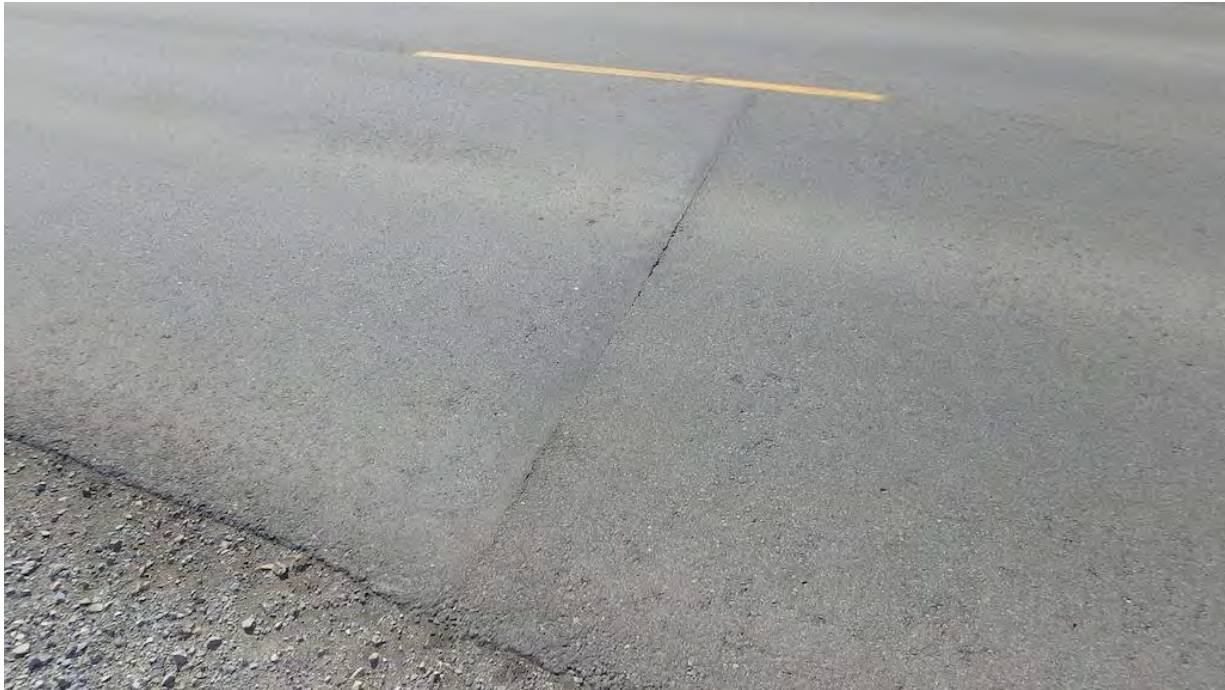
Figure 10 Transverse Crack in Wearing Surface

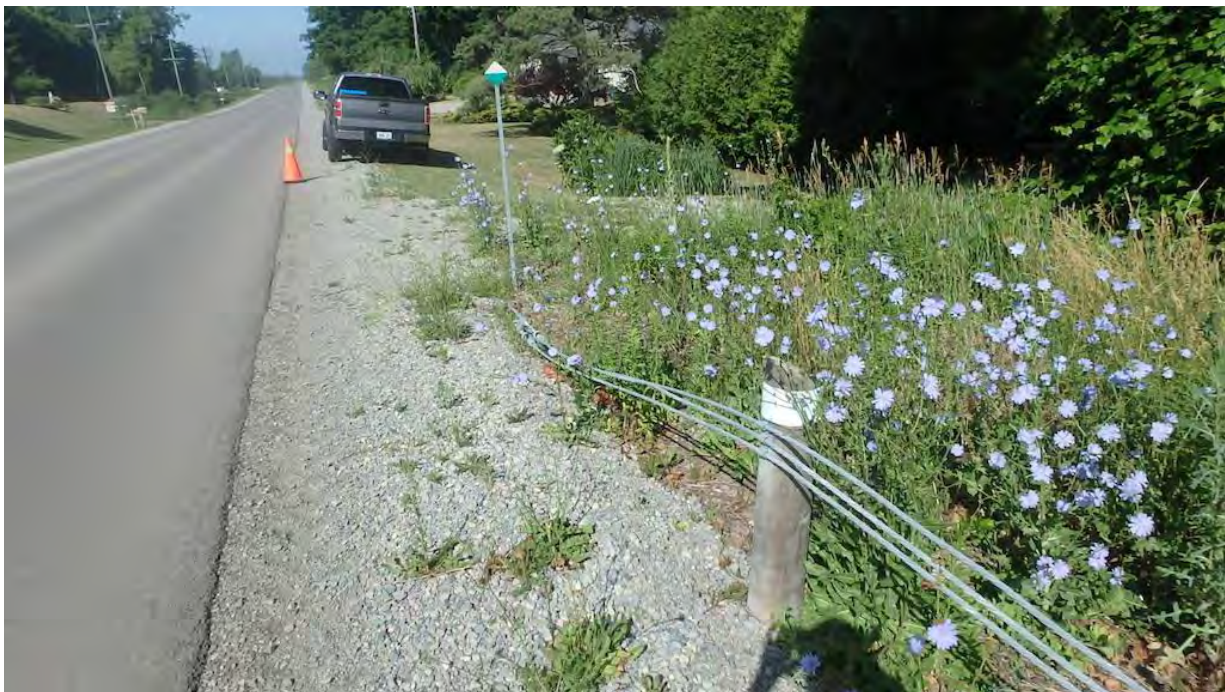
Overall Structure Notes:	
Recommended Work on Structure:	<input type="checkbox"/> None <input type="checkbox"/> Minor Rehab. <input type="checkbox"/> Replace <input checked="" type="checkbox"/> Maintenance <input type="checkbox"/> Major Rehab.
Timing of Recommended Work:	<input type="checkbox"/> 1 to 5 years <input type="checkbox"/> 6 to 10 years
Overall Comments:	Structure replaced fall 2013. Guiderail cables loose.
Date of next Inspection:	July 5, 2018

Figure 11 Loose Guiderail Cables
