WILBUR SMITH CULVERT

Site Number 974205

PORT ROWAN ROAD 42, SOUTH WALSINGHAM

Ontario Structure Inspection Manual - Inspection Form

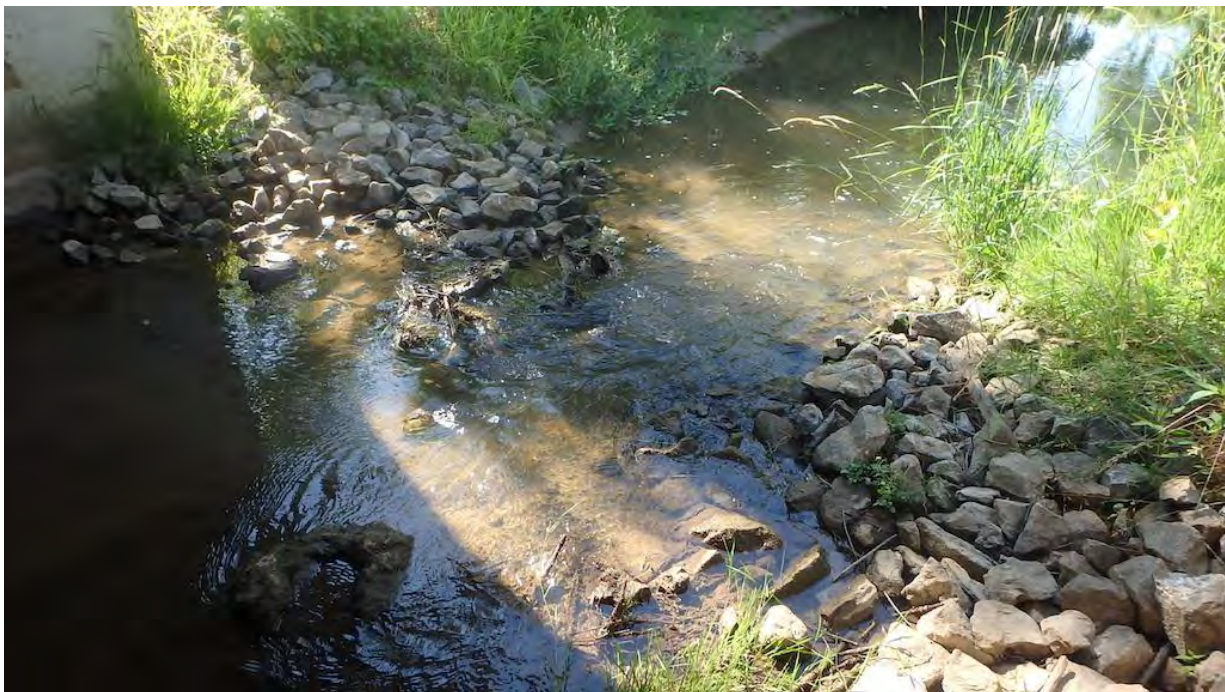
Figure 6 Riprap Build Up at Outlet

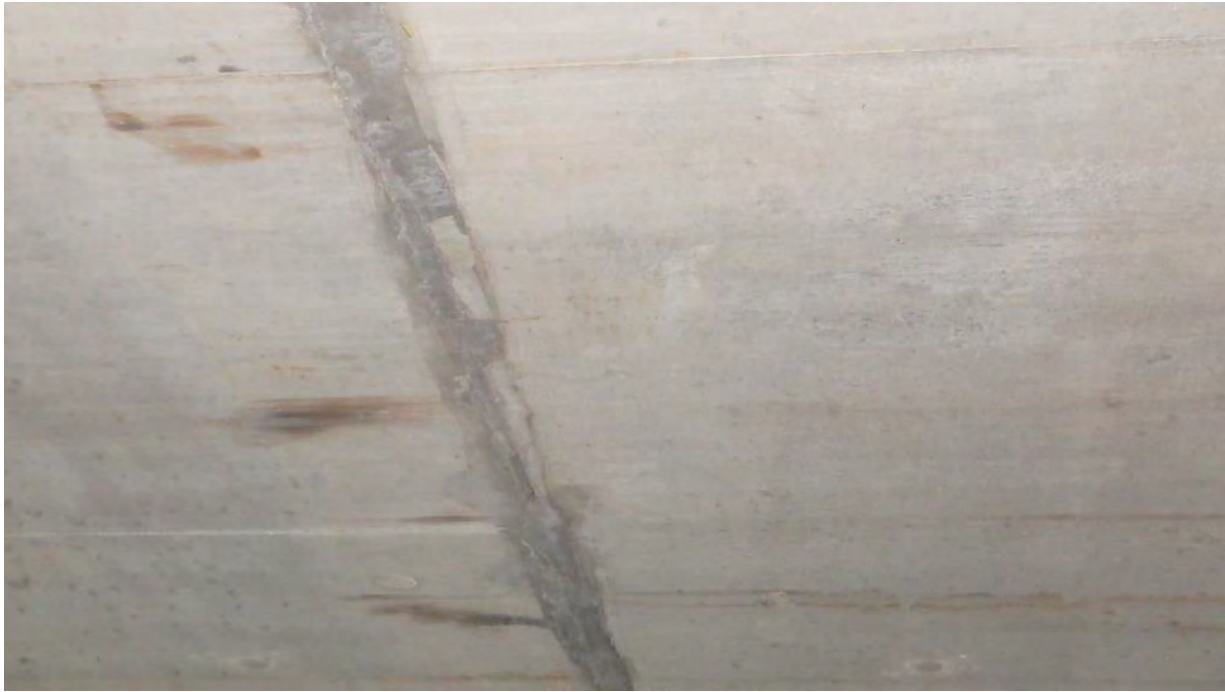
Figure 9 Parging Failing at Interior Joints

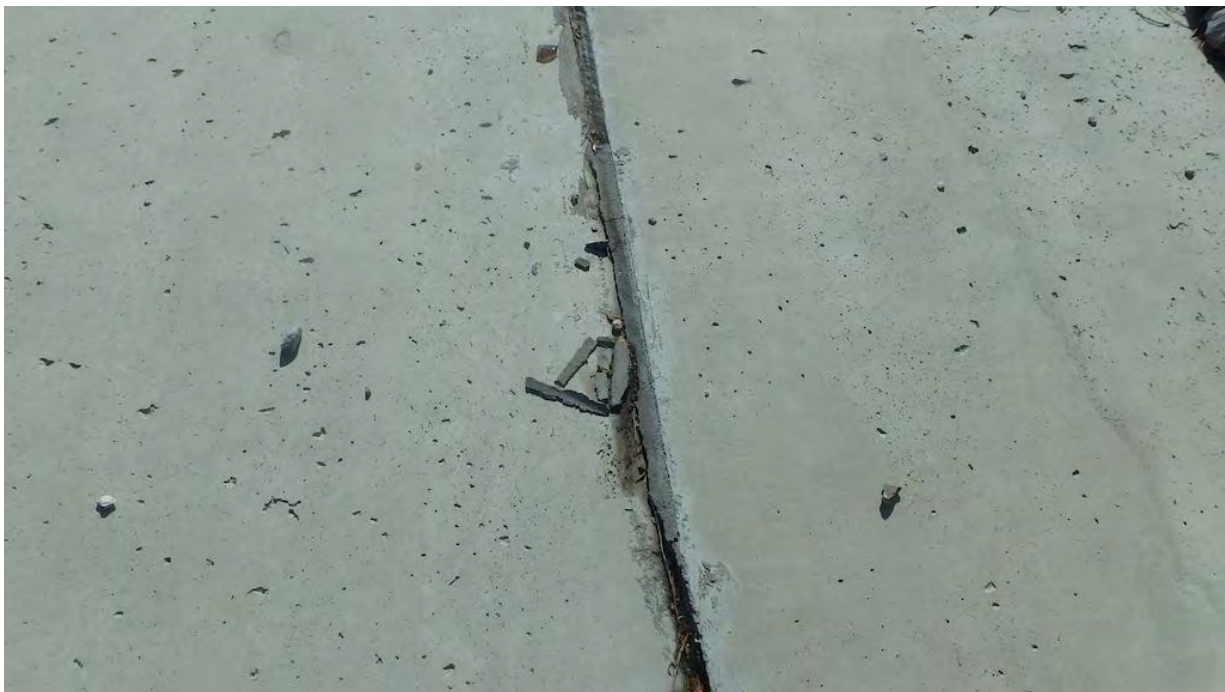
Figure 10 Parging Failing at Joints
