PINE GROVE LAKE CULVERT

Site Number 974601

COUNTY ROAD 46 (GILBERTSVILLE), MIDDLETON

Ontario Structure Inspection Manual - Inspection Form

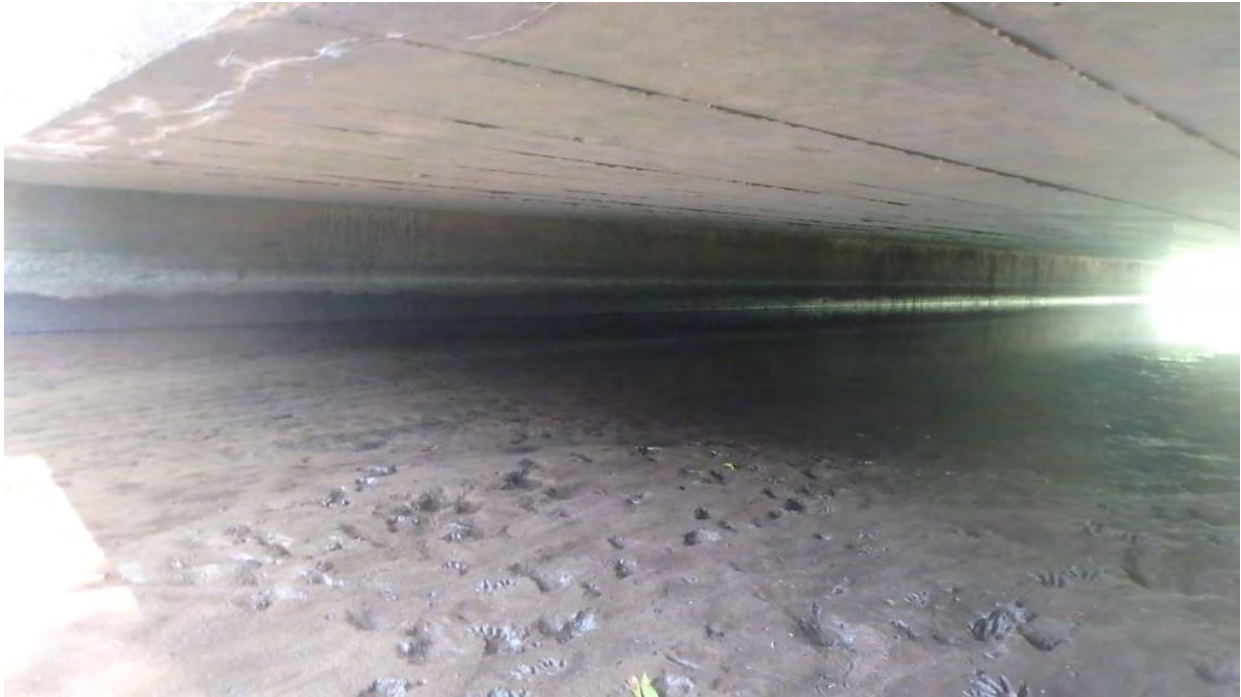
Figure 8 Soffit and North End, Note Amount of Fill

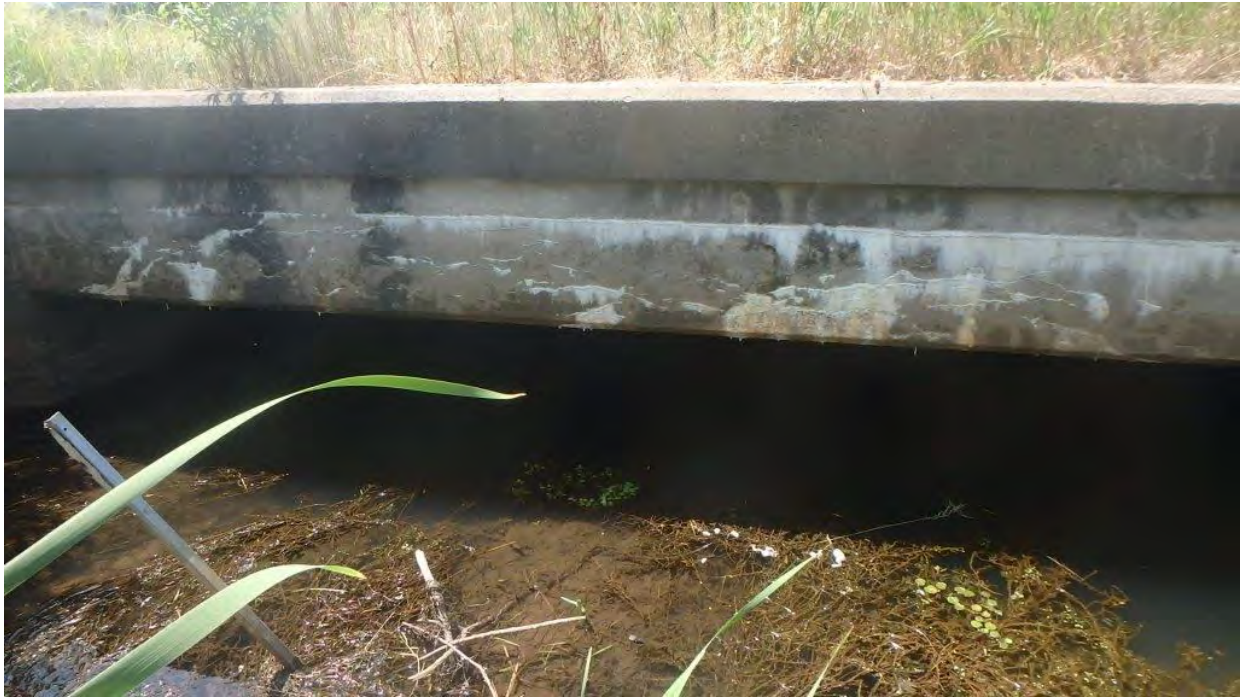
Figure 9 Hairline Cracking and Efflorescence at East

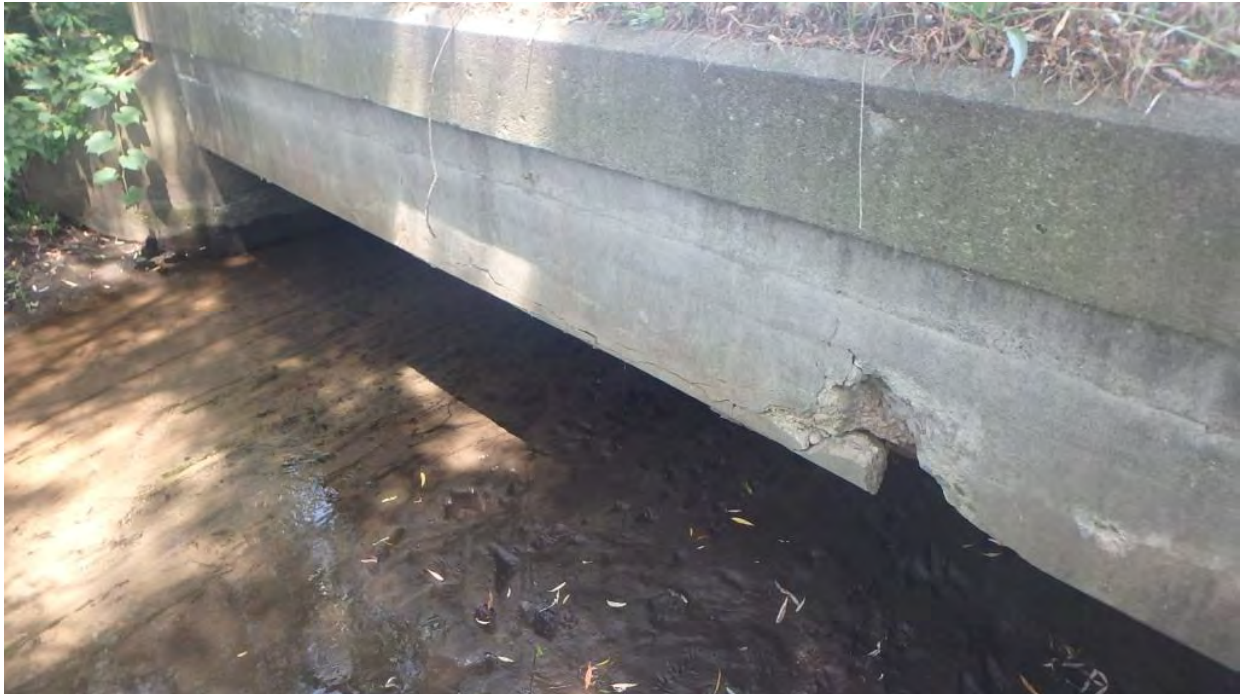
Figure 10 Crack and Spall at West End

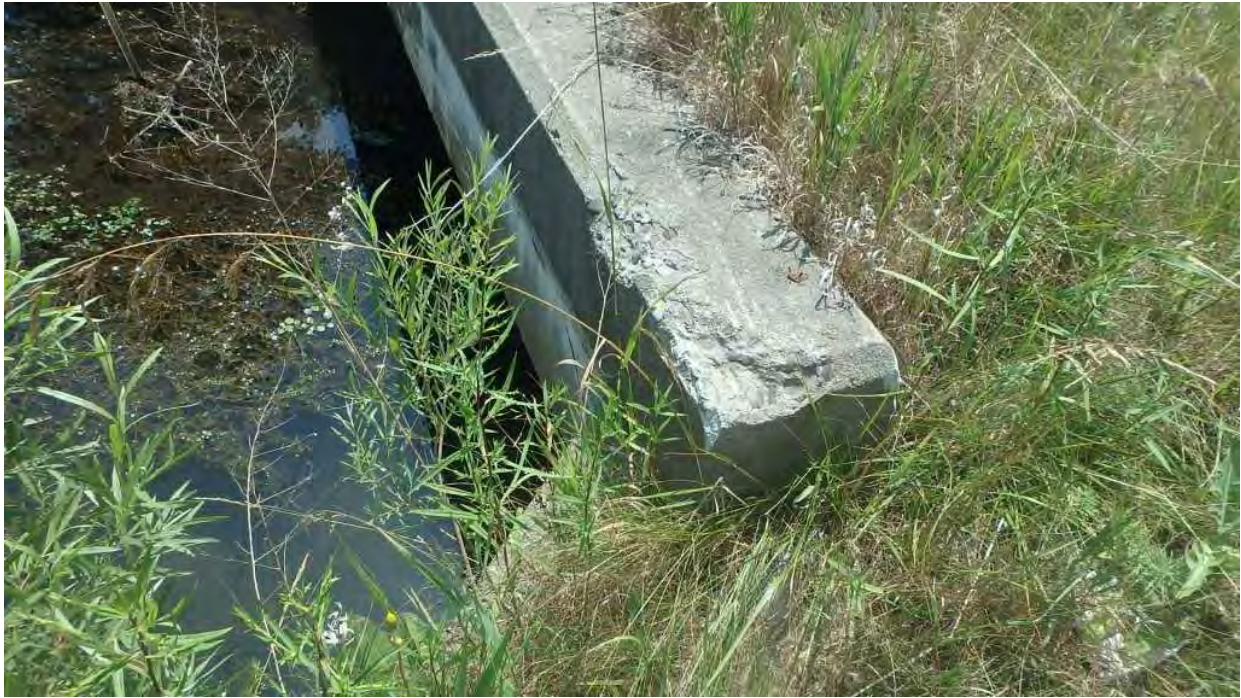
Figure 11 Impact Damage at NE Quadrant
