LITTLE OTTER CREEK CULVERT

Site Number 975901

HIGHWAY 59, MIDDLETON

Ontario Structure Inspection Manual - Inspection Form

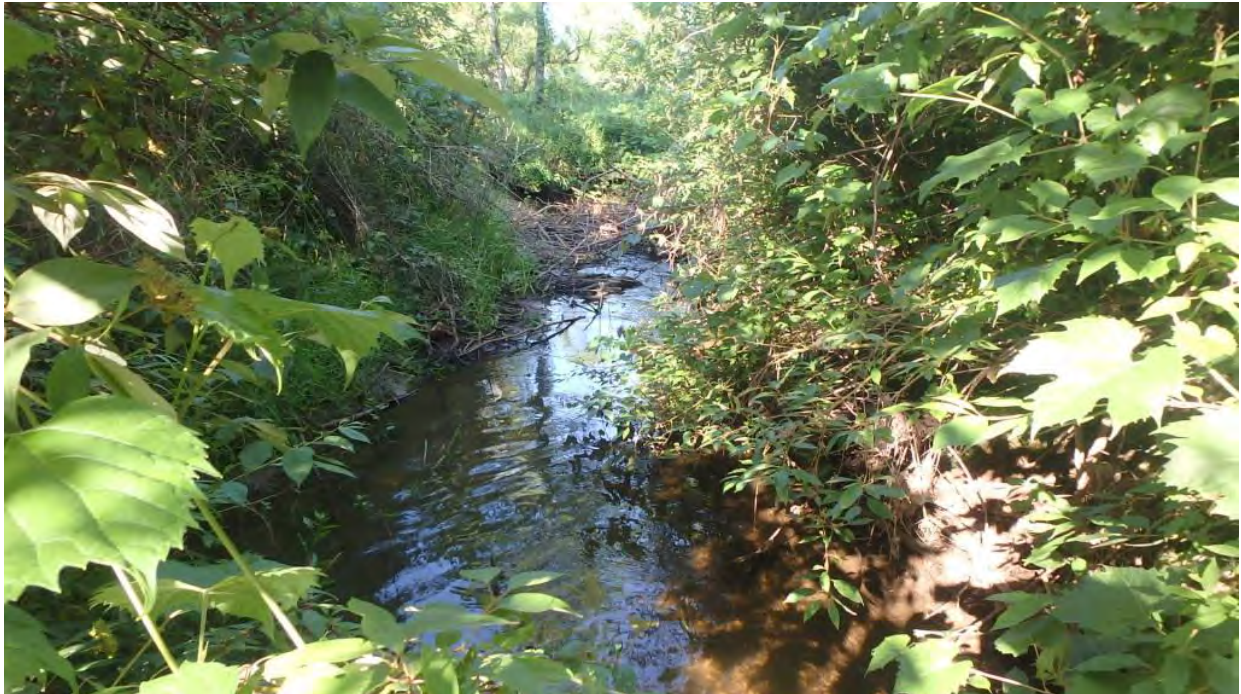
Figure 6 Downstream, Note Blockage at Downstream End

Element Group:	1400 Embankments & Streams	Length:											
Element Name:	1401 Streams and Waterways	Width:											
Location:		Height:											
Material:		Count:	1										
Element Type:		Total Quantity:	1										
Environment:		Limited Inspection:											
Protection System:	None	Perform. Deficiencies											
Condition Data:	<table border="1" style="width: 100%; border-collapse: collapse;"> <tr> <th style="width: 10%;">Units</th> <th style="width: 10%;">Exc.</th> <th style="width: 10%;">Good</th> <th style="width: 10%;">Fair</th> <th style="width: 10%;">Poor</th> </tr> <tr> <td></td> <td></td> <td></td> <td></td> <td></td> </tr> </table>	Units	Exc.	Good	Fair	Poor							
Units	Exc.	Good	Fair	Poor									
Comments:													
Bank is stable. Downstream end has debris blockage.													
Recommended Work:		Maintenance Needs:											
Rehab <input type="checkbox"/> Replace <input type="checkbox"/> Timing: Urgent <input type="checkbox"/> < 1yr <input type="checkbox"/> 1 - 5 yr <input type="checkbox"/> 6 - 10 yr <input type="checkbox"/>		Clear debris <input type="checkbox"/> Urgent <input checked="" type="checkbox"/> 1 year <input type="checkbox"/> 2 year

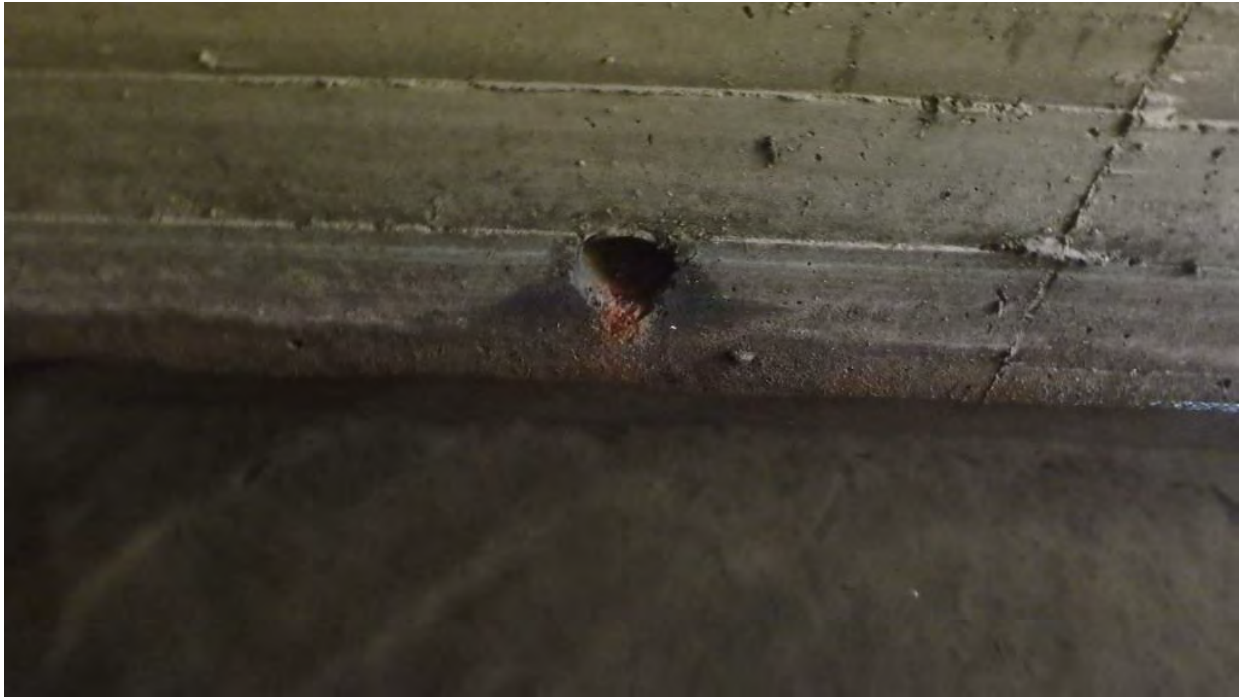
Figure 7 Staining and Scaling at Drains

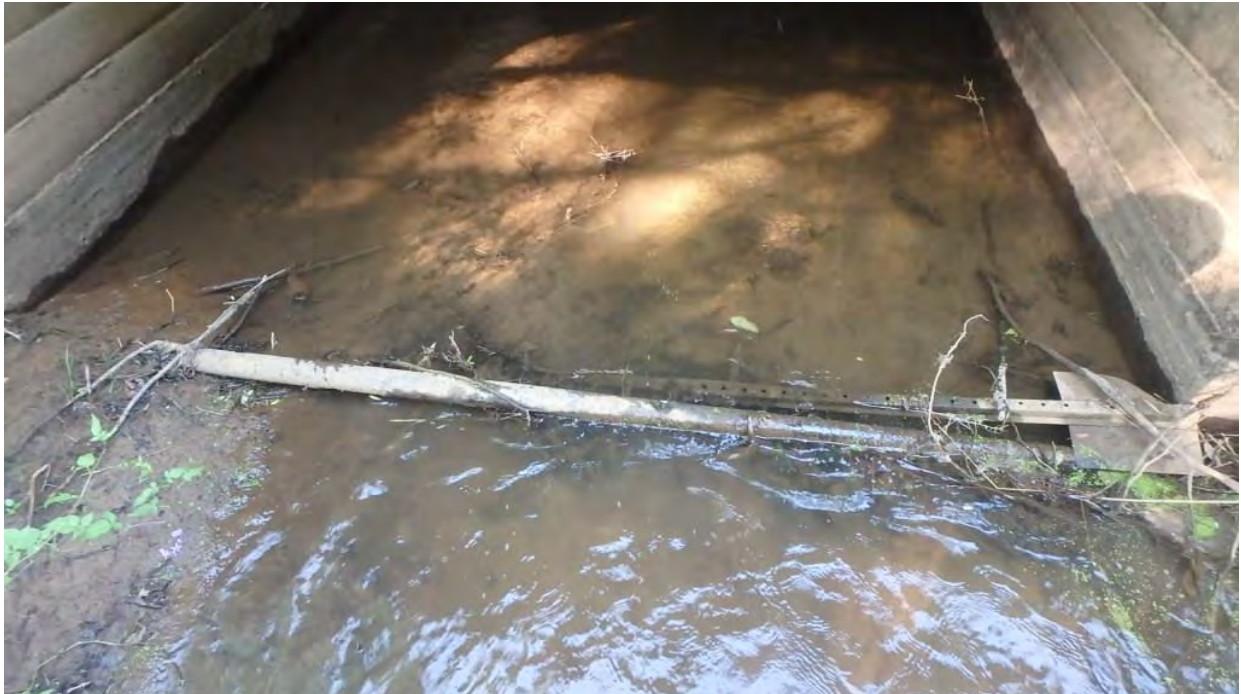
Overall Structure Notes:	
Recommended Work on Structure:	<input type="checkbox"/> None <input type="checkbox"/> Minor Rehab. <input type="checkbox"/> Replace <input checked="" type="checkbox"/> Maintenance <input type="checkbox"/> Major Rehab.
Timing of Recommended Work:	<input type="checkbox"/> 1 to 5 years <input type="checkbox"/> 6 to 10 years
Overall Comments:	No municipal drain - gas pipe exposed on East end.
Date of next Inspection:	July 21, 2018

Figure 8 Gas Line at Inlet

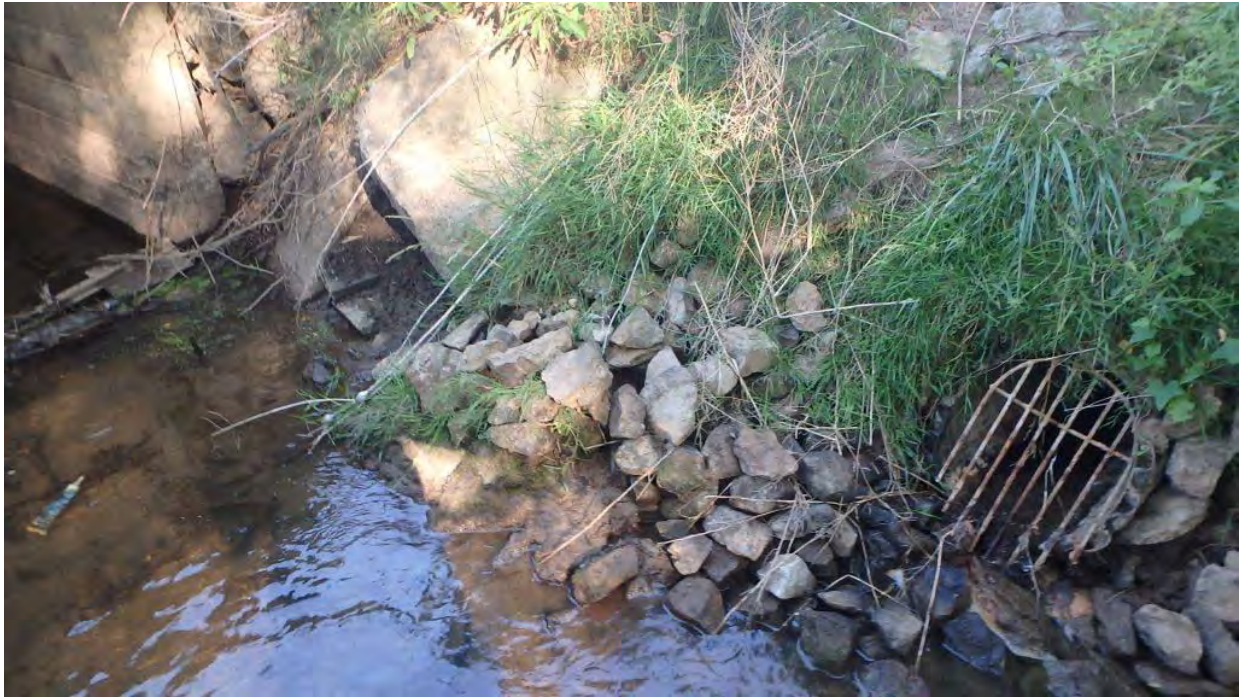
Figure 9 Drain Outlet at Northeast Quadrant

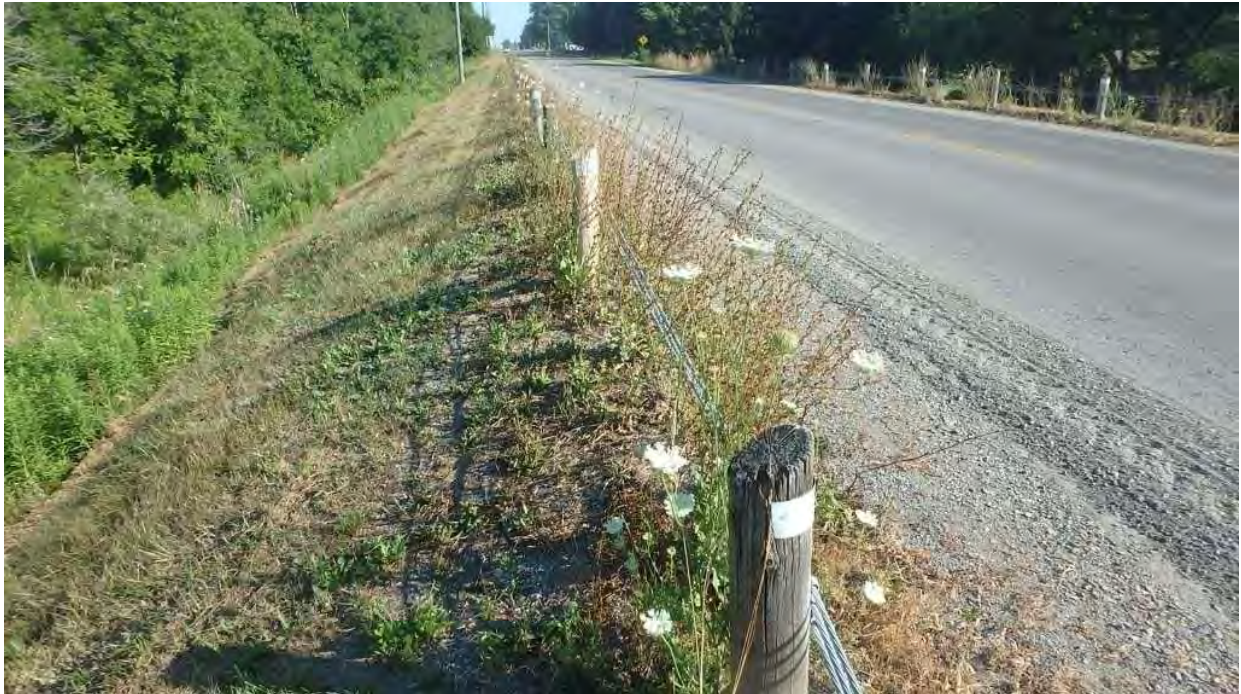
Figure 10 Three-Cable Guiderail

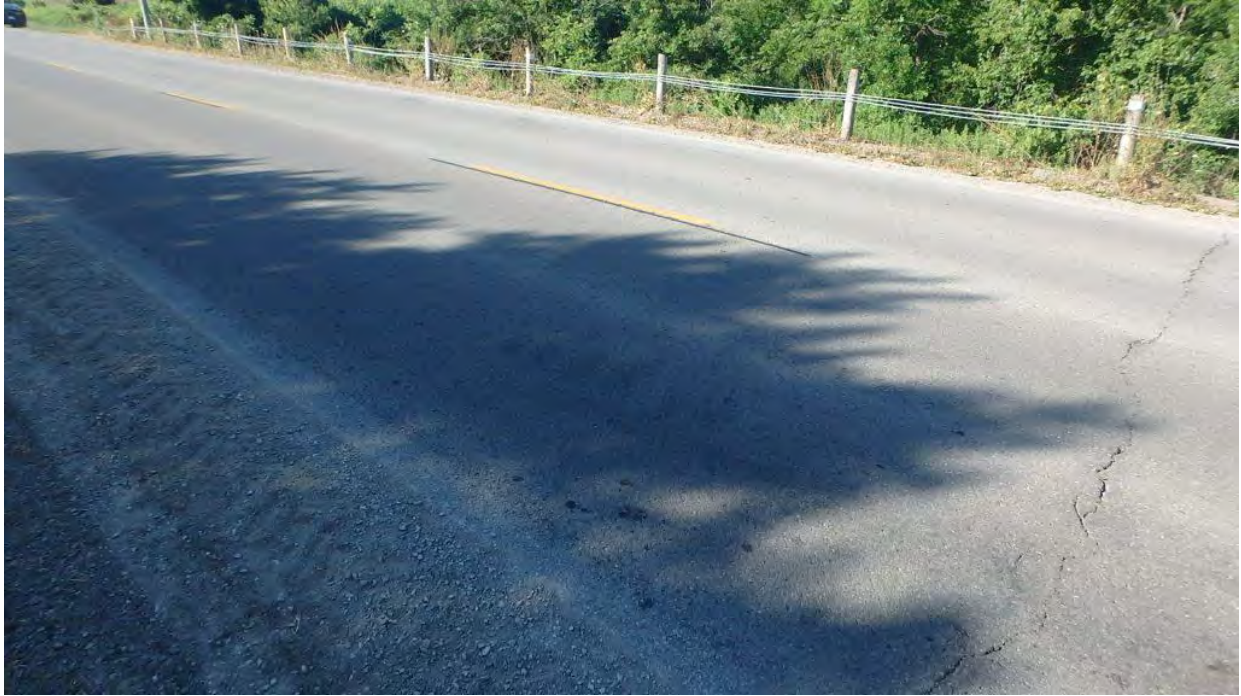
Figure 11 Asphalt Wearing Surface
