**TOWNSEND CENTRE BRIDGE**

Site Number 980502

**COUNTY ROAD 5 (COCKSHUTT), TOWNSEND**

**Ontario Structure Inspection Manual - Inspection Form**

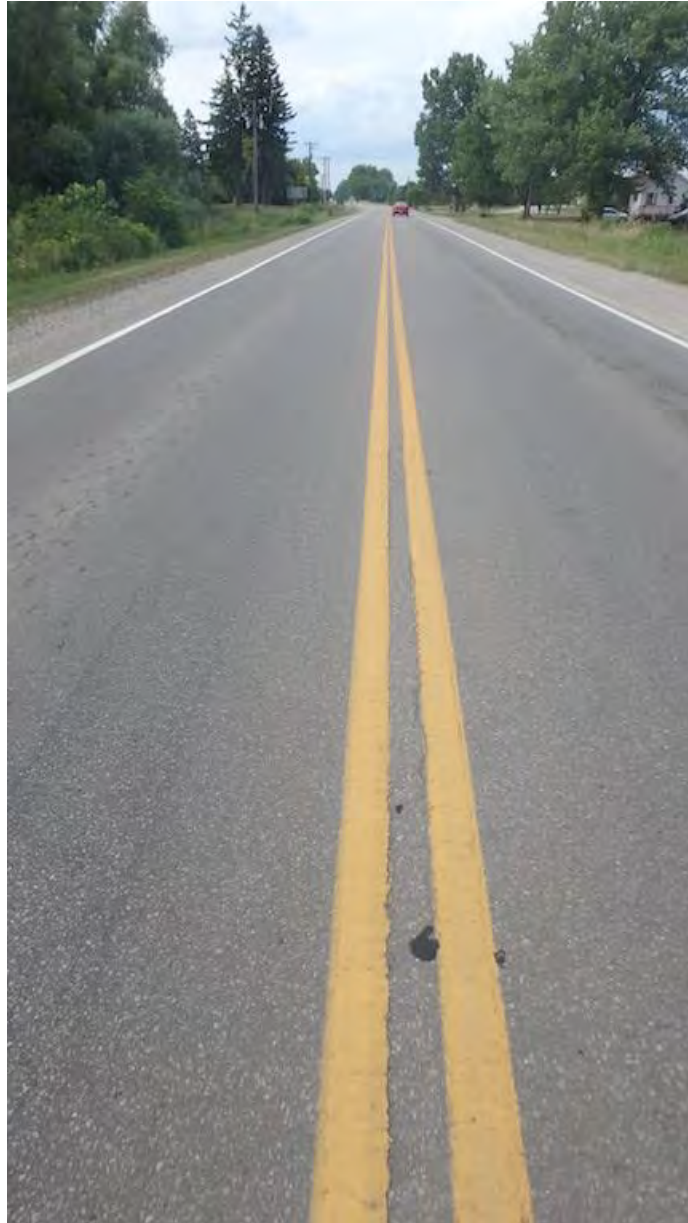
Element Group:	100 Decks					Length:	14.4
Element Name:	101 Wearing Surface					Width:	18.2
Location:	Top of Deck					Height:	
Material:	2 Asphalt					Count:	1
Element Type:						Total Quantity:	262.1 sq.m
Environment:	Severe					Limited Inspection:	
Protection System:	Unknown					Perform. Deficiencies	
Condition Data:	Units sq.m	Exc. 0	Good 0	Fair 262.1	Poor 0		
Comments: 1-5 years new surface required. Asphalt requires rout and seal and patch at various location on approaches. No drains. New surface scheduled for 2016.							
Recommended Work: Rehab <input type="checkbox"/> Replace <input checked="" type="checkbox"/>					Maintenance Needs:		
Timing: Urgent <input type="checkbox"/> < 1yr <input type="checkbox"/> 1 - 5 yr <input checked="" type="checkbox"/> 6 - 10 yr <input type="checkbox"/>					<input type="checkbox"/> Urgent <input type="checkbox"/> 1 year <input type="checkbox"/> 2 year

Figure 9 Small Longitudinal Cracks in Wearing Surface at Centreline

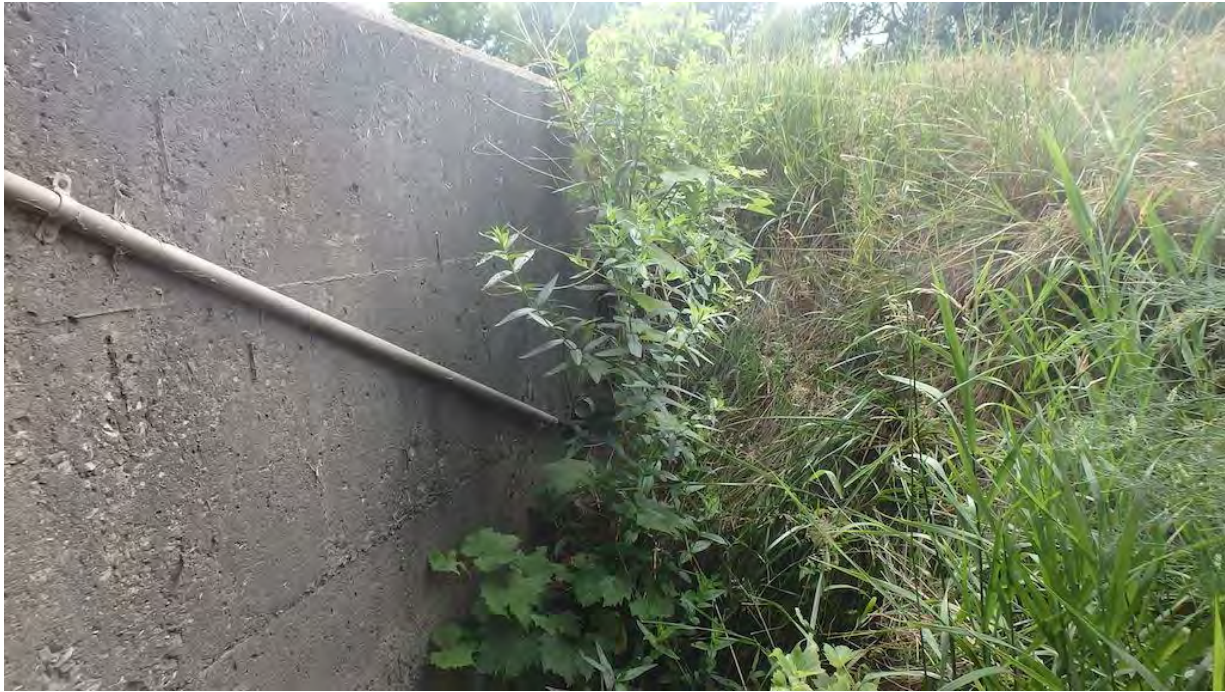
Figure 10 Minor Erosion at Northeast Quadrant
