**BOWEN STRUCTURE**

Site Number 981902

**COUNTY ROAD 19, TOWNSEND**

**Ontario Structure Inspection Manual - Inspection Form**

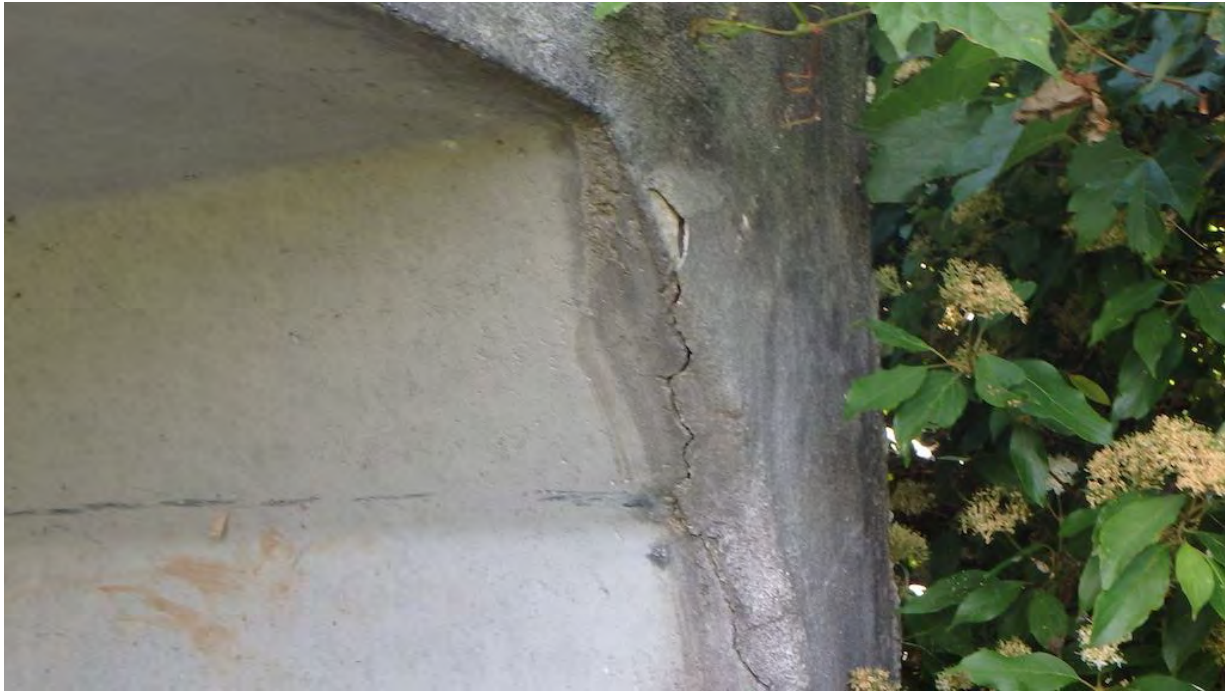
Figure 9 Light Delamination at Northwest Quadrant

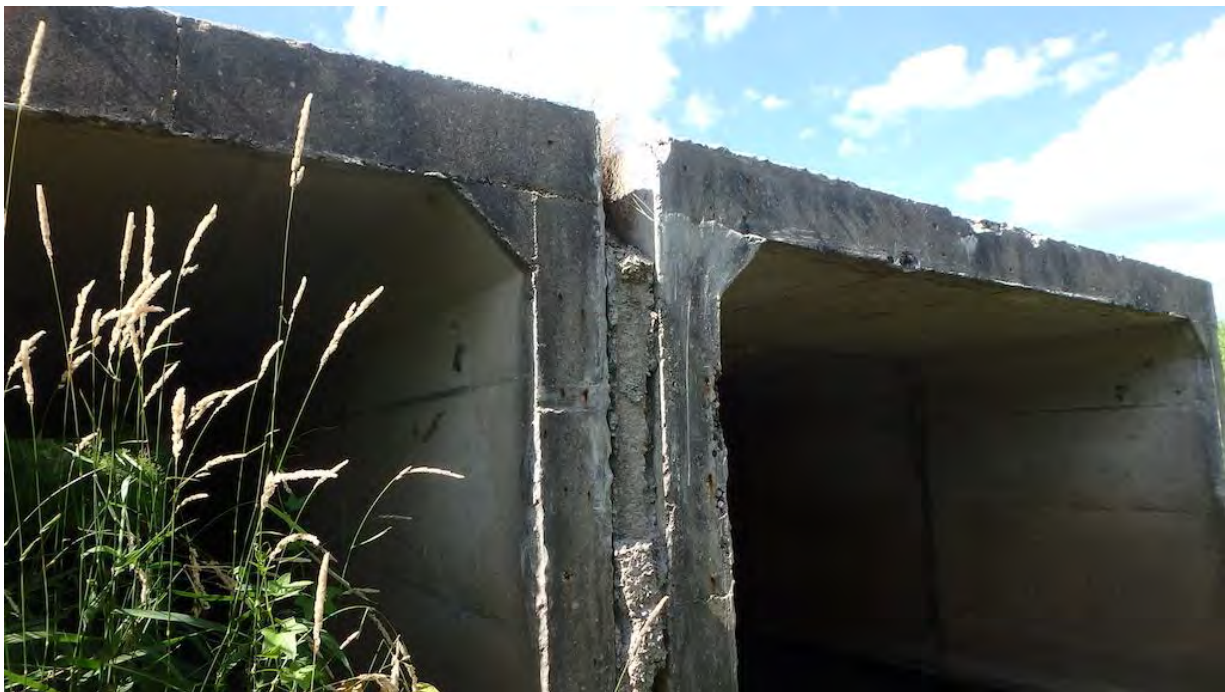
Figure 10 Separation of Parging Between Culvert at South Side

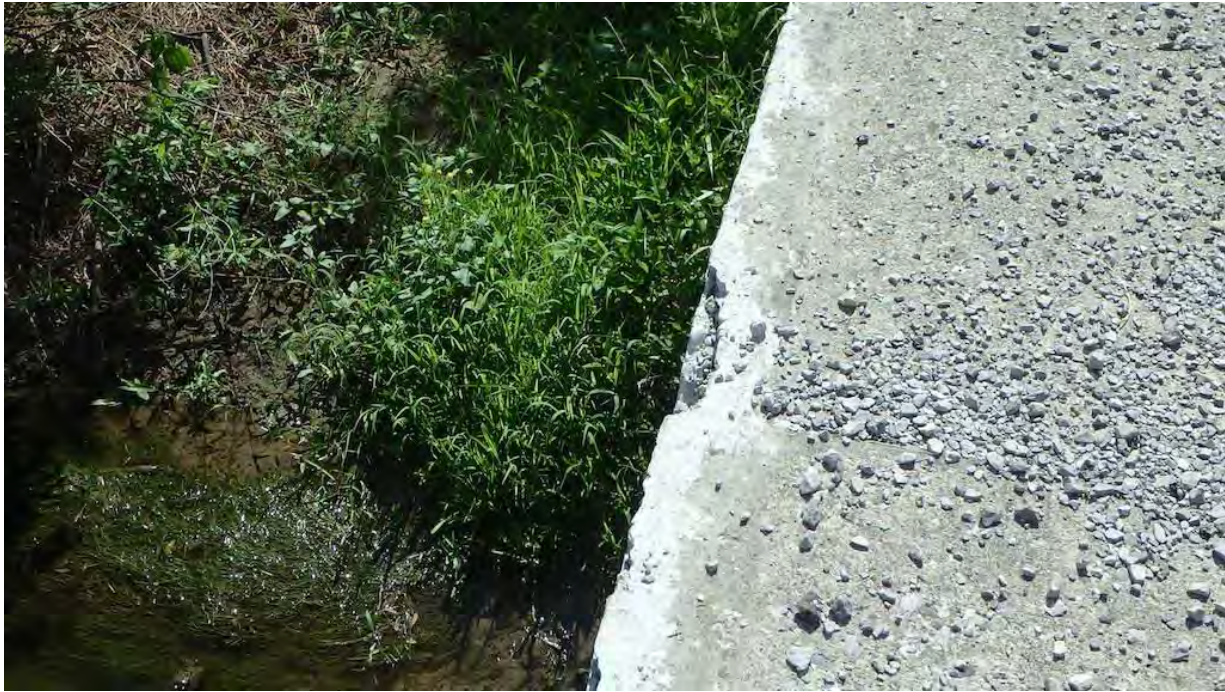
Figure 11 Small Spall at South Culvert

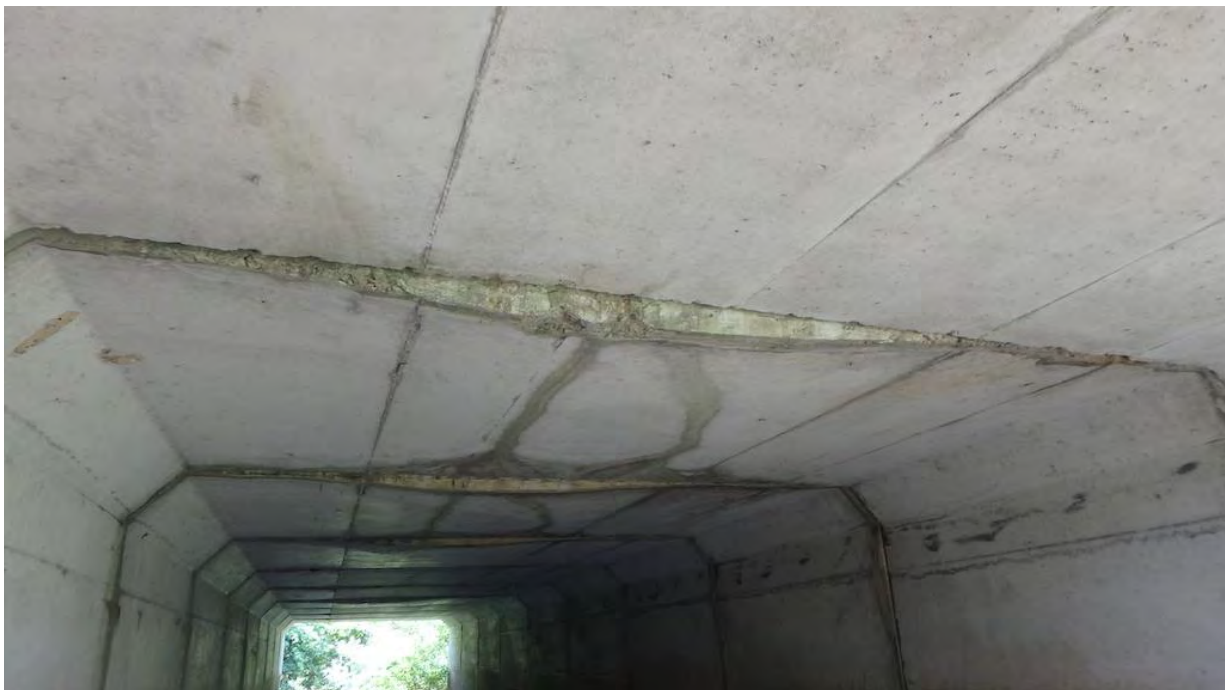
Figure 12 Typical Leakage at Precast Joints
