**SANDERS DRIVEWAY**

Site Number 981905

**COUNTY ROAD 19, TOWNSEND**

**Ontario Structure Inspection Manual - Inspection Form**

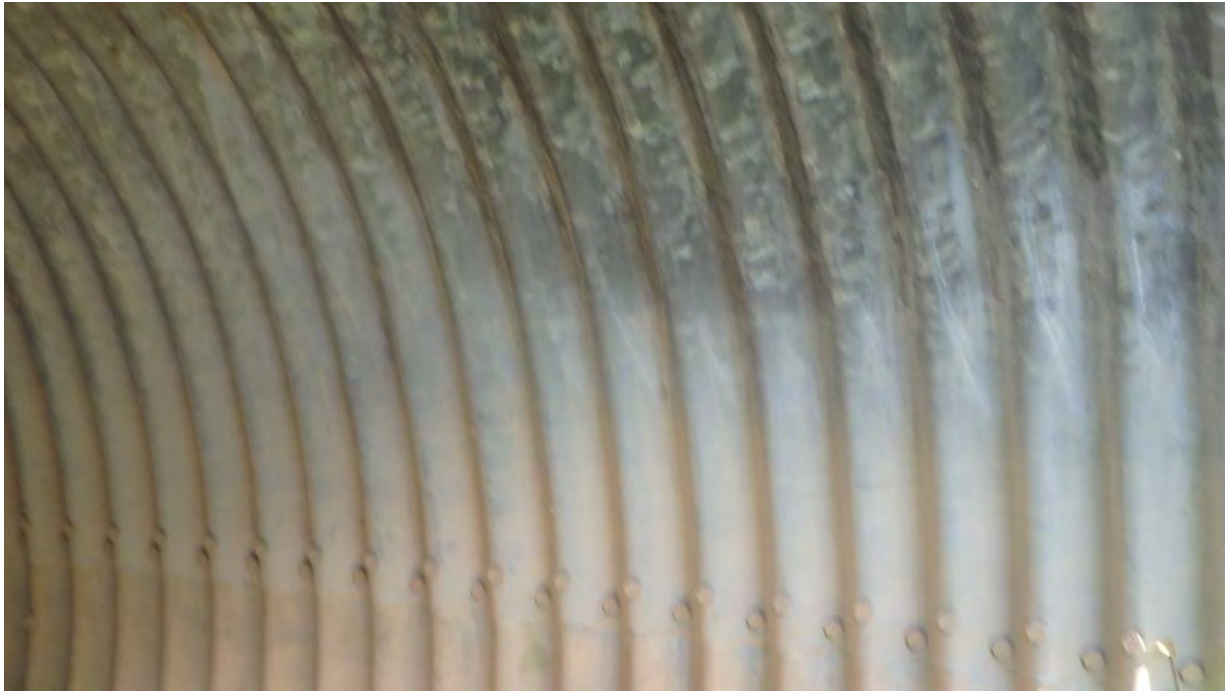
Figure 9 Minor Corrosion at Waterline

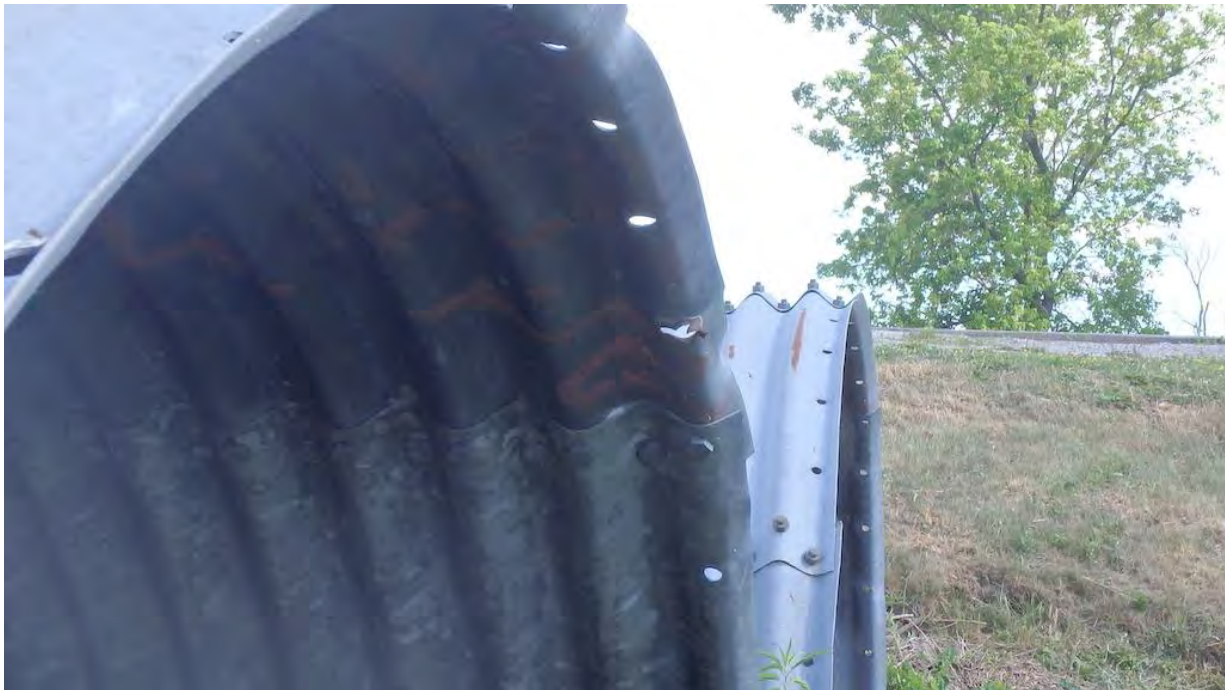
Figure 10 Minor Installation Damage
