**VEZSENYI DRIVEWAY**

Site Number 981906

**COUNTY ROAD 19, TOWNSEND**

**Ontario Structure Inspection Manual - Inspection Form**

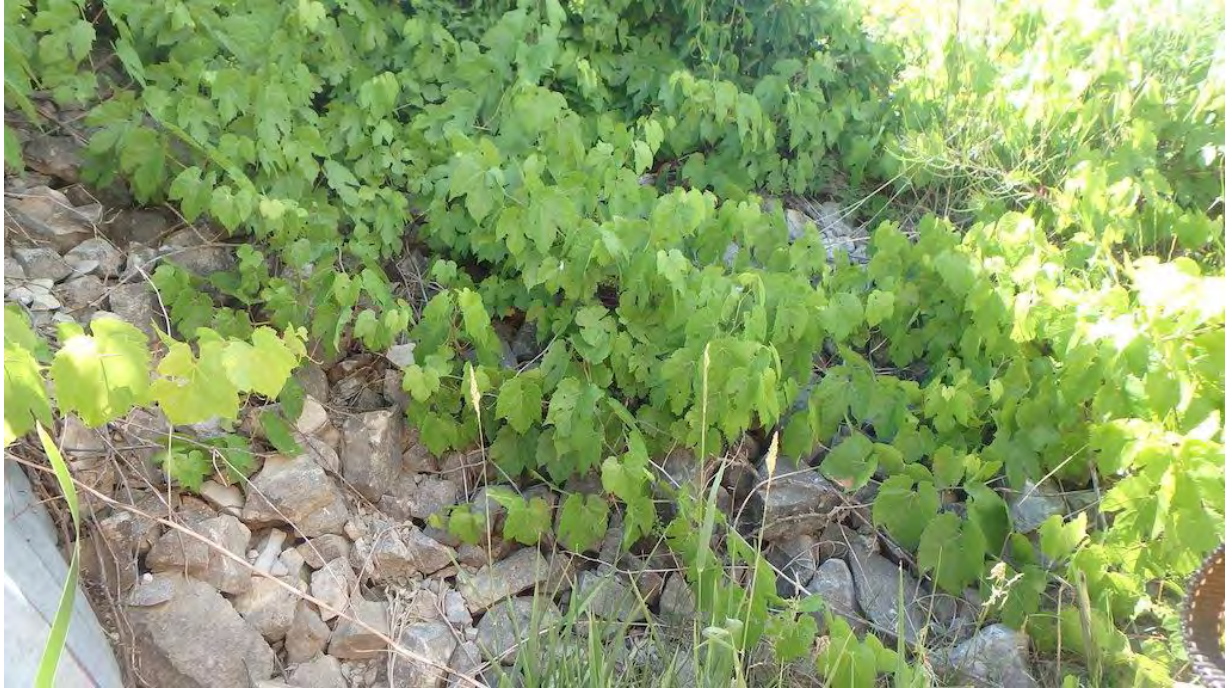
Figure 9 Minor Erosion at Northeast Quadrant

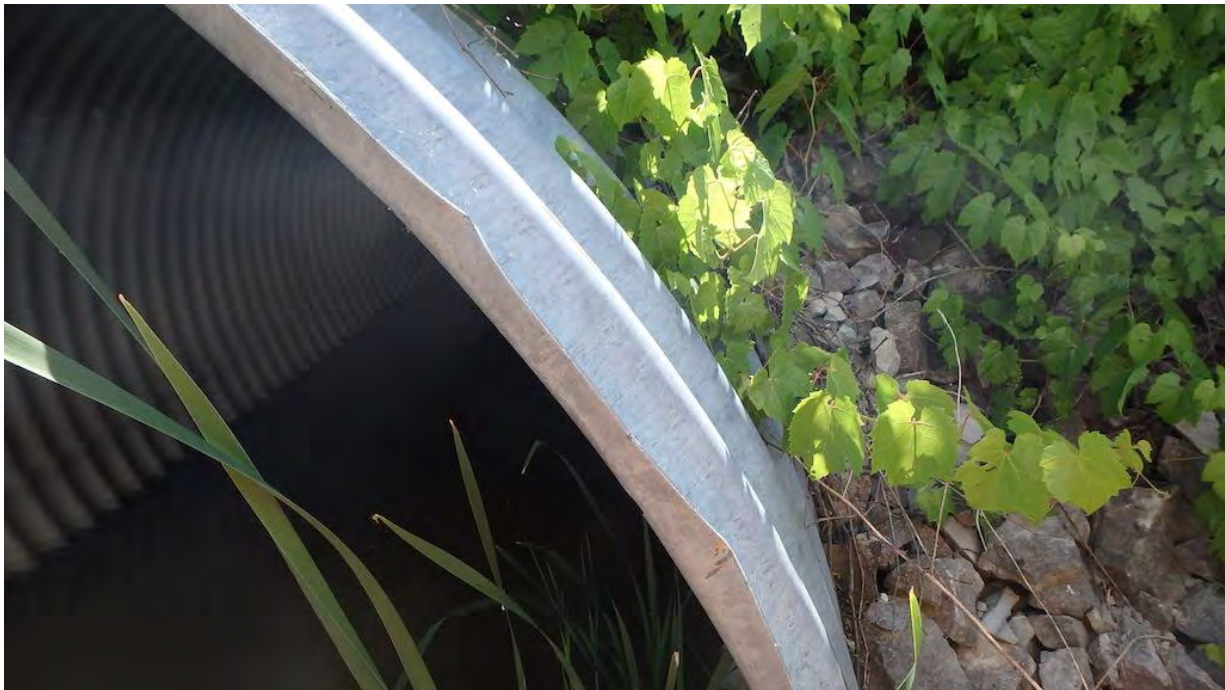
Figure 10 Minor Impact Damage on Culvert
