NANTICOKE CREEK BRIDGE

Site Number 981907

COUNTY ROAD 19, TOWNSEND

Ontario Structure Inspection Manual - Inspection Form

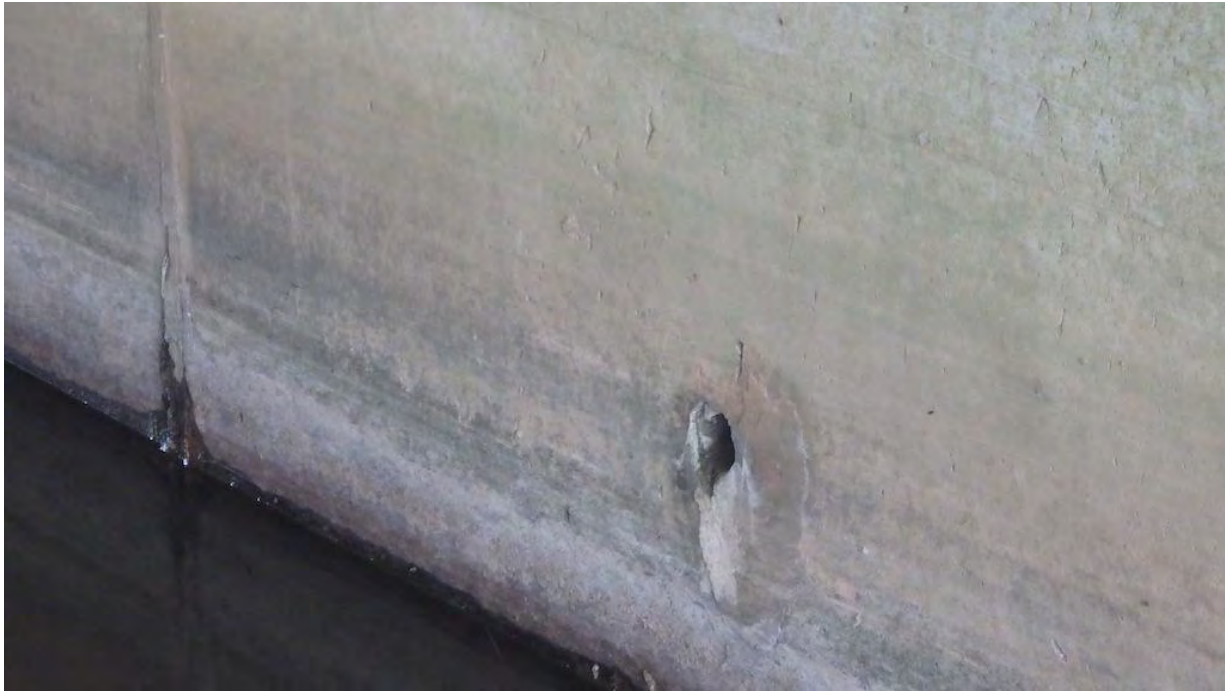
Figure 11 Drains with Staining

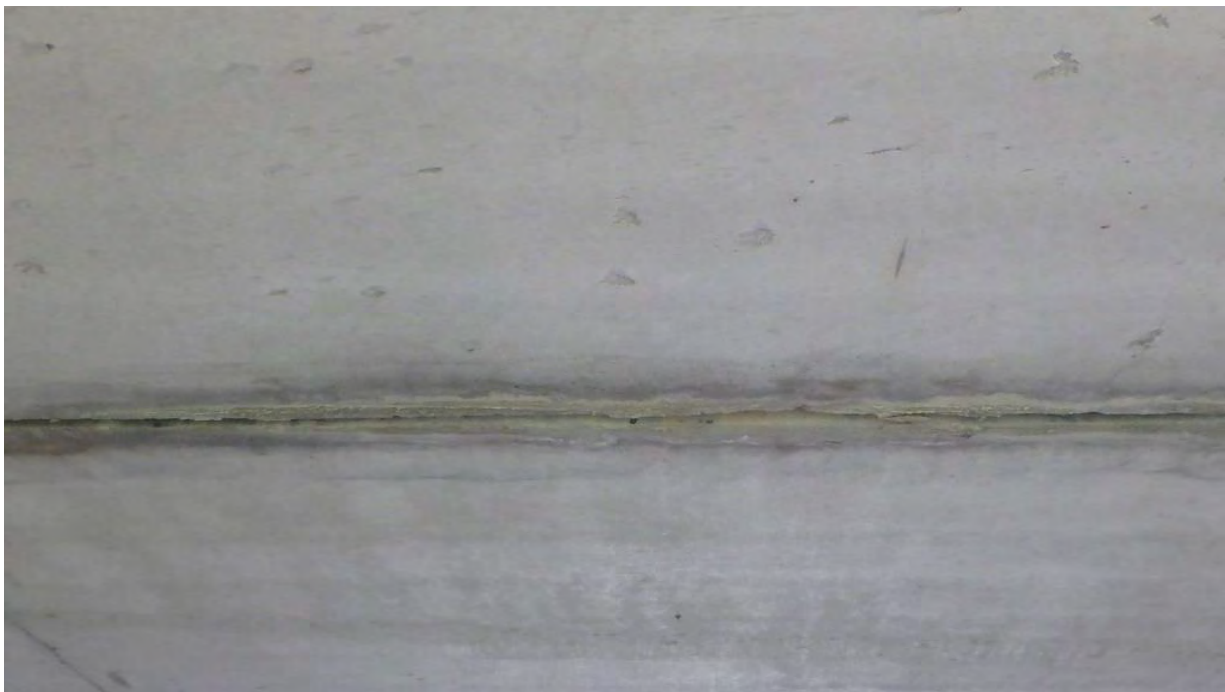
Figure 12 Leakage and Chlorides at Joints

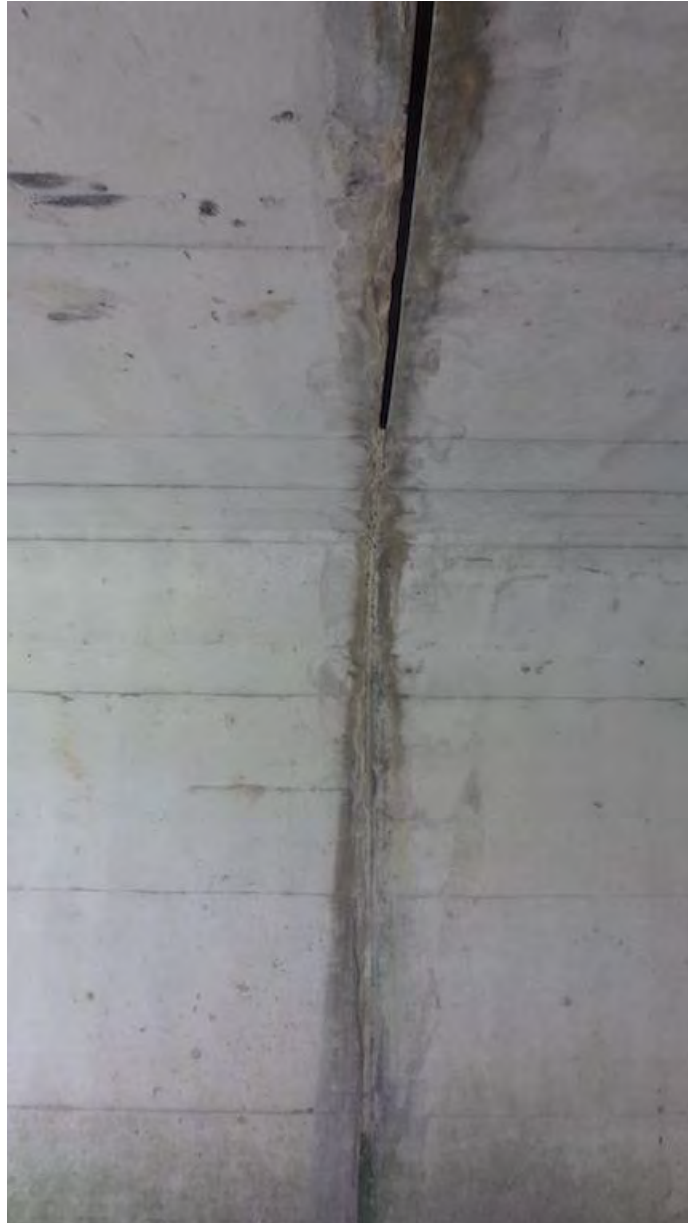
Figure 13 Cracking and Deterioration of Parging at Joint with Chlorides

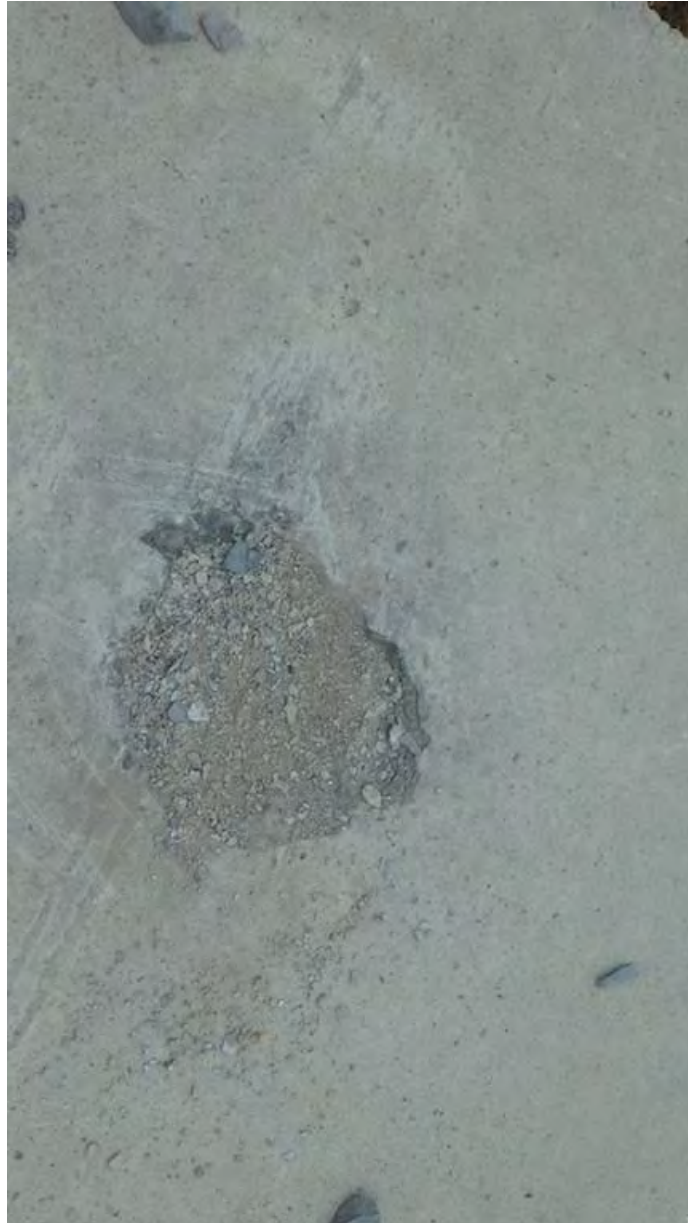
Figure 14 Failing of Parging at Lifting Hooks

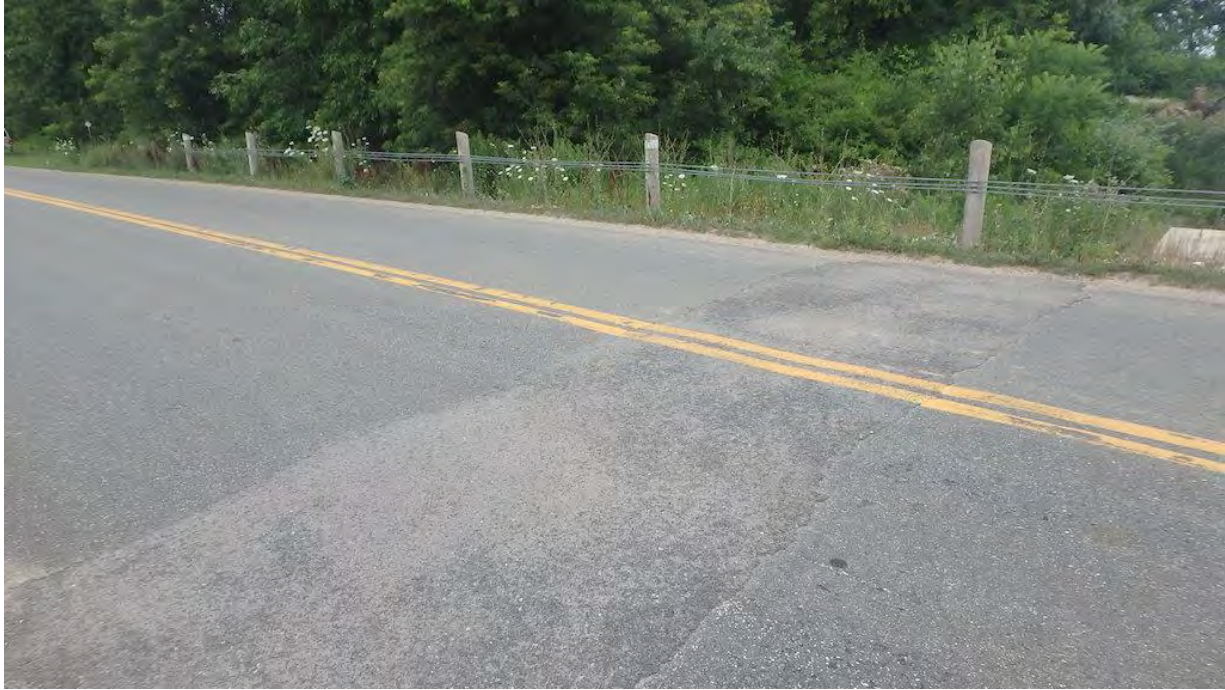
Figure 15 Large Patch at West Approach with apparent Settlement
