ELLIOTT CULVERT

Site Number 982403

COUNTY ROAD 24, TOWNSEND

Ontario Structure Inspection Manual - Inspection Form

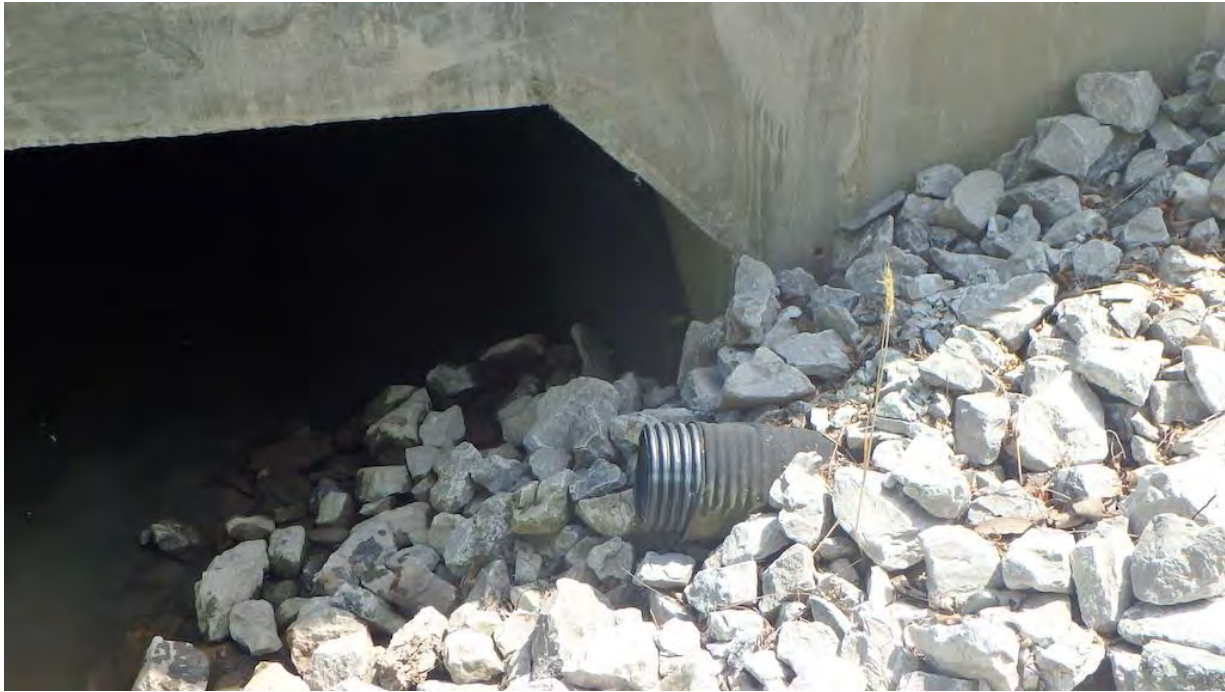
Figure 11 Typical Abutment Drain

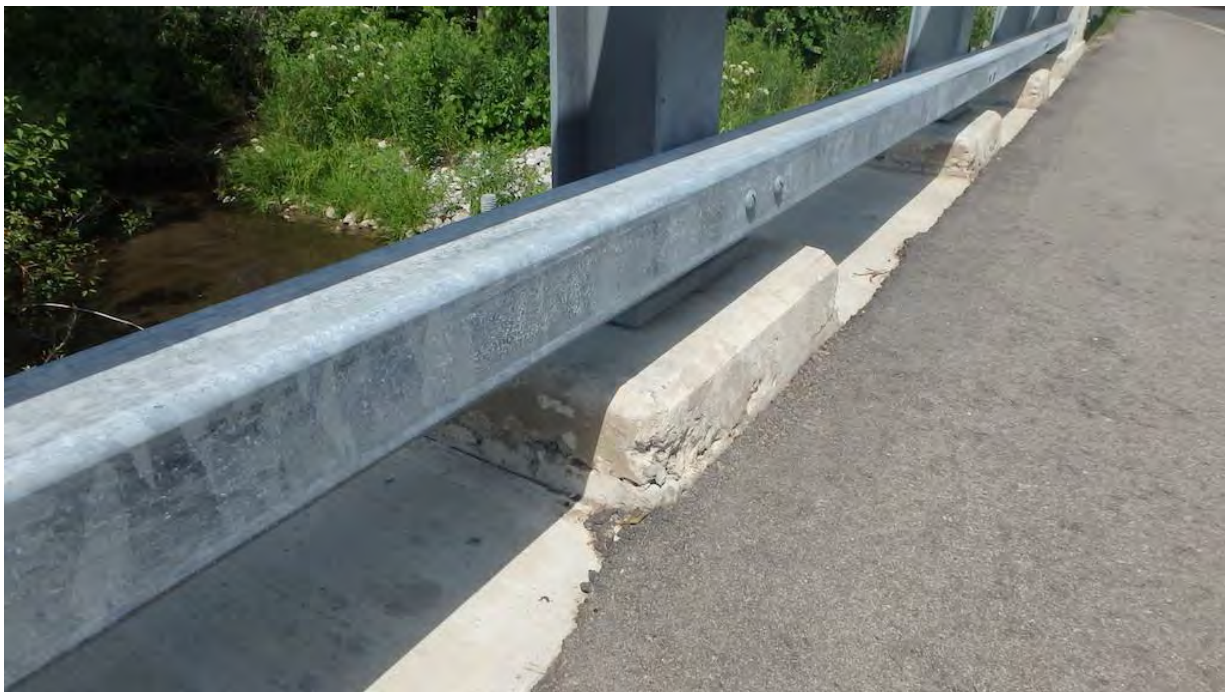
Figure 12 Typical Honeycombing on North Pedestals

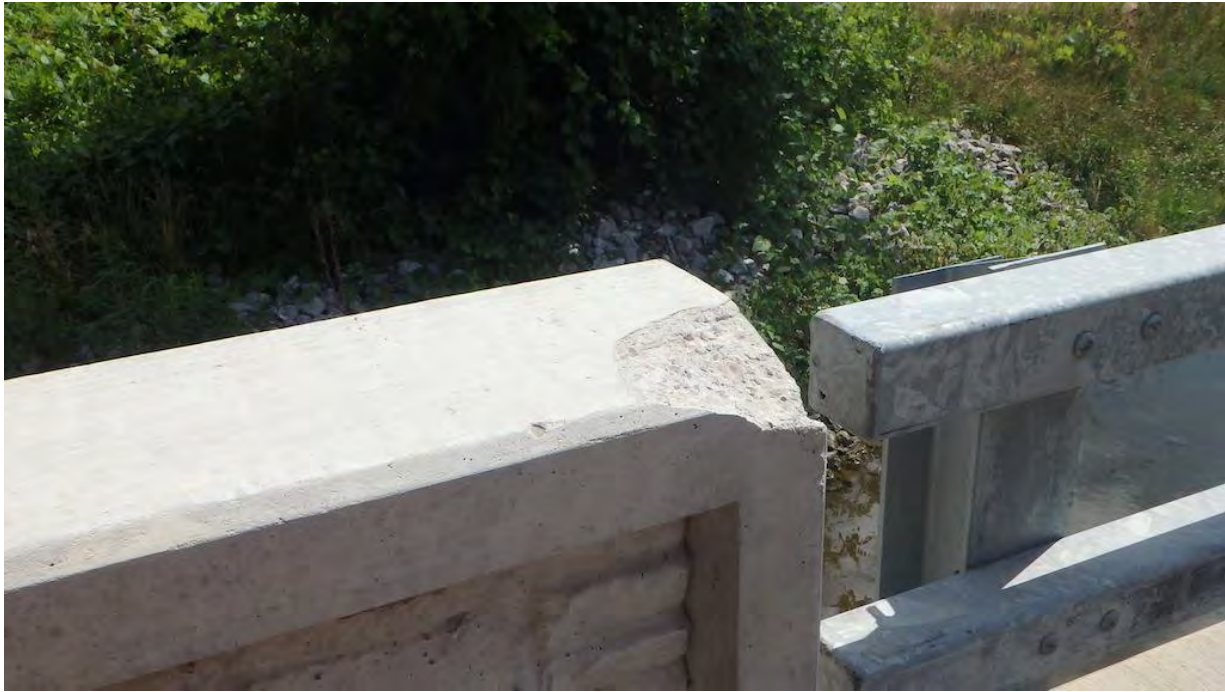
Figure 13 Impact Damage on South Endposts
