HUNT STREET BRIDGE

Site Number 983502

HUNT STREET, SIMCOE

Ontario Structure Inspection Manual - Inspection Form

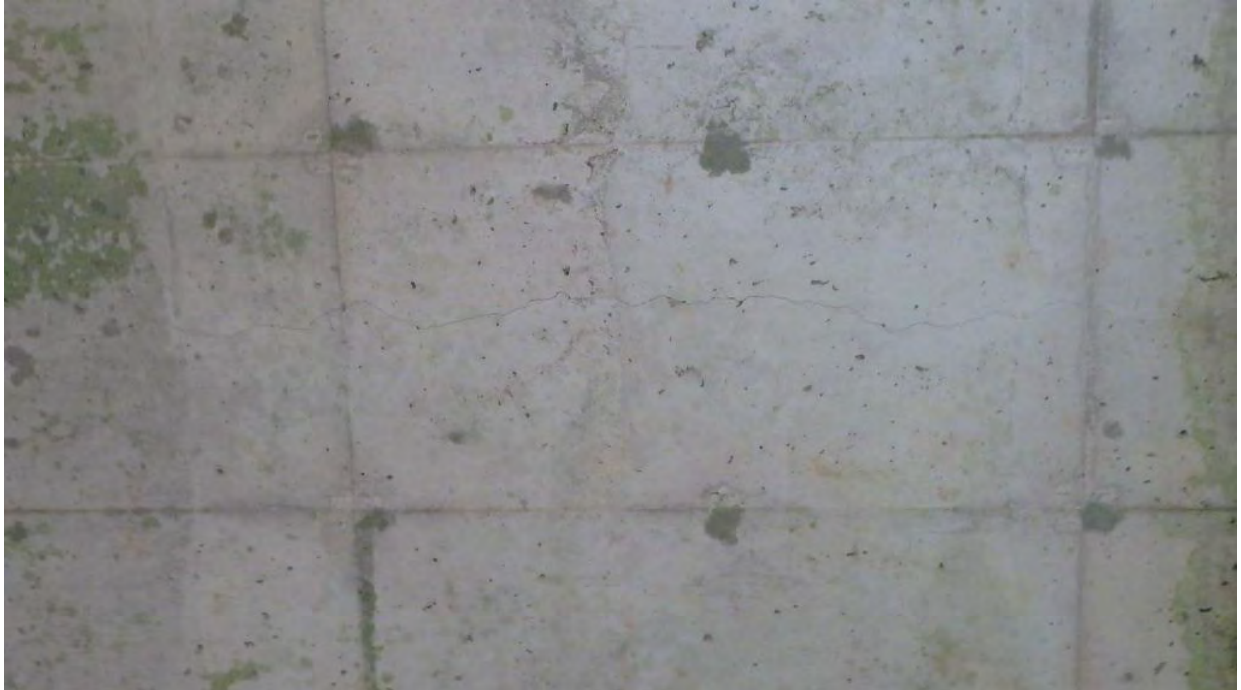
Figure 10 Vertical Hairline Crack in South Wall

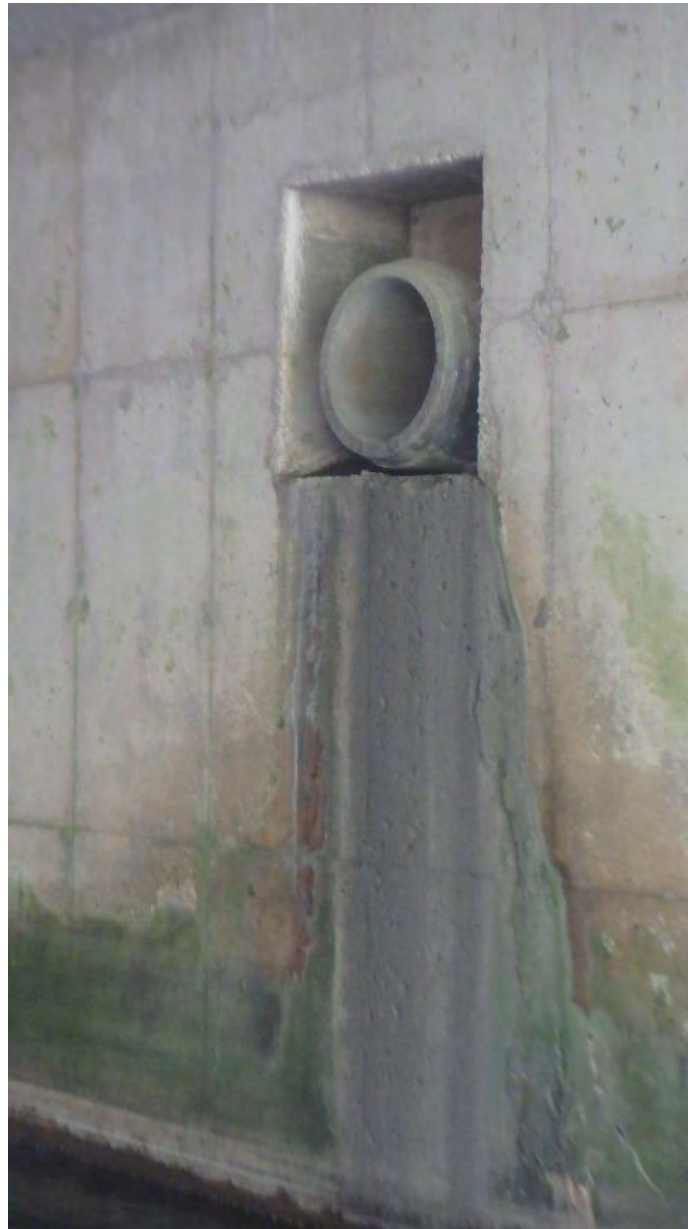
Figure 11 Staining & Minor Deterioration at Drains

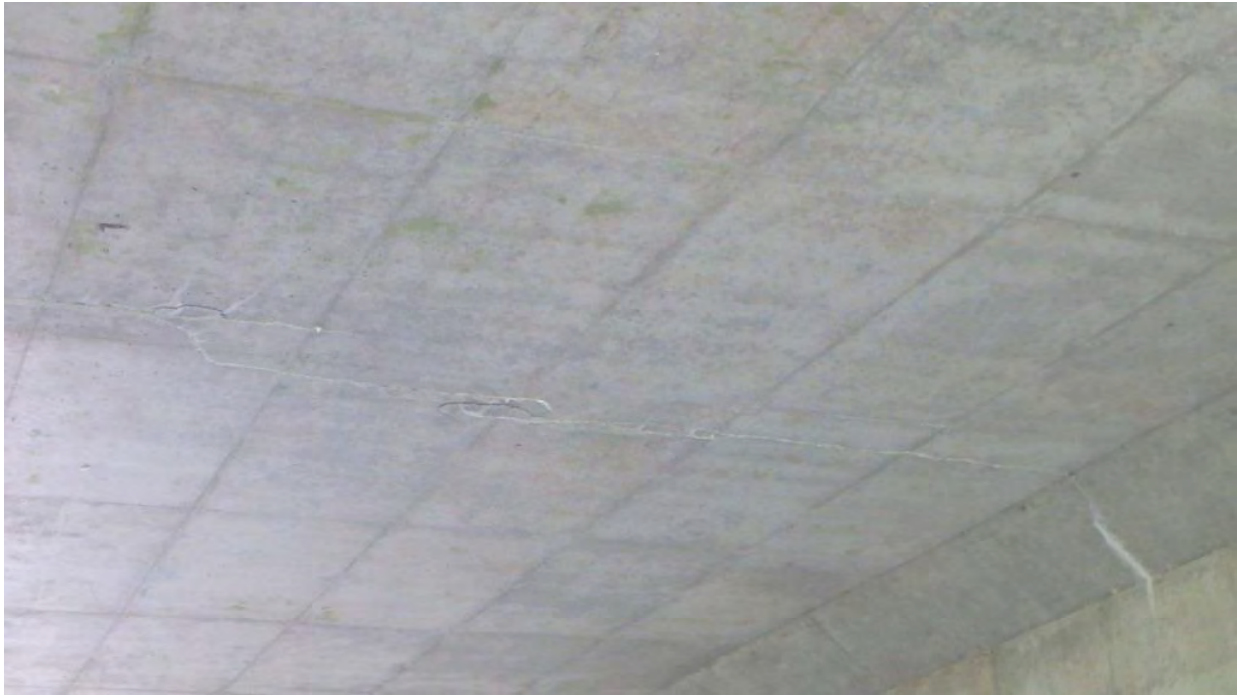
Figure 12 Crack in Soffit with Leakage & Chlorides

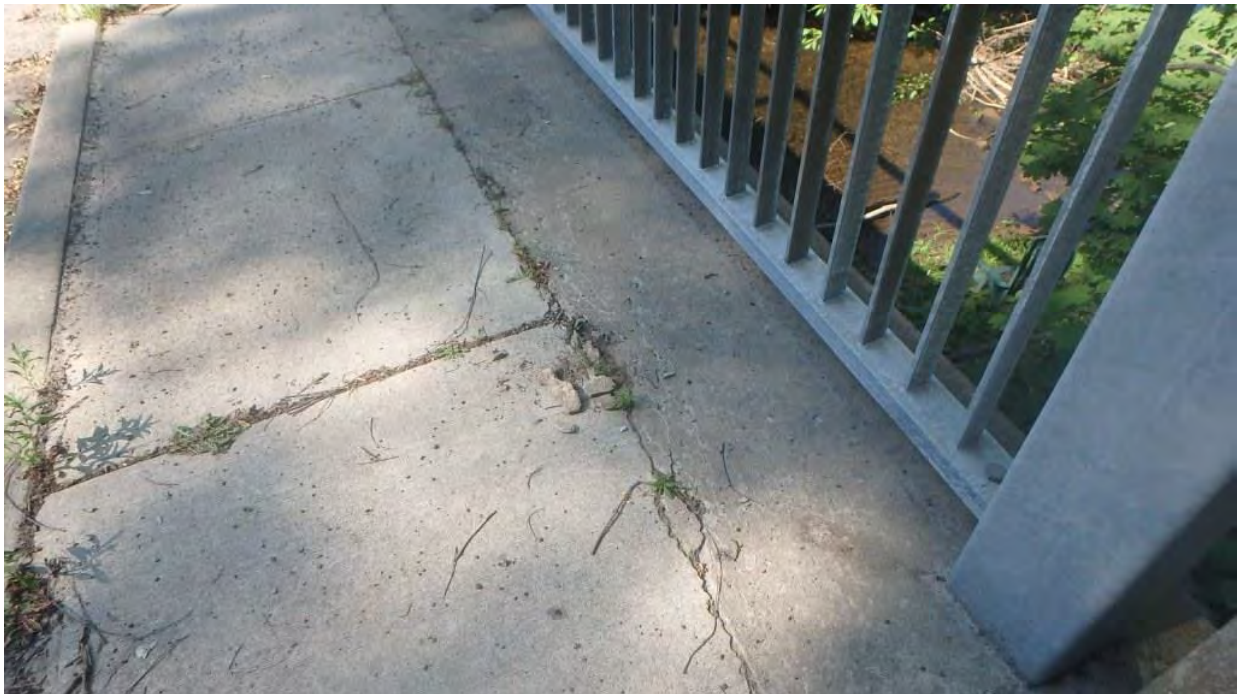
Figure 13 Crack & Spall in Sidewalks

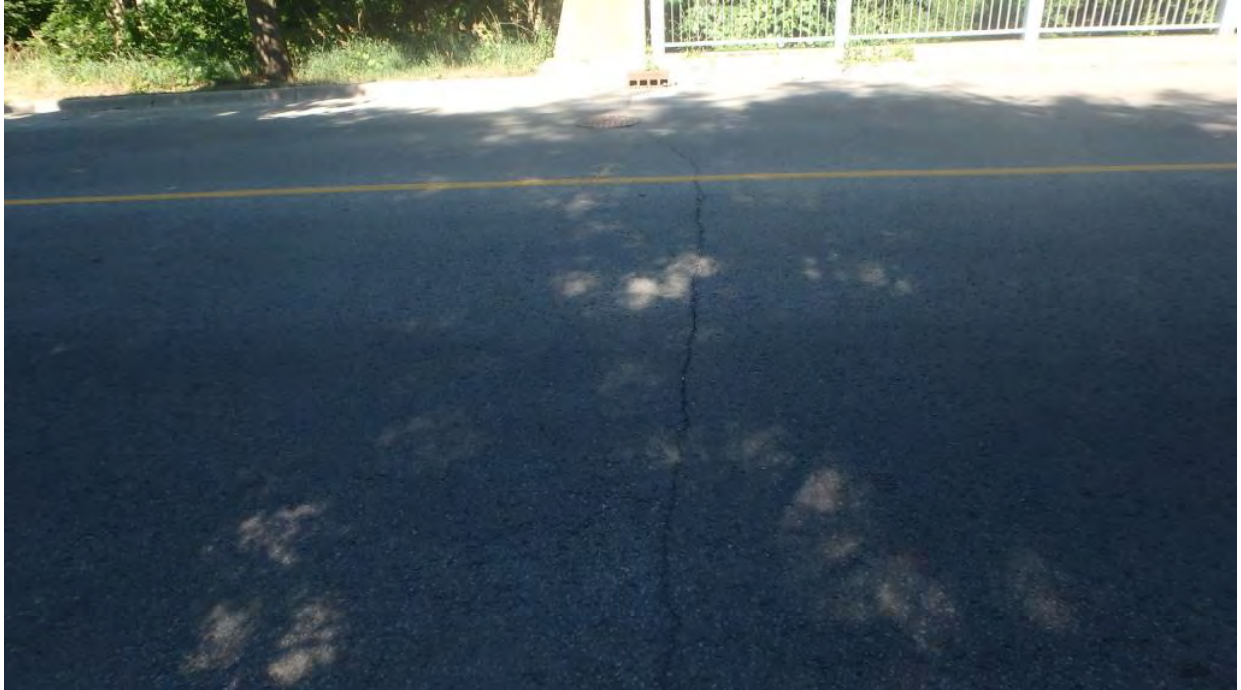
Figure 15 Transverse Crack in Wearing Surface
