**HILLCREST BRIDGE**

Site Number 984101

**COUNTY ROAD 41 HILLCREST, CHARLOTTEVILLE**

**Ontario Structure Inspection Manual - Inspection Form**

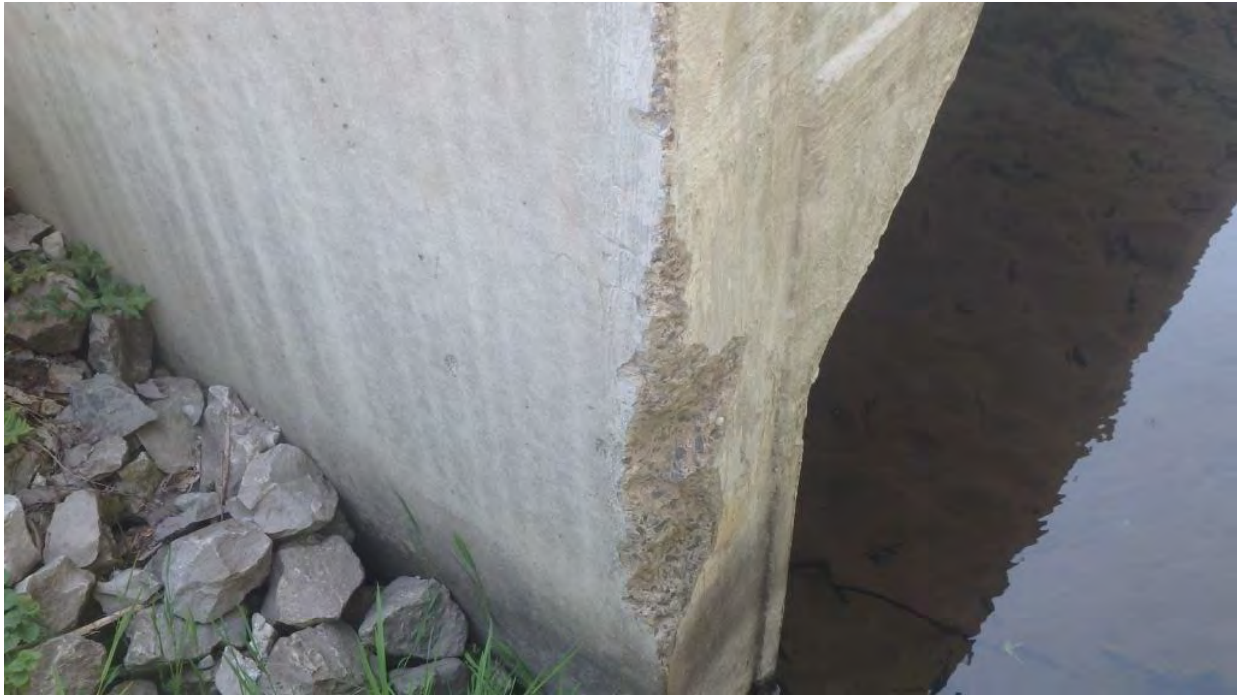
Figure 9 Minor Impact Damage in Southeast Quadrant

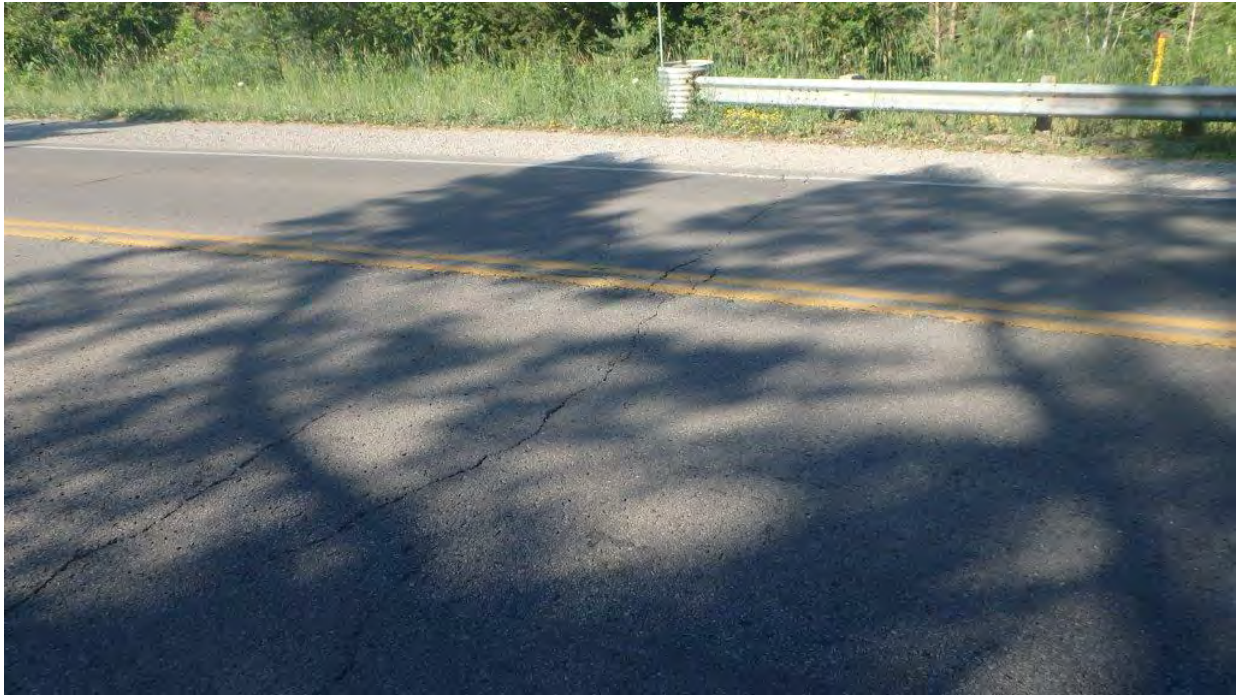
Figure 11 Transverse Cracks in Wearing Surface Approaches

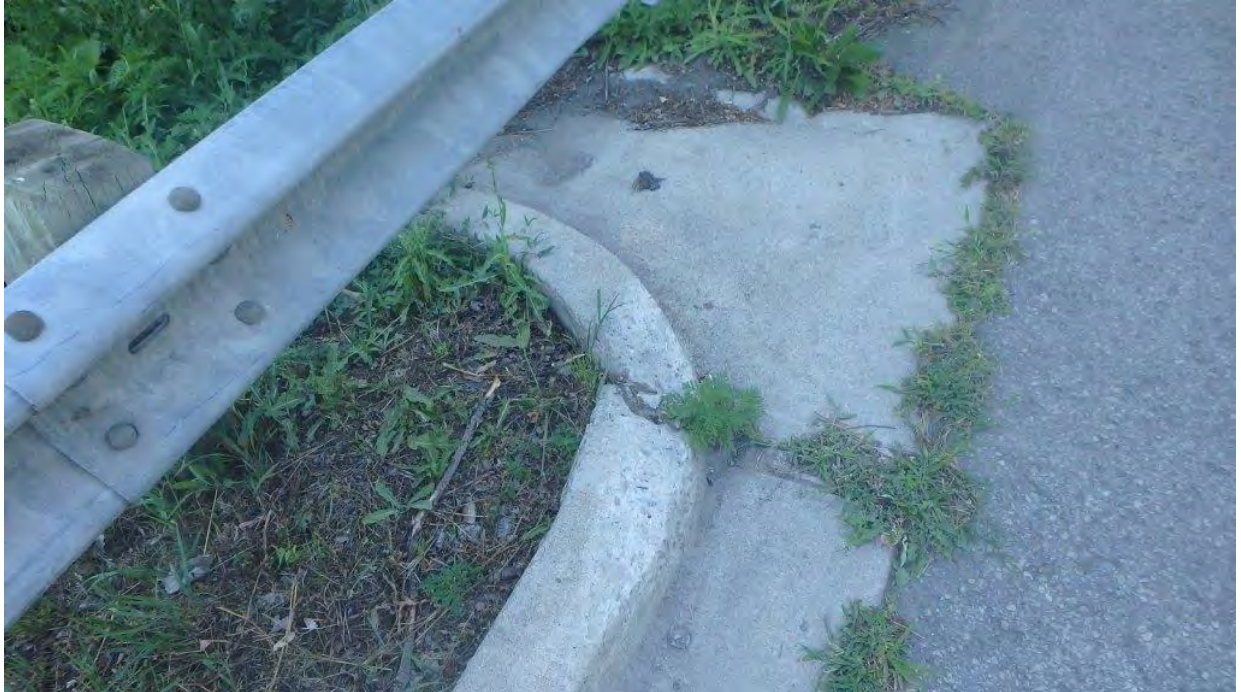
Figure 12 Minor Impact Damage at Curb

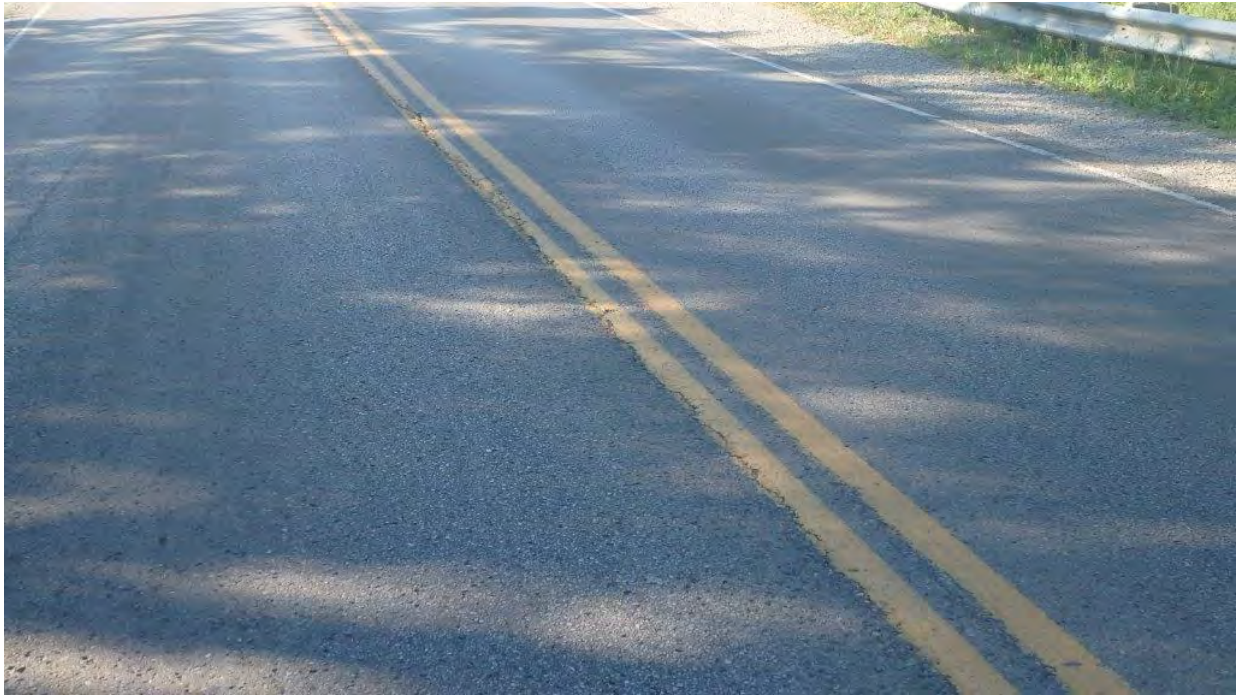
Figure 13 Longitudinal Crack in Wearing Surface Centreline
