VENISON CREEK BRIDGE

Site Number 986001

COUNTY ROAD 60, CONCESSION 5 SOUTH, SOUTH WALSINGHAM

Ontario Structure Inspection Manual - Inspection Form

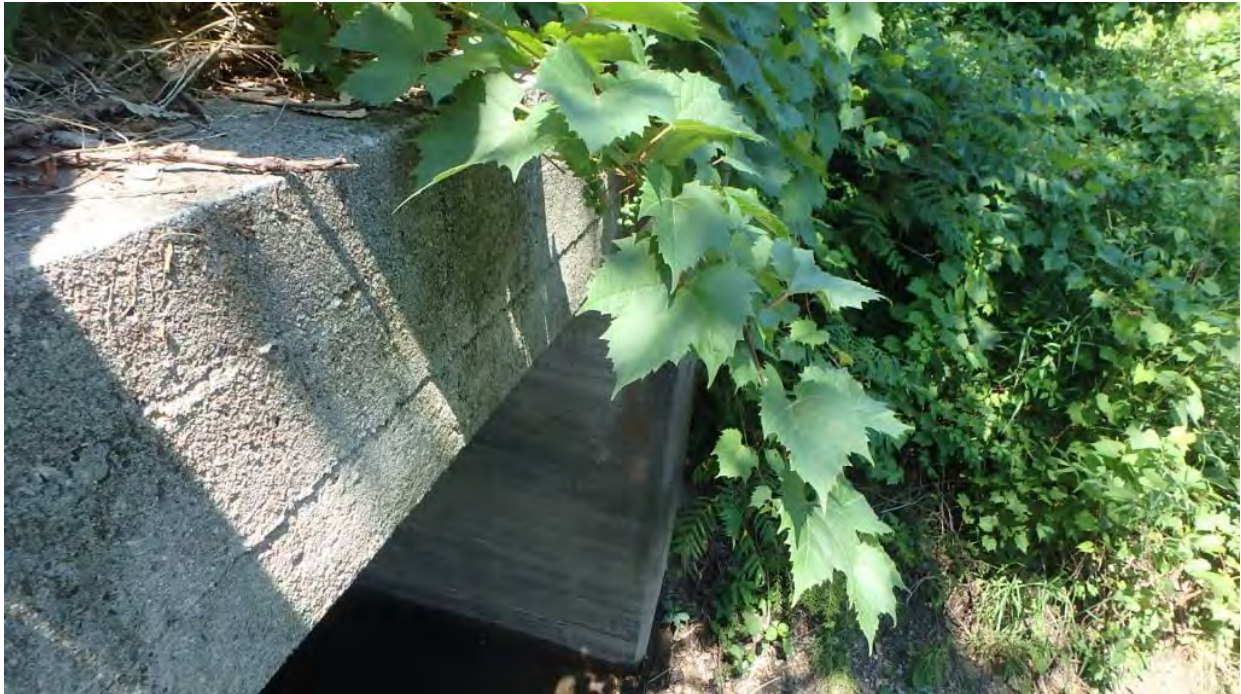
Figure 8 Minor Deterioration on South Fascia

Overall Structure Notes:	
Recommended Work on Structure:	<input type="checkbox"/> None <input checked="" type="checkbox"/> Minor Rehab. <input type="checkbox"/> Replace <input type="checkbox"/> Maintenance <input type="checkbox"/> Major Rehab.
Timing of Recommended Work:	<input type="checkbox"/> 1 to 5 years <input checked="" type="checkbox"/> 6 to 10 years
Overall Comments:	South fascia and slope protection / drainage improvements.
Date of next Inspection:	July 12, 2018

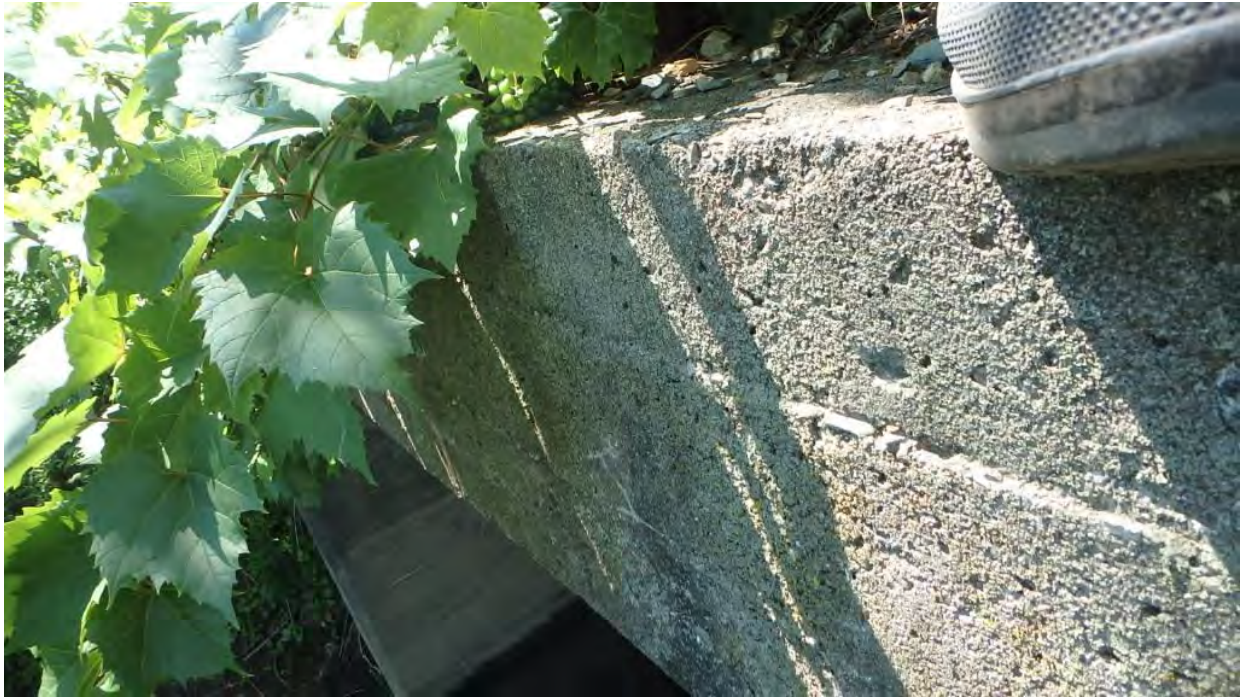
Figure 9 Scaling on Fascia

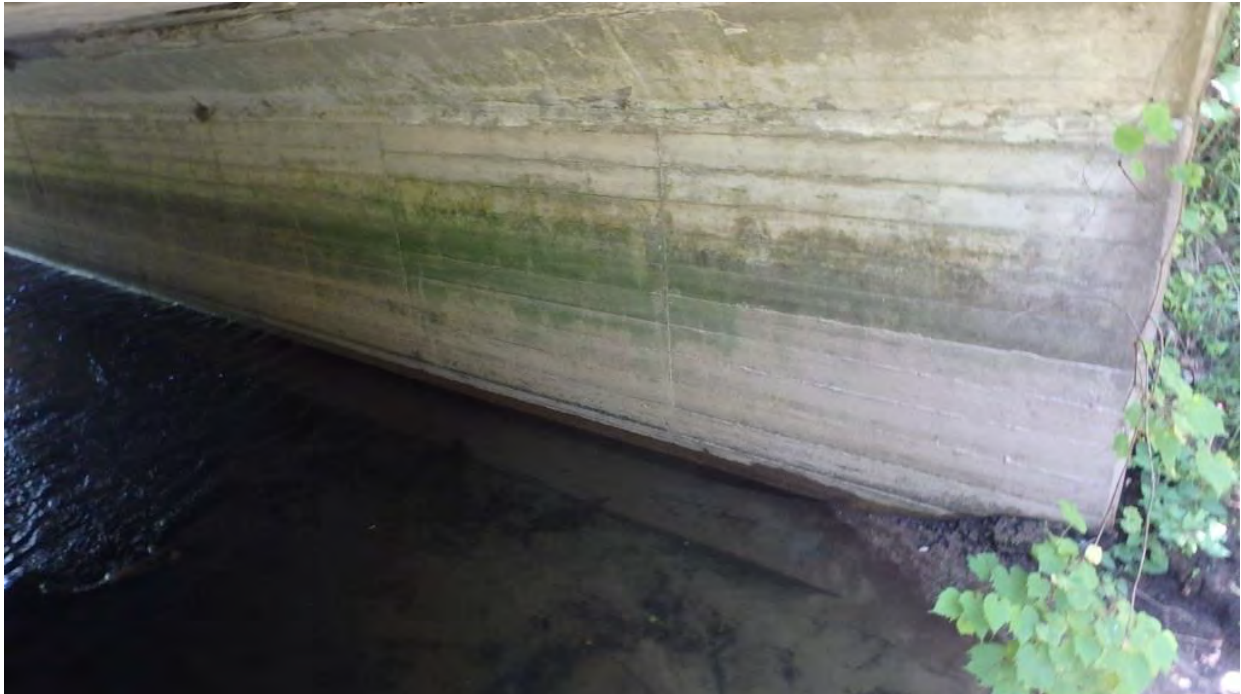
Figure 10 Staining on Culvert Walls

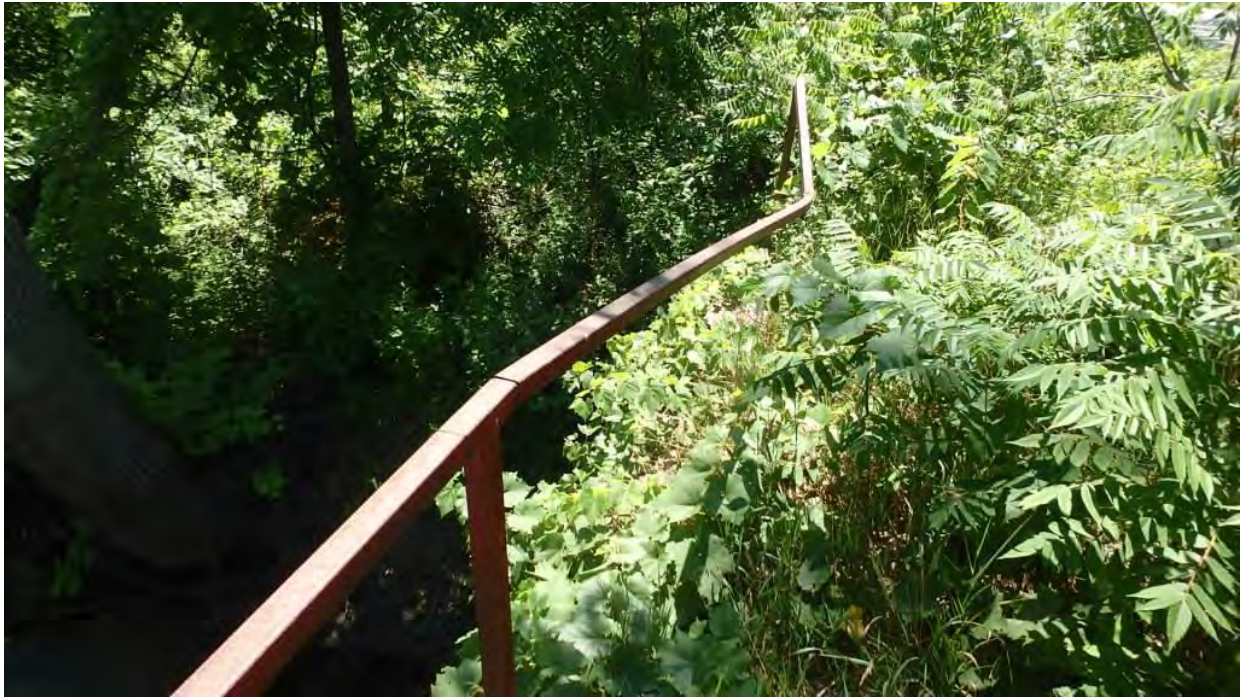
Figure 11 Damaged Handrail on South Culvert Top

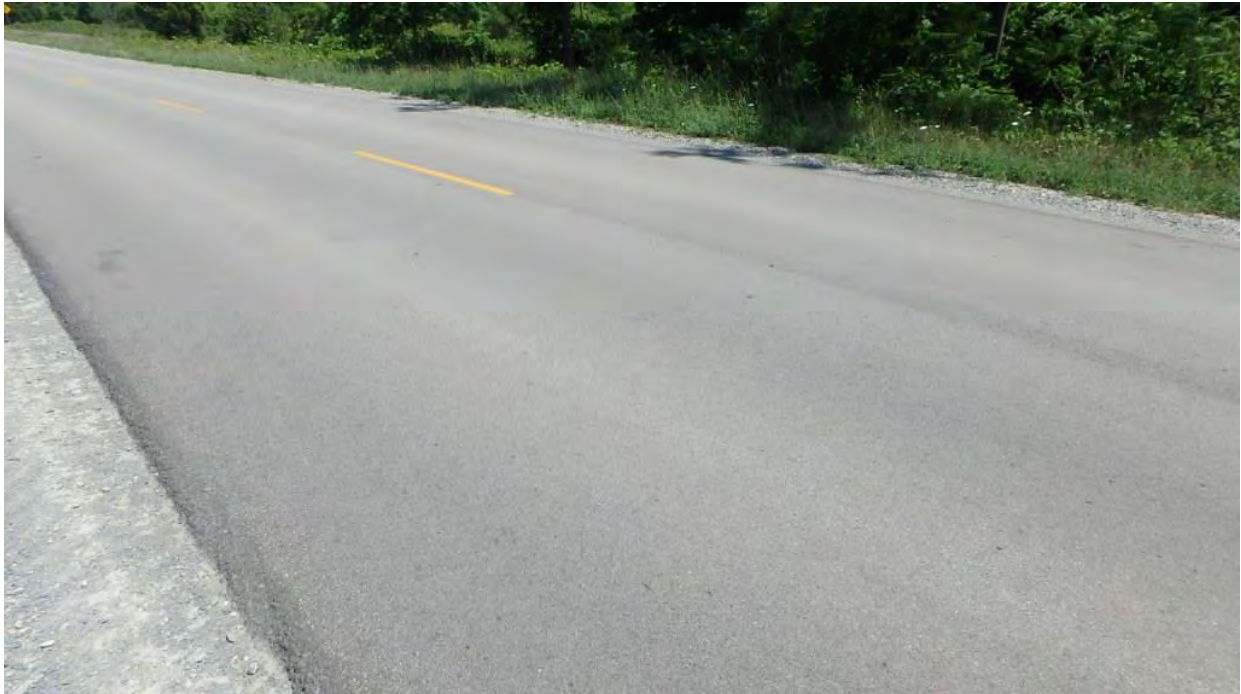
Figure 12 New Asphalt Wearing Surface
