PEN CENTRAL UNDERPASS LOT 18 – 19

Site Number D00010

WINDHAM W. ¼ LINE ROAD, WINDHAM

Ontario Structure Inspection Manual - Inspection Form

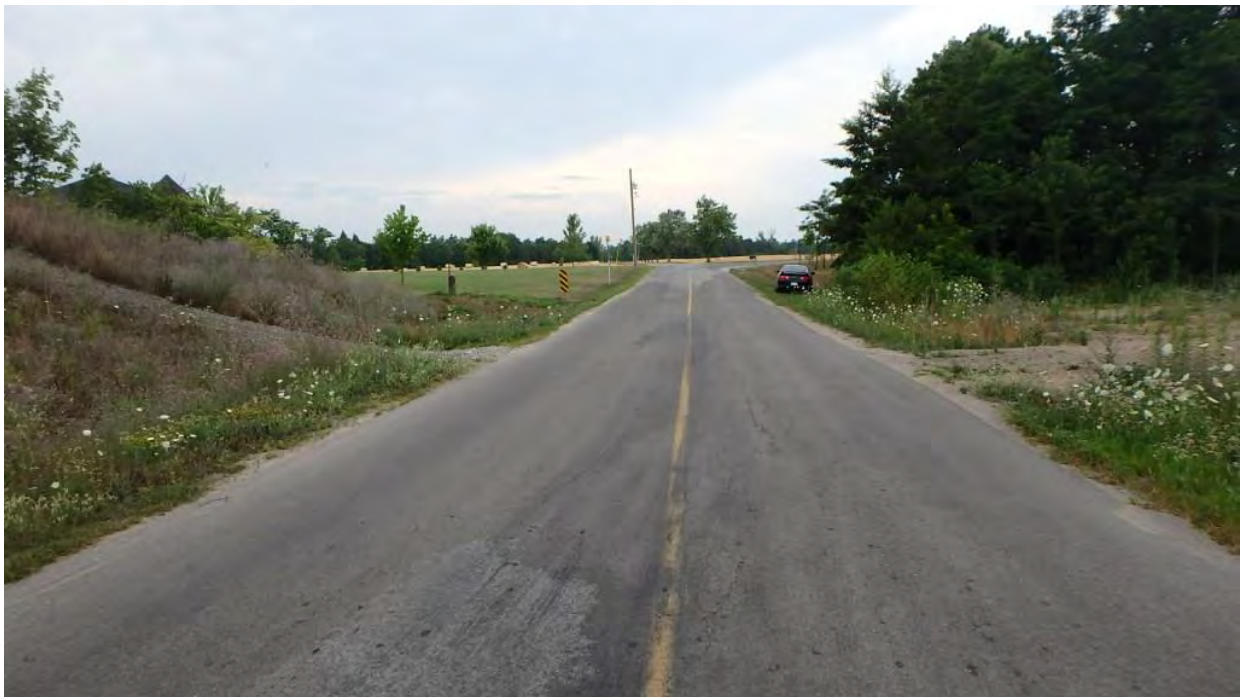
Overall Structure Notes:	
Recommended Work on Structure:	<input checked="" type="checkbox"/> None <input type="checkbox"/> Minor Rehab. <input type="checkbox"/> Replace <input type="checkbox"/> Maintenance <input type="checkbox"/> Major Rehab.
Timing of Recommended Work:	<input type="checkbox"/> 1 to 5 years <input type="checkbox"/> 6 to 10 years
Overall Comments:	Structure removed in 2011 and regraded.
Date of next Inspection:	July 21, 2018

Figure 2 South Approach, Note Structure Removed

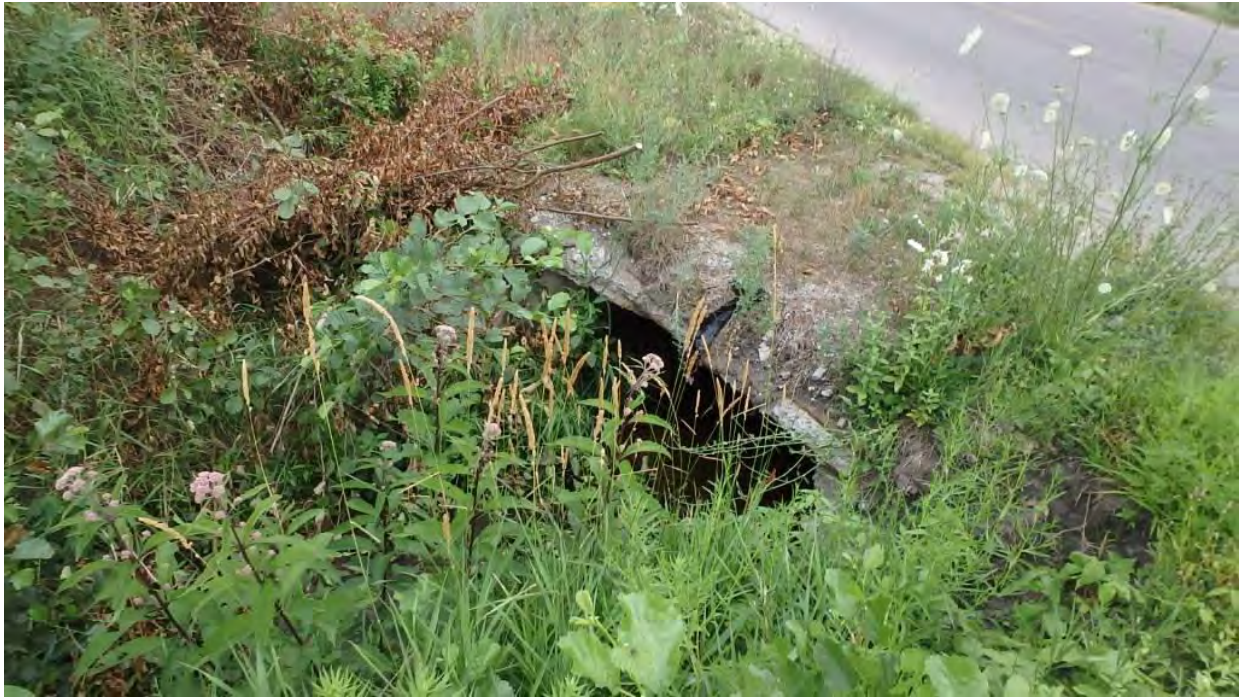
Figure 3 Outlet, Small Culvert

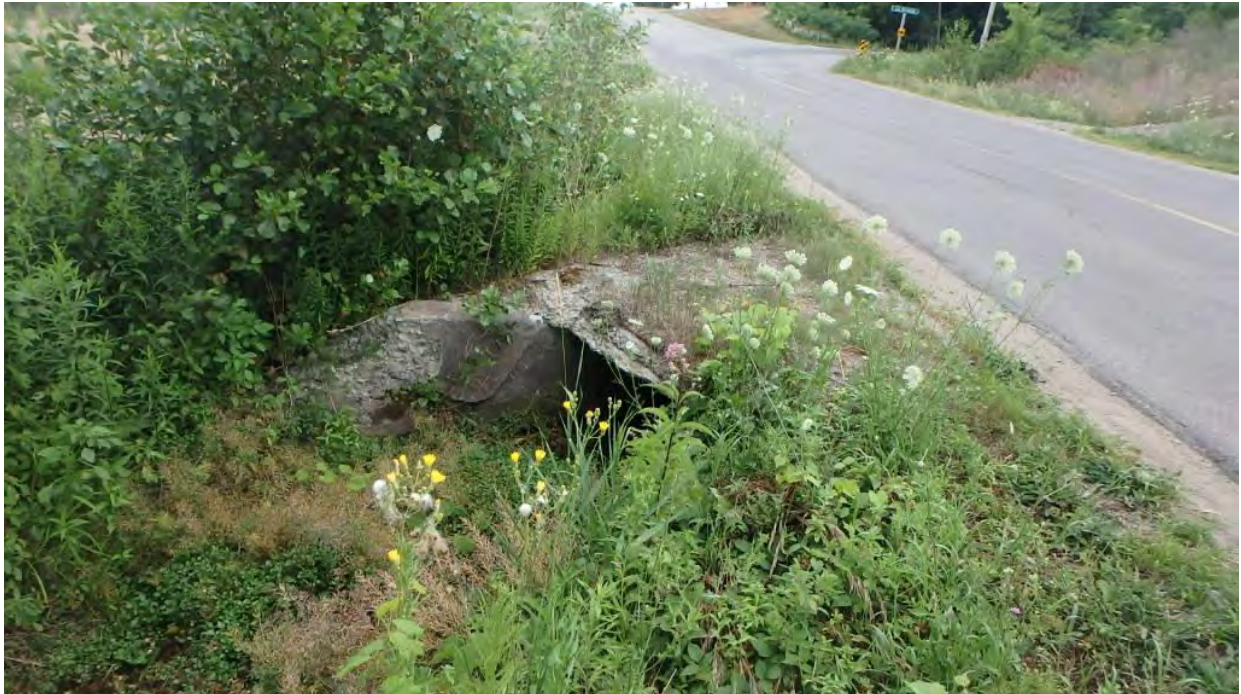
Figure 4 Inlet, Small Culvert
