EAST ¼ LINE CONCESSION 10, WINDHAM

Site Number D00028

EAST ¼ LINE ROAD, WINDHAM

Ontario Structure Inspection Manual - Inspection Form

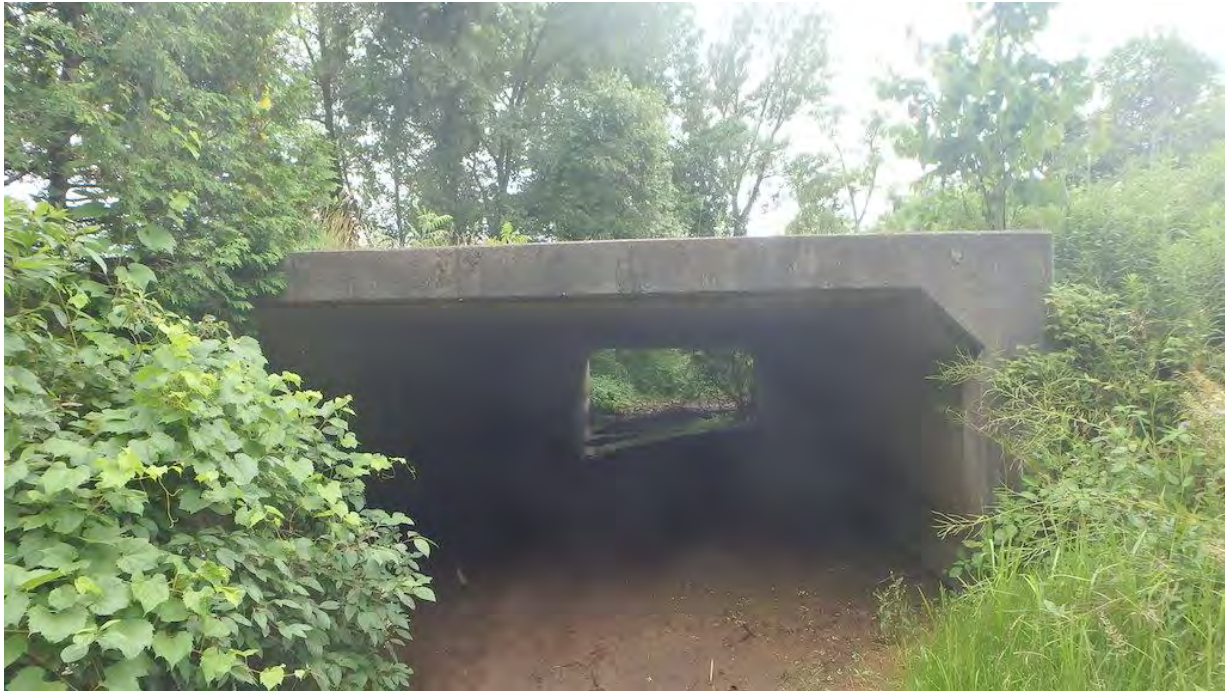
Figure 3 East Profile, Outlet

Element Group:		1200 Culverts				Length:	5.3
Element Name:		1202 Outlet Components				Width:	0.4
Location:		East End				Height:	1.7
Material:		4 Cast-in-place Concrete				Count:	1
Element Type:						Total Quantity:	3.5 sq.m
Environment:		Moderate				Limited Inspection:	
Protection System:		Unknown				Perform. Deficiencies	
Condition Data:	Units sq.m	Exc. 0	Good 3.5	Fair 0	Poor 0		
Comments:							
Recommended Work:				Rehab <input type="checkbox"/> Replace <input type="checkbox"/>		Maintenance Needs:	
Timing:				Urgent <input type="checkbox"/> < 1yr <input type="checkbox"/> 1 - 5 yr <input type="checkbox"/> 6 - 10 yr <input type="checkbox"/>		<input type="checkbox"/> Urgent <input type="checkbox"/> 1 year <input type="checkbox"/> 2 year

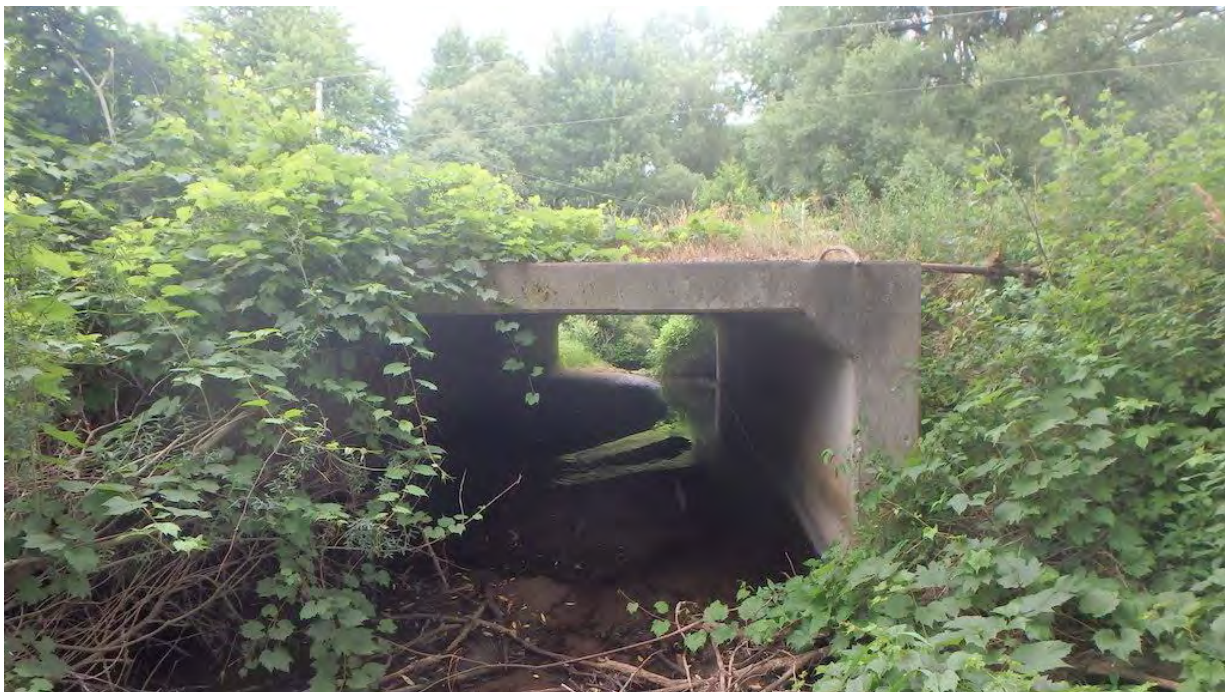
Figure 4 West Profile, Inlet

Element Group:		1200 Culverts				Length:	5.3
Element Name:		1201 Inlet Components				Width:	0.4
Location:		West End				Height:	1.7
Material:		4 Cast-in-place Concrete				Count:	1
Element Type:						Total Quantity:	3.5 sq.m
Environment:		Moderate				Limited Inspection:	
Protection System:		Unknown				Perform. Deficiencies	
Condition Data:	Units sq.m	Exc. 2.5	Good 1	Fair 0	Poor 0		
Comments: Surface cracking. Vegetation needs to be cleared. Utility pipe on top of inlet.							
Recommended Work:				Rehab <input type="checkbox"/> Replace <input type="checkbox"/>		Maintenance Needs:	
Timing:				Urgent <input type="checkbox"/> < 1yr <input type="checkbox"/> 1 - 5 yr <input type="checkbox"/> 6 - 10 yr <input type="checkbox"/>		<input type="checkbox"/> Urgent <input type="checkbox"/> 1 year <input type="checkbox"/> 2 year

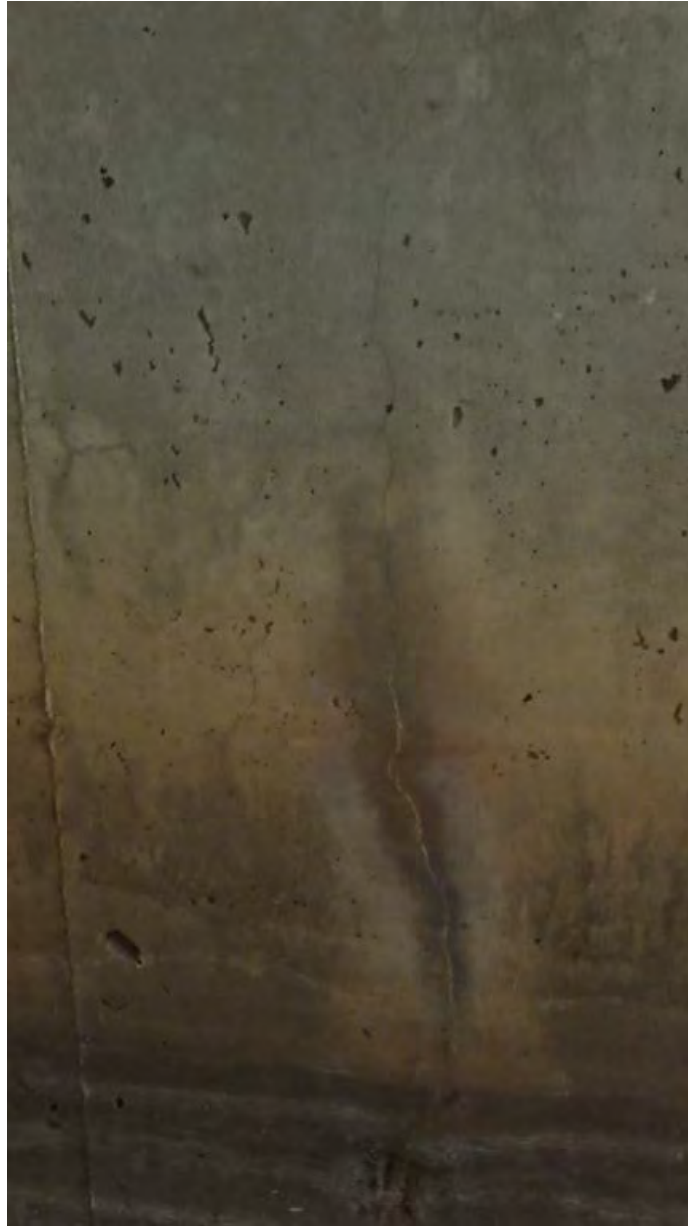
Element Group:		1200 Culverts				Length:	17.5
Element Name:		1203 Barrels				Width:	8
Location:						Height:	
Material:		4 Cast-in-place Concrete				Count:	1
Element Type:						Total Quantity:	140 sq.m
Environment:						Limited Inspection:	
Protection System:		Unknown				Perform. Deficiencies	
Condition Data:	Units sq.m	Exc. 0	Good 130	Fair 10	Poor 0		
Comments: Narrow vertical cracks visible on North and South wall.							
Recommended Work:				Rehab <input type="checkbox"/> Replace <input type="checkbox"/>		Maintenance Needs: Concrete Sealing	
Timing:				Urgent <input type="checkbox"/> < 1yr <input type="checkbox"/> 1 - 5 yr <input type="checkbox"/> 6 - 10 yr <input type="checkbox"/>		<input type="checkbox"/> Urgent <input type="checkbox"/> 1 year <input checked="" type="checkbox"/> 2 year

Figure 9 Typical Crack on Wall with Staining

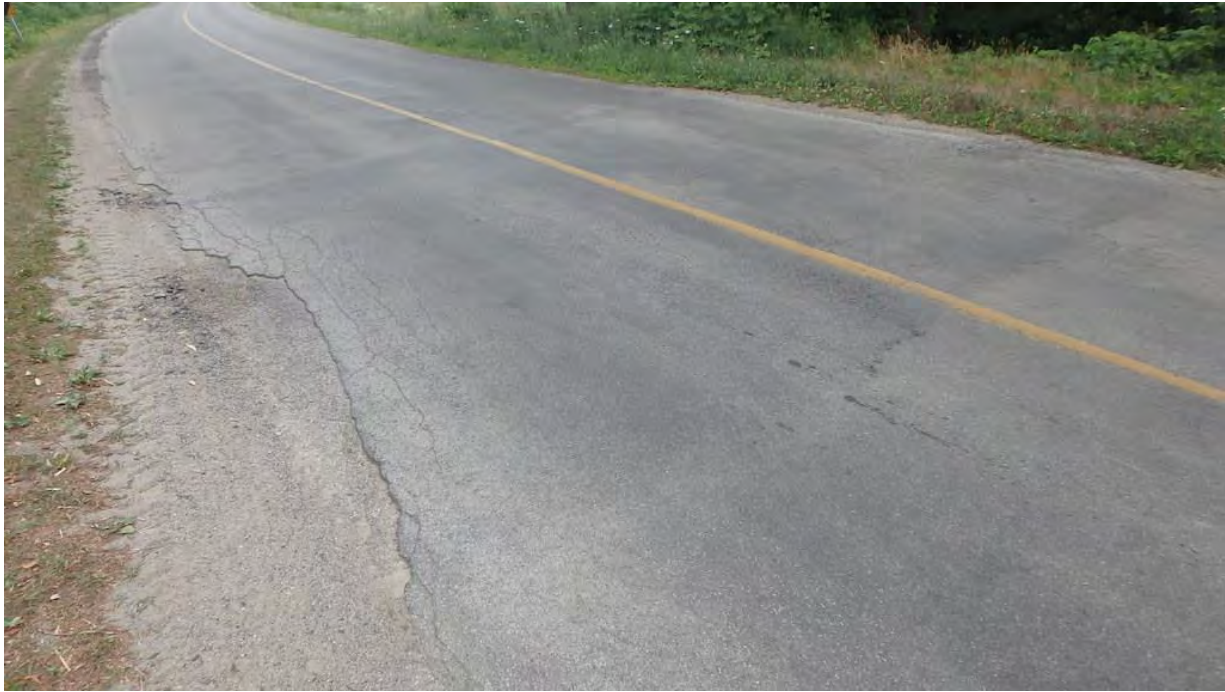
Element Group:		100 Decks				Length:	5.3
Element Name:		101 Wearing Surface				Width:	7
Location:		Top of Deck				Height:	
Material:		2 Asphalt				Count:	1
Element Type:						Total Quantity:	37.1 sq.m
Environment:		Severe				Limited Inspection:	
Protection System:		None				Perform. Deficiencies	
Condition Data:	Units	Exc.	Good	Fair	Poor		
	sq.m	0	29.6	7.5	0		
Comments: Light map cracking. Slight settlement at structure edges.							
Recommended Work: Rehab <input type="checkbox"/> Replace <input type="checkbox"/>				Maintenance Needs: Bridge Surface Repair			
Timing: Urgent <input type="checkbox"/> < 1yr <input type="checkbox"/> 1 - 5 yr <input type="checkbox"/> 6 - 10 yr <input type="checkbox"/>				<input type="checkbox"/> Urgent <input type="checkbox"/> 1 year <input checked="" type="checkbox"/> 2 year

Figure 10 Settlement and Edge Deterioration in Wearing Surface at Culvert
