**LOT 18 - 19 CONCESSION 5**

Site Number D00031

**WEST ¼ LINE ROAD, WINDHAM**

**Ontario Structure Inspection Manual - Inspection Form**

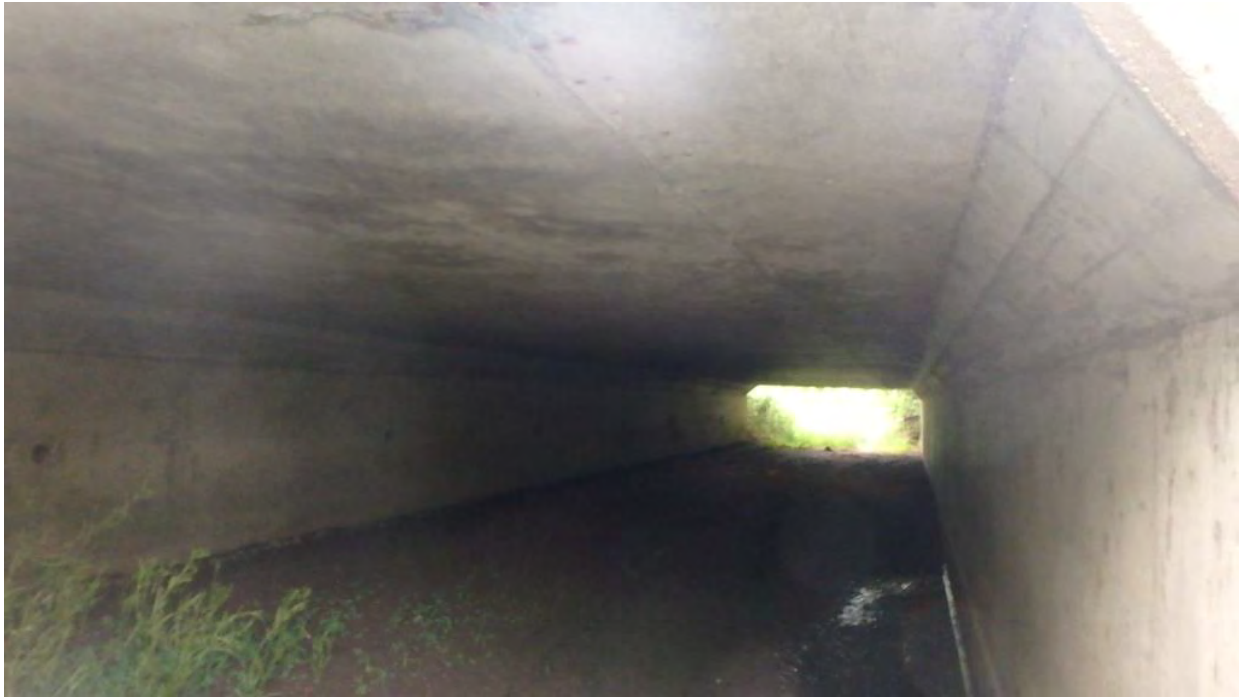
Element Group:		1200 Culverts				Length:	22.3
Element Name:		1203 Barrels				Width:	6.5
Location:		Inside				Height:	1.8
Material:		4 Cast-in-place Concrete				Count:	1
Element Type:						Total Quantity:	260.9 sq.m
Environment:		Moderate				Limited Inspection:	
Protection System:		Unknown				Perform. Deficiencies	
Condition Data:	Units sq.m	Exc. 0	Good 259	Fair 0	Poor 1.9		
Comments: Narrow vertical cracks at barrel walls at some drains. Transverse soffit crack at West end of culvert.							
Recommended Work:				Rehab <input type="checkbox"/> Replace <input type="checkbox"/>		Maintenance Needs: Concrete Sealing	
Timing:				Urgent <input type="checkbox"/> < 1yr <input type="checkbox"/> 1 - 5 yr <input type="checkbox"/> 6 - 10 yr <input type="checkbox"/>		<input type="checkbox"/> Urgent <input type="checkbox"/> 1 year <input checked="" type="checkbox"/> 2 year

Figure 7 Barrel

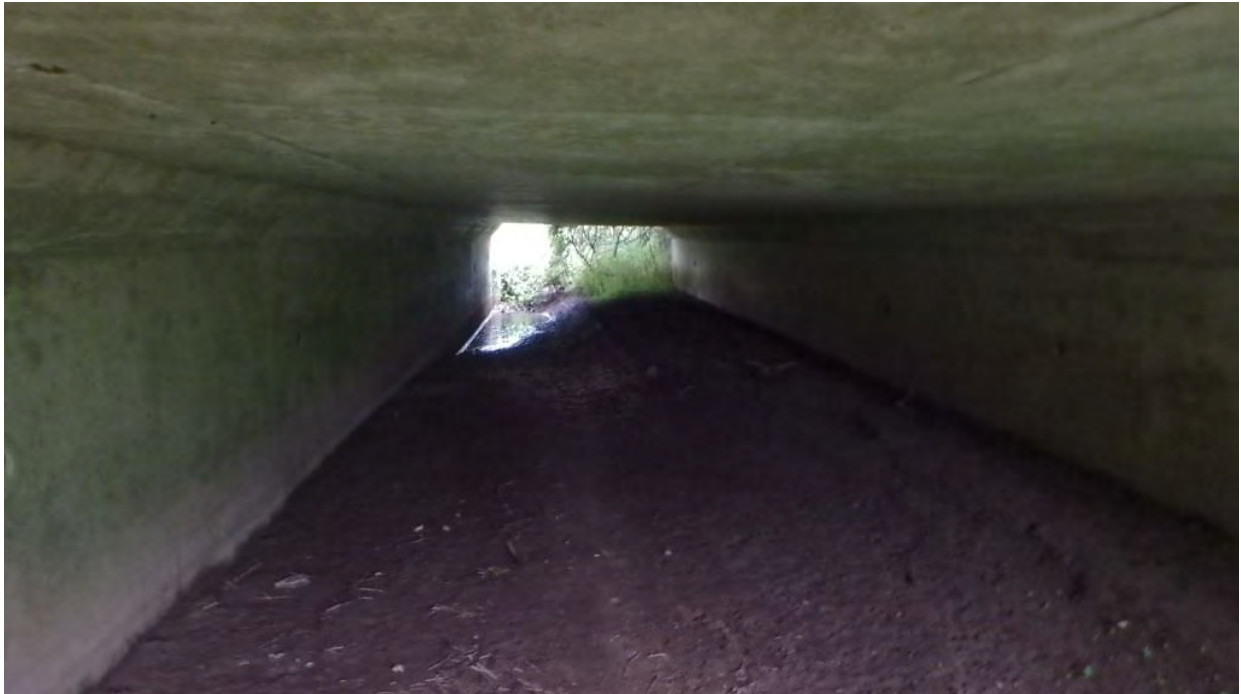
Element Group:		1200 Culverts				Length:	6.5
Element Name:		1201 Inlet Components				Width:	0.4
Location:						Height:	1.8
Material:		4 Cast-in-place Concrete				Count:	1
Element Type:						Total Quantity:	4.7 sq.m
Environment:		Severe				Limited Inspection:	
Protection System:		Unknown				Perform. Deficiencies	
Condition Data:	Units sq.m	Exc. 0	Good 4.7	Fair 0	Poor 0		
Comments: Thick overgrowth at inlet.							
Recommended Work:				Rehab <input type="checkbox"/> Replace <input type="checkbox"/>		Maintenance Needs:	
Timing:				Urgent <input type="checkbox"/> < 1yr <input type="checkbox"/> 1 - 5 yr <input type="checkbox"/> 6 - 10 yr <input type="checkbox"/>		<input type="checkbox"/> Urgent <input type="checkbox"/> 1 year <input type="checkbox"/> 2 year

Figure 8 Overgrowth at Inlet

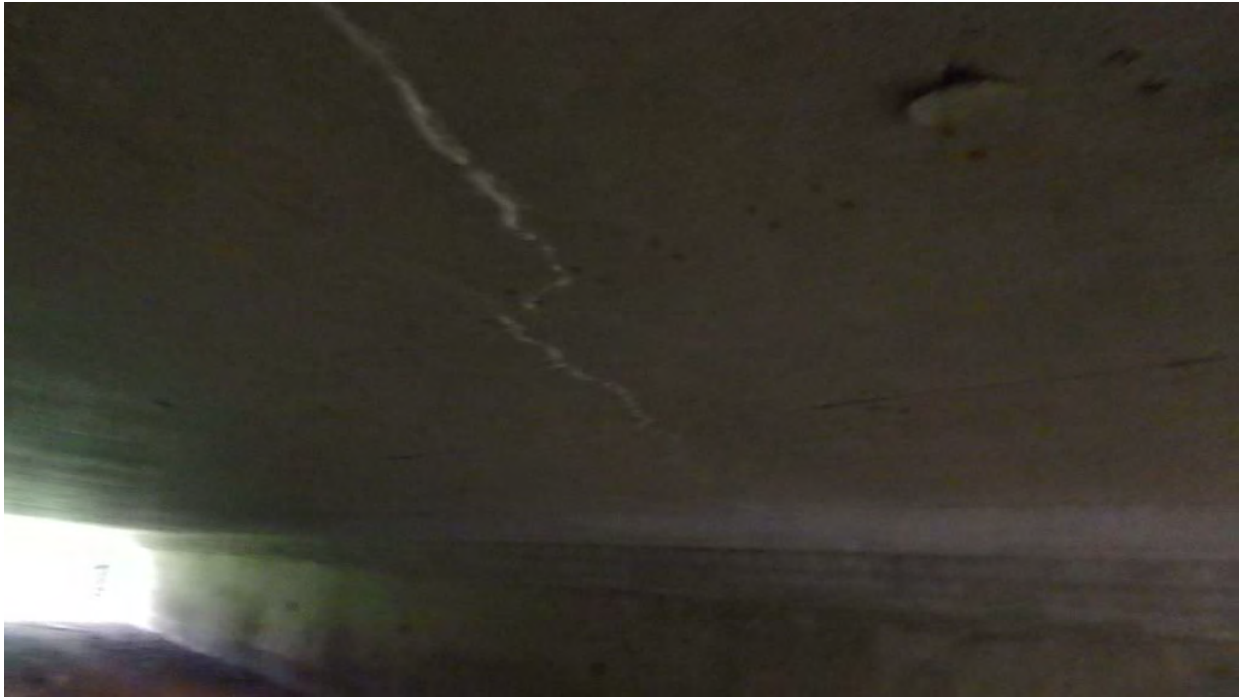
Figure 9 Transverse Soffit Crack

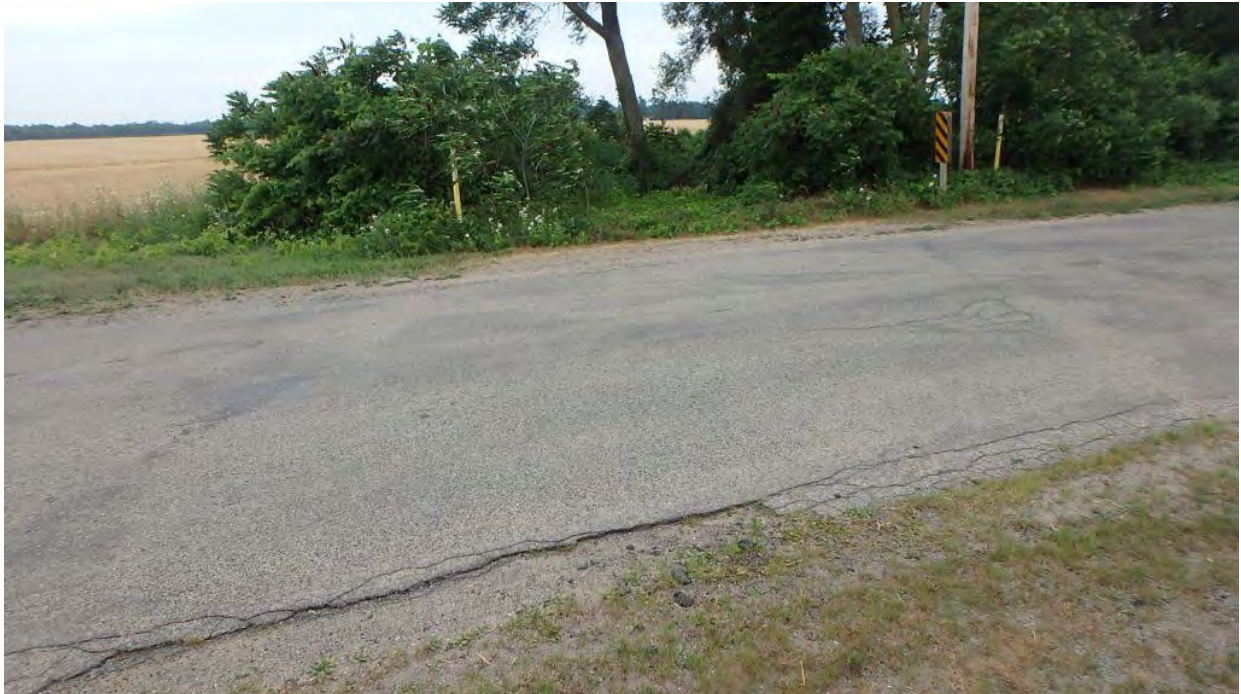
Element Group:		1600 Approaches				Length:	30
Element Name:		1601 Wearing Surface (Approaches)				Width:	6.5
Location:		Top of Deck				Height:	
Material:		2 Asphalt				Count:	1
Element Type:						Total Quantity:	195 sq.m
Environment:		Moderate				Limited Inspection:	
Protection System:		Unknown				Perform. Deficiencies	
Condition Data:	Units sq.m	Exc. 0	Good 0	Fair 195	Poor 0		
Comments: Settlement at structure edges. Cracking throughout at approaches.							
Recommended Work:				Rehab <input checked="" type="checkbox"/> Replace <input type="checkbox"/>		Maintenance Needs: Bridge Surface Repair	
Timing:				Urgent <input type="checkbox"/> < 1yr <input type="checkbox"/> 1 - 5 yr <input type="checkbox"/> 6 - 10 yr <input checked="" type="checkbox"/>		<input type="checkbox"/> Urgent <input type="checkbox"/> 1 year <input checked="" type="checkbox"/> 2 year

Figure 10 Wearing Surface
