LOT 16 CONCESSION 4 – 5 CHARLOTTEVILLE

Site Number D00034

CONCESSION 5 ROAD, CHARLOTTEVILLE

Ontario Structure Inspection Manual - Inspection Form

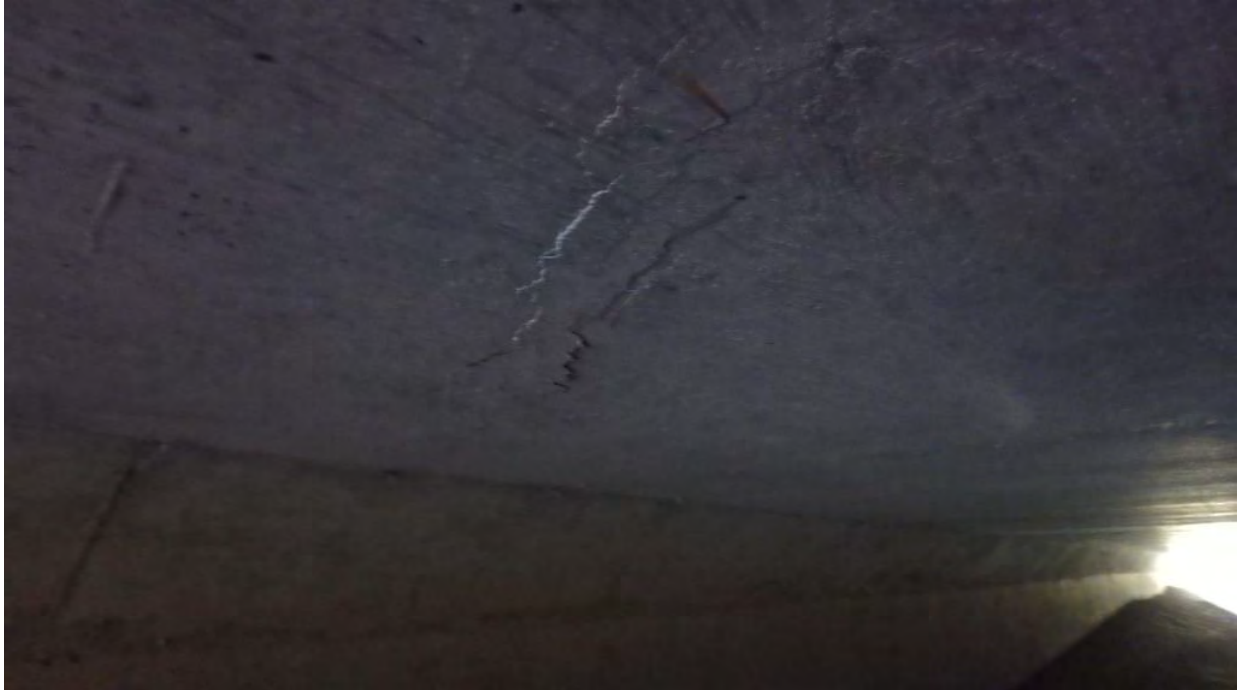
Figure 8 Narrow Crack in Soffit

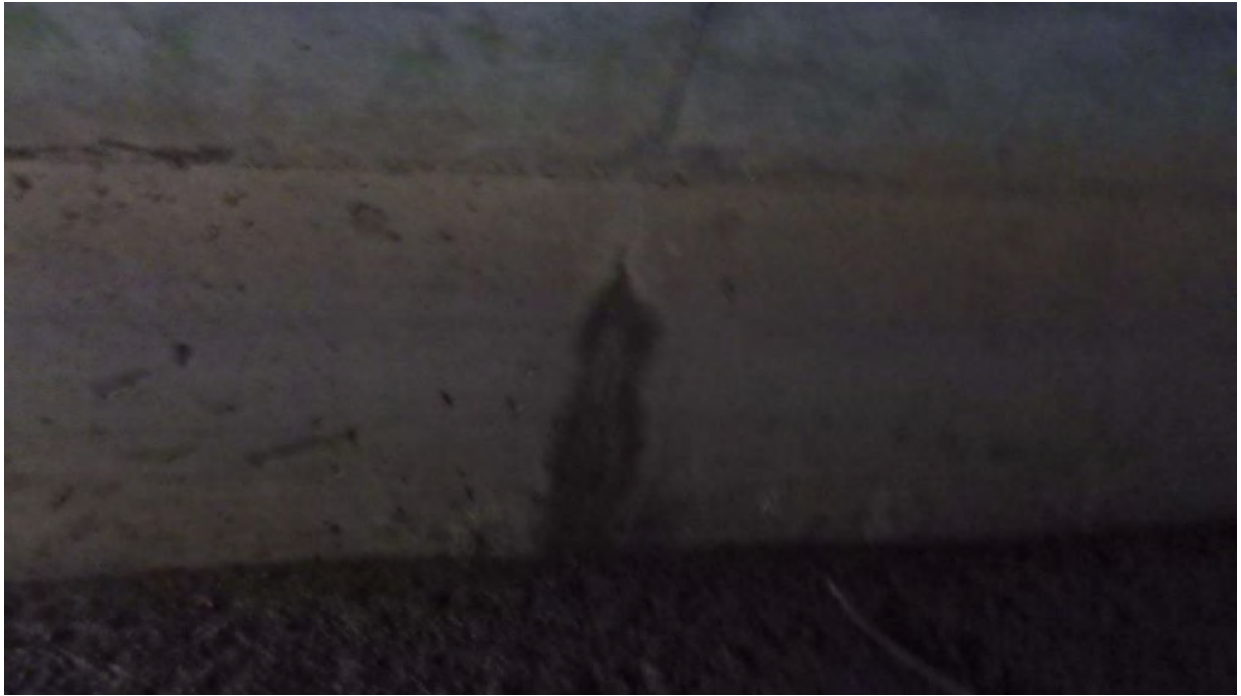
Figure 9 Narrow Vertical Crack in West Wall

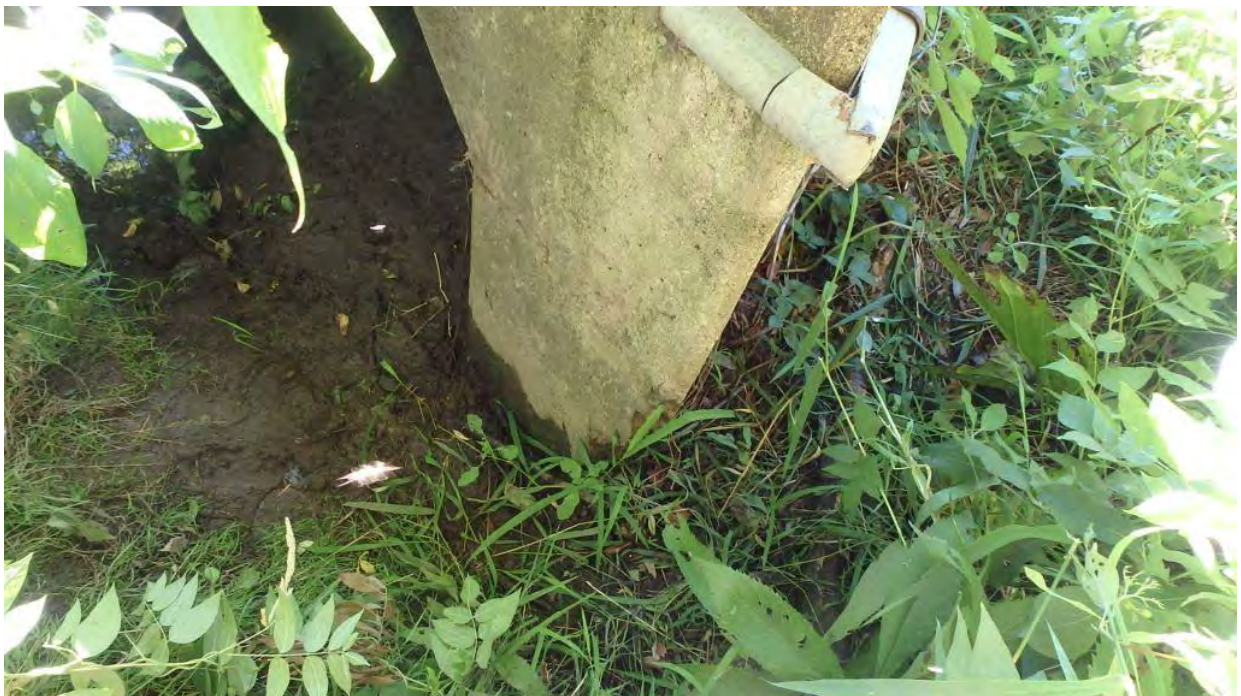
Figure 10 Delamination at NW Quadrant

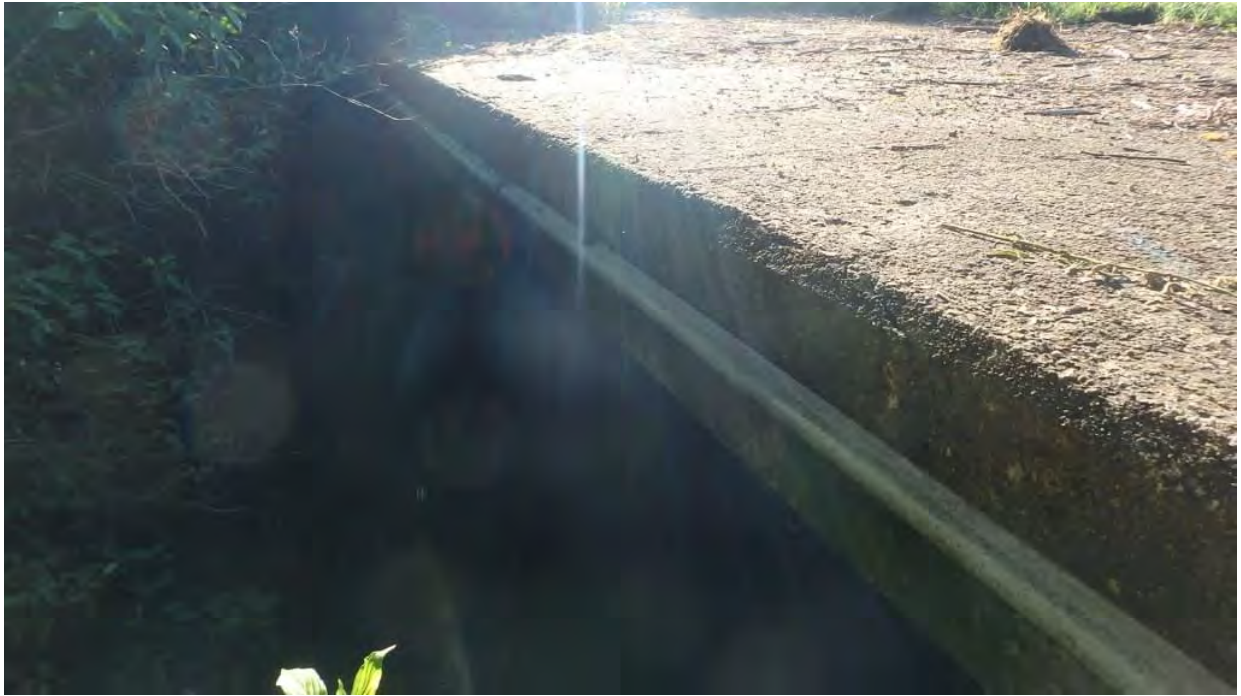
Figure 11 Utility Attached at Inlet
