**BUILDING CONDITION ASSESSMENT REPORT
VARIOUS COUNTY BUILDINGS**

044-P-0014110-0-00-100-01-TO-R-0001-00

December 2017

4.42 Courtland Scout Hall

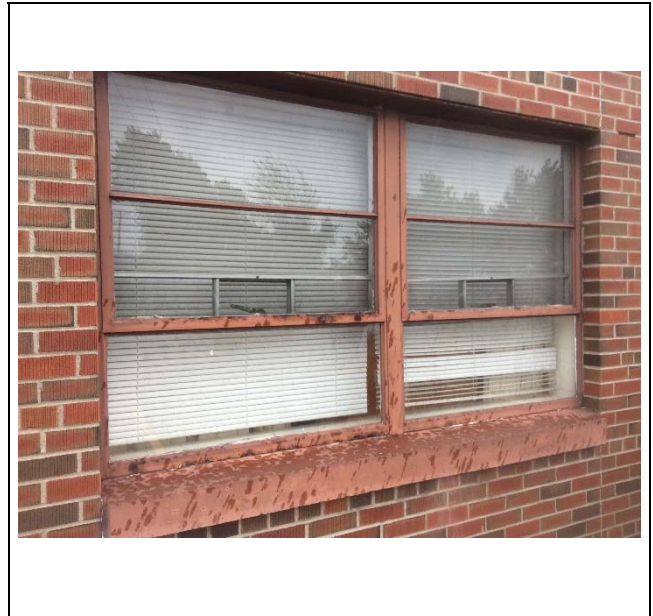
Photo 2: Window with steel frame.

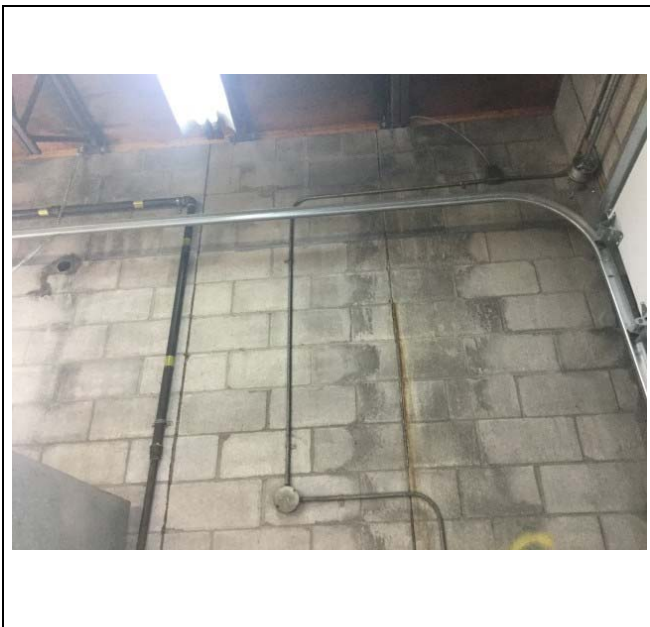
Photo 3: Infiltration on the concrete block wall.

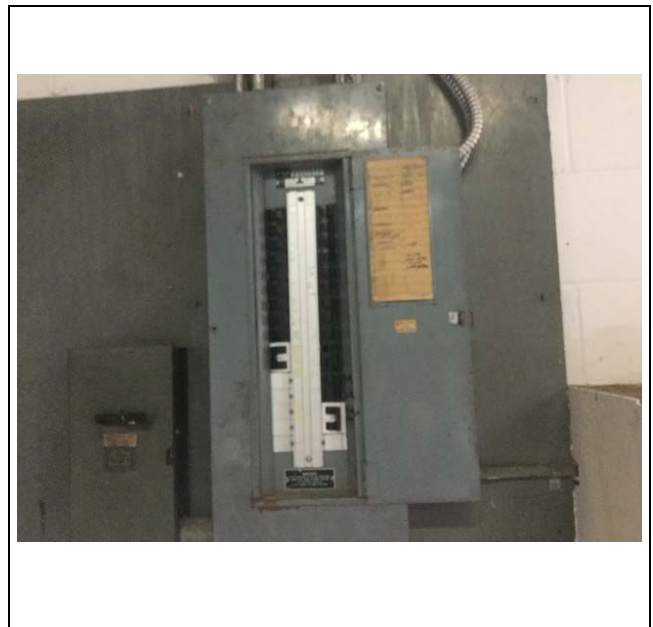
The Electrical Service for the building is fed from an underground connection to the main switch and panel at 120/240V. It is then distributed to secondary panels. The electric meter is located outside the building and is not protected by a cabinet. The electrical distribution appears to be in overall poor condition. The main switch and panels are old and have reached their service life, replacement should be expected in the near future. There is no generator.

Photo 4: Old electrical panel and main switch.
