**WATERFORD CAUSEWAY BRIDGE**

Site Number 120000

**ST. JAMES STREET, WATERFORD**

**Ontario Structure Inspection Manual - Inspection Form**

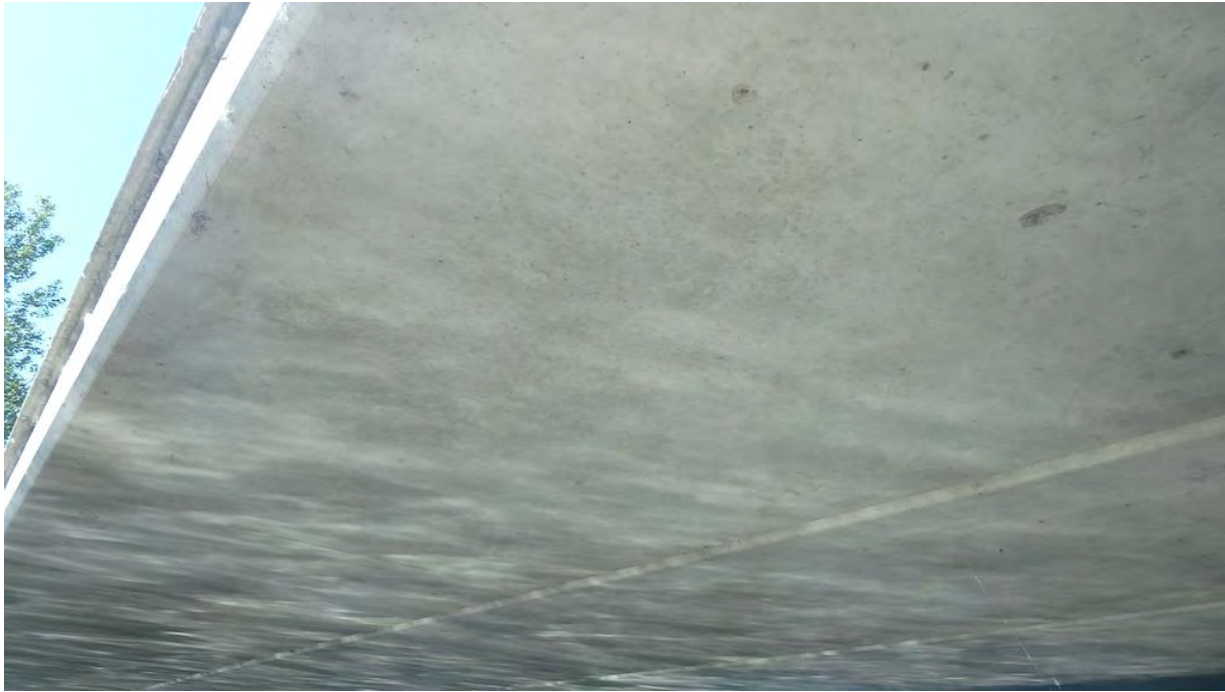
Figure 9      Soffit

Element Group:		500 Beams/MLE's				Length:	
Element Name:		501 Girders				Width:	
Location:						Height:	
Material:		12 Precast Concrete				Count:	1
Element Type:						Total Quantity:	1 Each
Environment:						Limited Inspection:	
Protection System:		Unknown				Perform. Deficiencies	
Condition	Units	Exc.	Good	Fair	Poor		
Data:	Each	0	0.7	0.3	0		
Comments: Beams are fair to good condition.							
Recommended Work:    Rehab <input type="checkbox"/> Replace <input type="checkbox"/>					Maintenance Needs:		
Timing:    Urgent <input type="checkbox"/> < 1yr <input type="checkbox"/> 1 - 5 yr <input type="checkbox"/> 6 - 10 yr <input type="checkbox"/>					<input type="checkbox"/> Urgent <input type="checkbox"/> 1 year <input type="checkbox"/> 2 year
