# 2018 OSIM INSPECTIONS SUMMARY REPORT

Our Project #18-010

August 13, 2018

## NORFOLK COUNTY 2018 OSIM INSPECTIONS SUMMARY REPORT

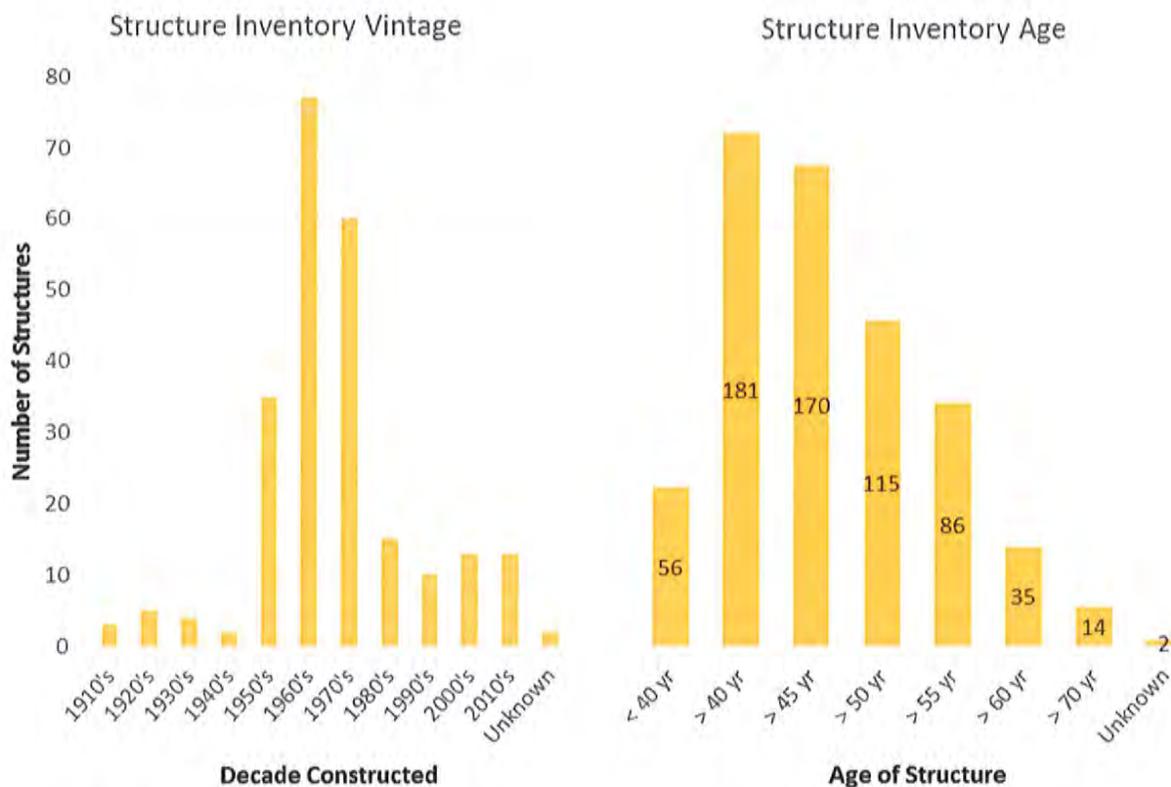
## APPENDIX F: STRUCTURE INVENTORY AGE

The types of structures owned by the County are varied in size, age, and material. An analysis of the current inventory reveals that over 50% of those examined are rigid frame or box concrete structures. This style of construction was prevalent throughout the late 1940's until the mid-1970s. Examining the age of structures reveals that approximately 75% of the inventory was built before 1978 and is over 40 years old. Current standards dictate that bridges are to be designed with a lifespan of 75 years, however damage and deterioration due to wear and exposure is inevitable and degradation of structural elements may occur much earlier.
